Assembly Fit-up Issue: Investigation of a First Stage High Pressure Gas Turbine Rotor

Antonio Miranda Rivera
Master of Engineering in Mechanical Engineering
Advisor: Rafael Nieves, PharmD.
Mechanical Engineering Department
Polytechnic University of Puerto Rico

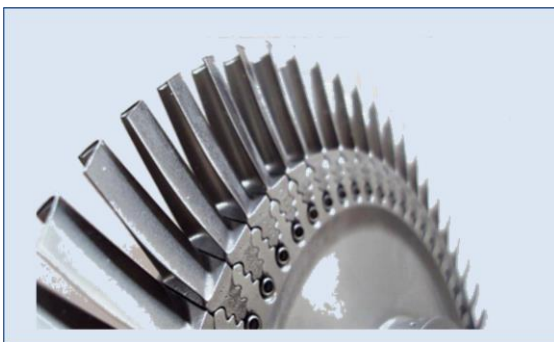
Figure 2
Turbopfan HPT Rotor Sub-Assembly

During the rotor sub-assembly, that is made up of blades and disk, the customer reported fit-up issues that affected the assembly line normal flow which then affected the total cycle time.

The blade dovetail configuration incorporates 4 total pressure faces. These blades will slide in into the disk which will incorporate a similar dovetail design. The assembly fit-up issues occur during the installation process of the high-pressure turbine blades and disk.
