# *Analysis of Billboards Signs Collapse Due to Intensive Wind of Hurricane Maria*

*Ernesto J. Santiago Caraballo, B.S.C.E., P.E.  
Master of Engineering in Civil Engineering  
Advisor: Gustavo E. Pacheco-Crosetti, Ph.D.  
Civil and Environmental Engineering & Land Surveying Department  
Polytechnic University of Puerto Rico*

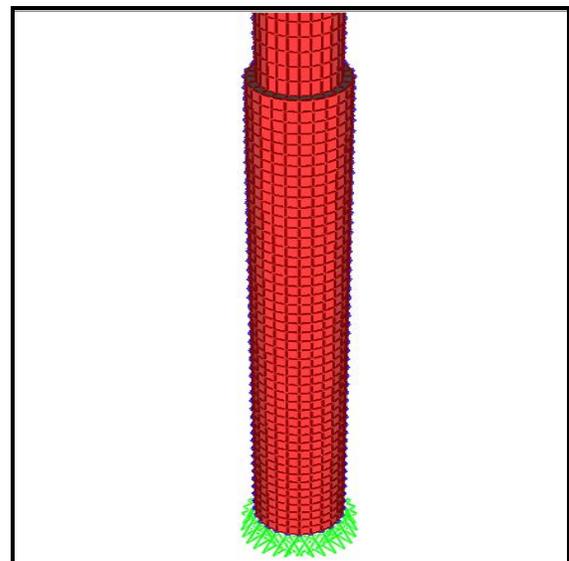
**Figure 7**  
**FEA Software Sap 2000 Analytical Model**

Remember that the most common ASTM A-36 material was assumed and defined for this analysis. We did not find real evidence of the kind of steel was used in the existing condition.

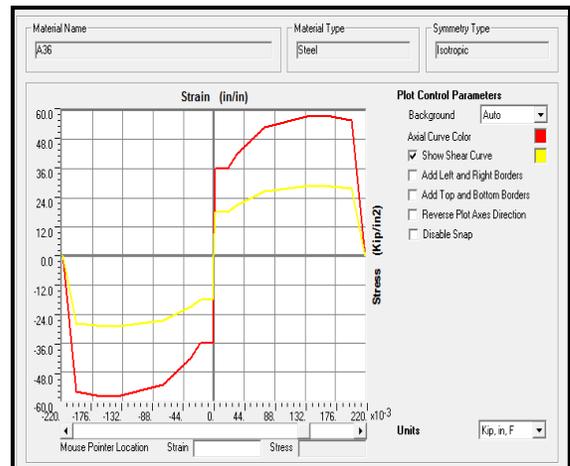
**Figure 11**  
Stress vs. Strain Relationship for Steel A-36  $F_y = 36,000$  ksi

Material nonlinearity can be defined from the stress-strain relationship as shown in Figure 11.
