Building Rehabilitation of a Military Colonial Architecture: Miraflores Gunpowder Storage Building

Sadally Orama Figueroa

Master of Engineering in Civil Engineering

Polytechnic University of Puerto Rico

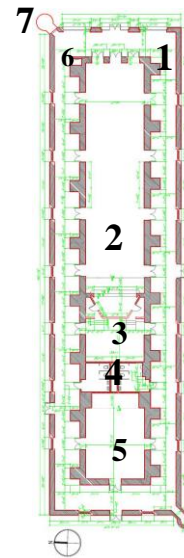
Figure 2
Miraflores Gunpowder Magazine's As-Built
Plan View, Not to Scale

To complete a full map of the structure, elements, materials and connection were identified. Table 1 shows the building spaces, element and materials and figure 2 shows its location on floor plan view.

#	Space	Description
1	Surround Hall	Clay brick thick wall with a concrete layer, openings to exterior 10% with iron fence, 50% open and 40% walled up with concrete brick.
2	Main Space (or Chapel)	Clay brick thick wall and ceiling. Broken wood door and evidence of air condition system installation.
3	Sacristy Space	Wood panel covering reinforced concrete walls, Clay brick thick walls
4	Bathrooms	Height ceiling and complete bathroom features
5	Small Chapel	Evidence of air condition system installation, Clay brick thick walls
6	Building Roof	Inverted beam, assumed connection with buttresses, evident roof treatment, deteriorated drainage system.
7	Sentry boxes	At the building front 90% missing, at the back some problems with vegetation that are peeling off the concrete coating, the ceiling (half dome) has several cracks.

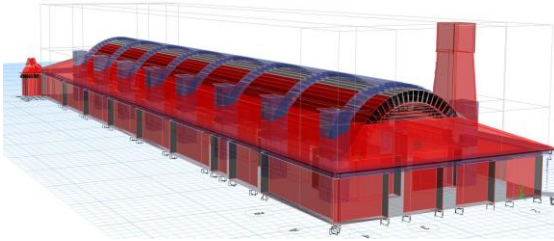
Figure 14
Structure Model on Etabs: Front Facade

As-built plans were made using AutoCad application which makes easier the construction of the 3D model and using it as a base. The structure was modeled using an engineering software product named Etabs 2015, version 15.2.2. Transferring all information collected in the digital model was the same thing as making a 3d free body diagram. It is necessary to understand or at least have an idea of the structure behavior. For example, the junction between the curved concrete beam and the clay brick buttress cannot be seen. The connection

between those two elements was assumed and interpreted in the model as a semi-rigid beam to column connection to establish the linking. The interior and exterior wall, the sentry box, the barrel vault, the buttresses, the reinforced concrete beam and roof were modeled with their respective measurements. Using the data collected in the investigation and previously discussed assumptions the specific properties was added to the modeled structure. Figure 14 shows the building model.

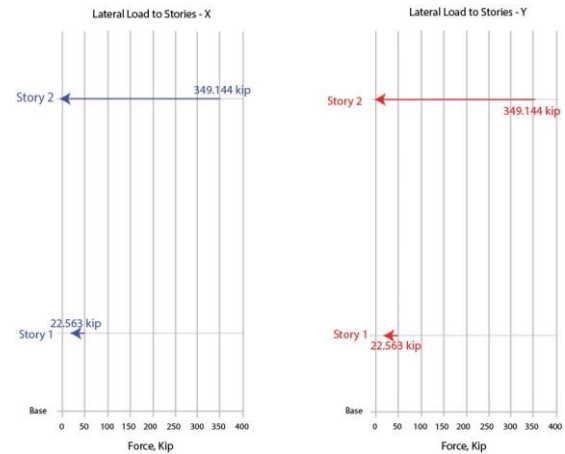
Figure 15
Story Forced Calculated by Etabs

The calculated base shear was 425.552 kips (425,000 lb.) for x and y direction with a used period of 0.384 sec. As shows on figure 15, for both direction, was calculated a seismic force at 8 ft. above base 22.56 kips (22,560 lb.) and at 32.79 ft. (bell tower) a 349.14 kips (349,140 lb.).

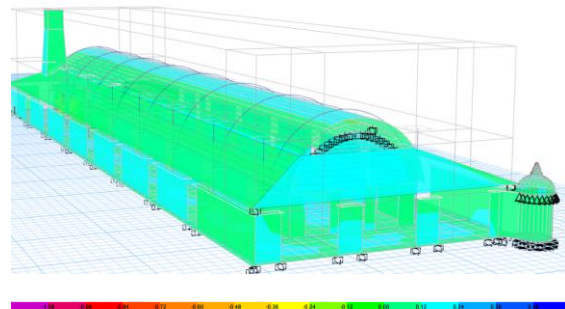
Figure 16
Direct Force per Unit Length by Etabs

Reading the result obtained, the building generates an enormous force and moment at the base for seismic reaction. That behavior was expected corresponding massively of the majority of the studied elements. Figure 16 shows the direct force per unit length acting on the elements. Predominant colors are green and cyan with the corresponding value from 0.00 to 0.24, respectively.

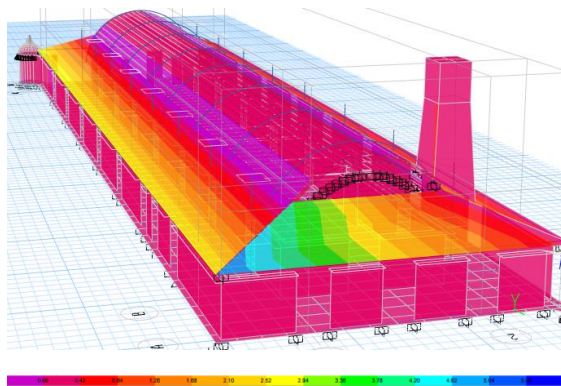
Figure 17
Maximum Forces per Unit Length Graphic by Etabs

The analysis result was a wind applied force of 12.59 kips (12,590 lb.) and 19.69 kips (19,690 lb.) at top story as maximum x and y direction respectively. The structure had a maximum displacement of 0.00764 of an inch and a minimum of 0 of an inch at the base. No significant drift of 0.000031 and a shear force of 52 kips (52,000 lb.).

Figure 17 shows the maximum principal force per unit length acting in the element. The predominant color for clay brick element is fuchsia purple wish value range is from 0.00 to 0.42. On the top surface of the reinforced concrete roof the range are variable.
