VULNERABILITY OF SCHOOLS IN PUERTO RICO TO TSUNAMI EVENTS

RESEARCH FINAL REPORT

POLYTECHNIC UNIVERSITY OF PUERTO RICO

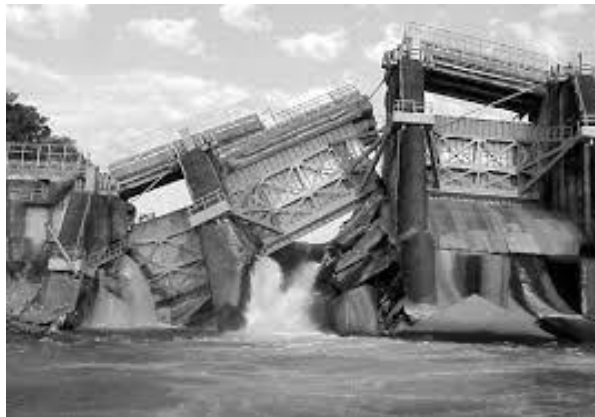
Strong earthquakes can provoke dam walls to crack and later subside, causing severe flooding to areas nearby (Figure 2-8).

Figure 2-8 Collapse of the Shih-Kang dam

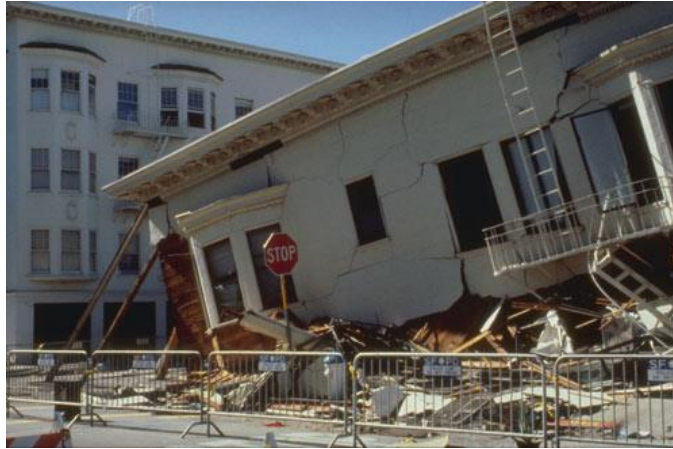
can occur beneath buildings, houses, or other structures, it can sink it completely to the ground or overturn and buried tanks and other cavities rise to the top. The increased use of reclaimed land for urbanization has increased the vulnerability of many parts in the Eastern Caribbean (The University of West Indies) as shown in Figure 2-9.

Figure 2-9 Landfill liquefied in the 1989 Loma Prieta earthquake.

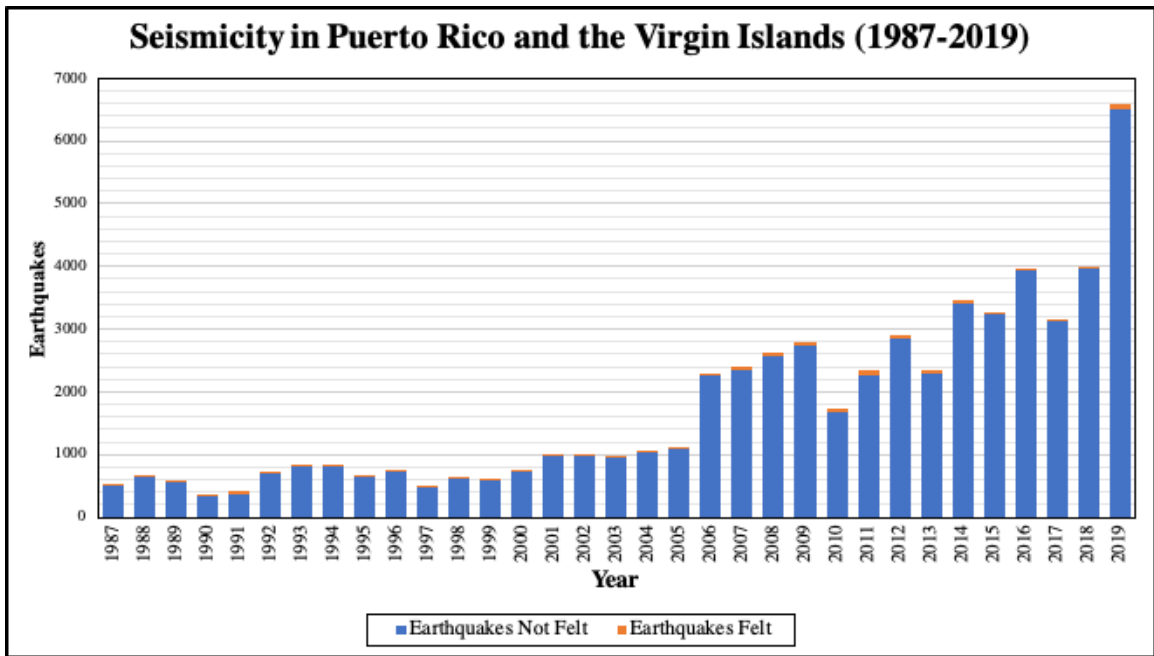
From 1987 to 2019, the Puerto Rico Seismic Network (PRSN) located a total of 56,760 earthquakes (Figure 2-14). Of those events, only 928 earthquakes have been felt considering the Richter scale.

Figure 2-14 Distribution of earthquakes (1987-2019)

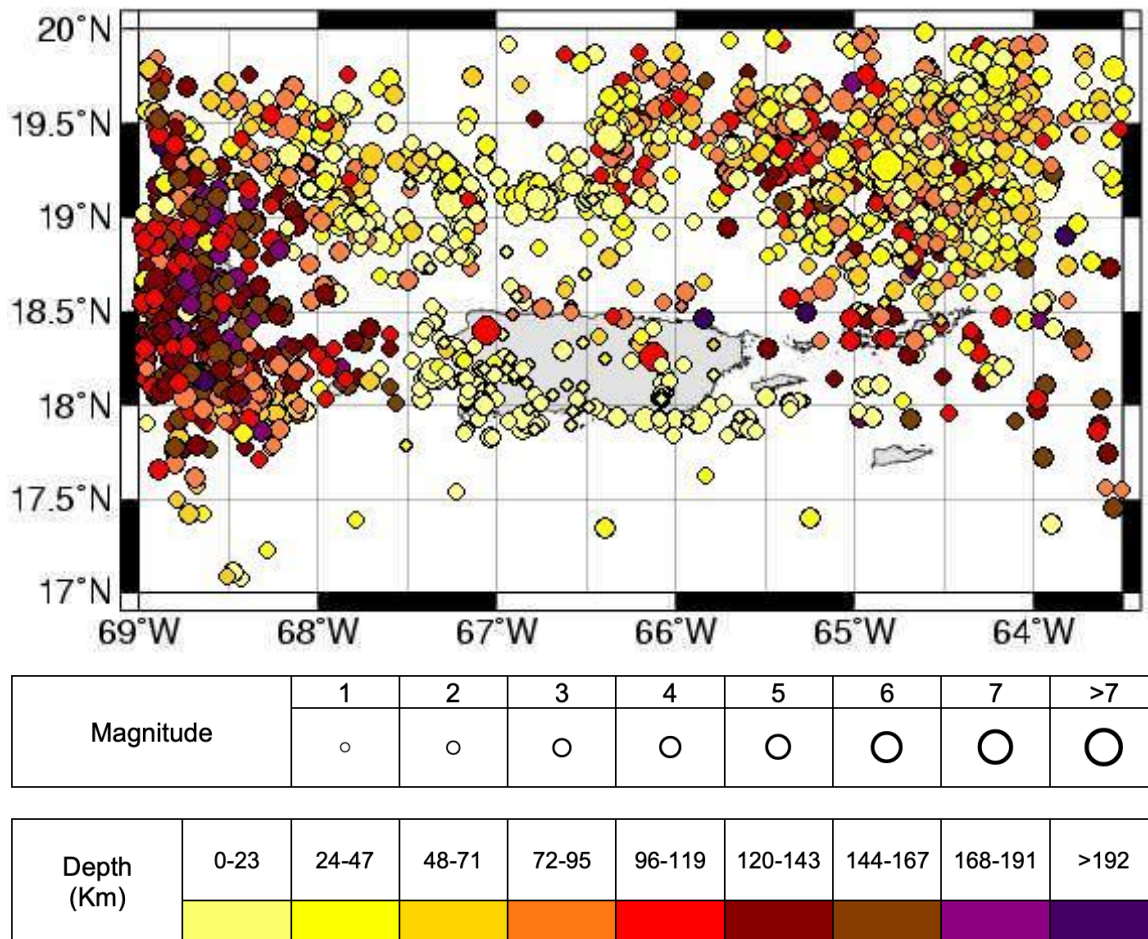
The events mentioned in Table 2-2 are shown according to their location by size due to magnitude and color due to depth (Figure 2-15). The map shows the epicentral origin where the seismic events occurred from 2008 to 2020. The earthquakes are shown with their respective size of figures due to the number of magnitude and depth in the intensity of colors.

Figure 2-15 Epicentral map of the earthquakes felt in Puerto Rico and the Virgin Islands from 2008 to 2020 (PRSN-UPRM)

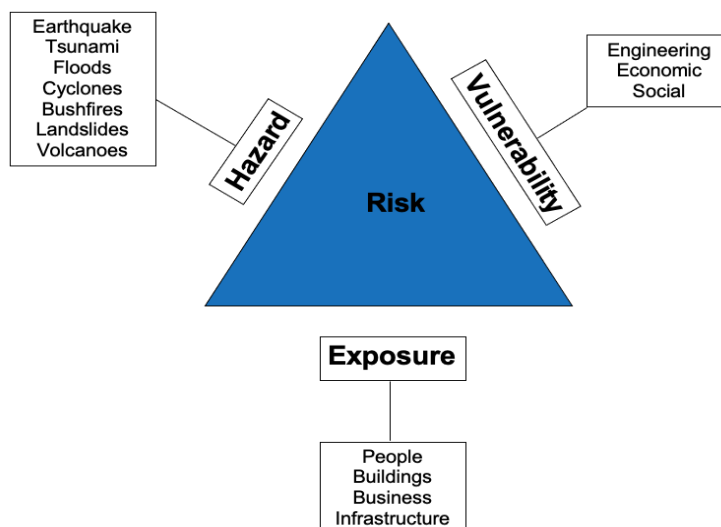
Figure 2-16 Trigram of disaster risk

The diagram represents the relationship between risk and the components associated with harm through descriptions of hazard, exposure, and vulnerability (Figure 2-16).

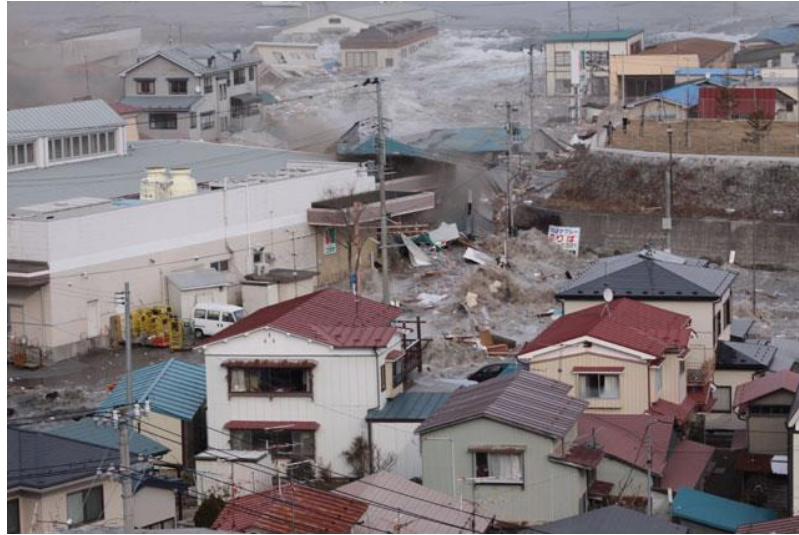
Figure 2-20 Effect of Tsunami Flooding in Yamada, Japan
From “Tsunami Inundation”, by Earthquake Memorial Museum, 2011,
National Weather Service, (https://www.weather.gov/jetstream/tsu_inundation). Copyright 2011 by Yamada.

The Figure 2-20 shows the flooding from the March 11, 2011, tsunami and earthquake in Yamada city in northern Japan transported houses in collision.

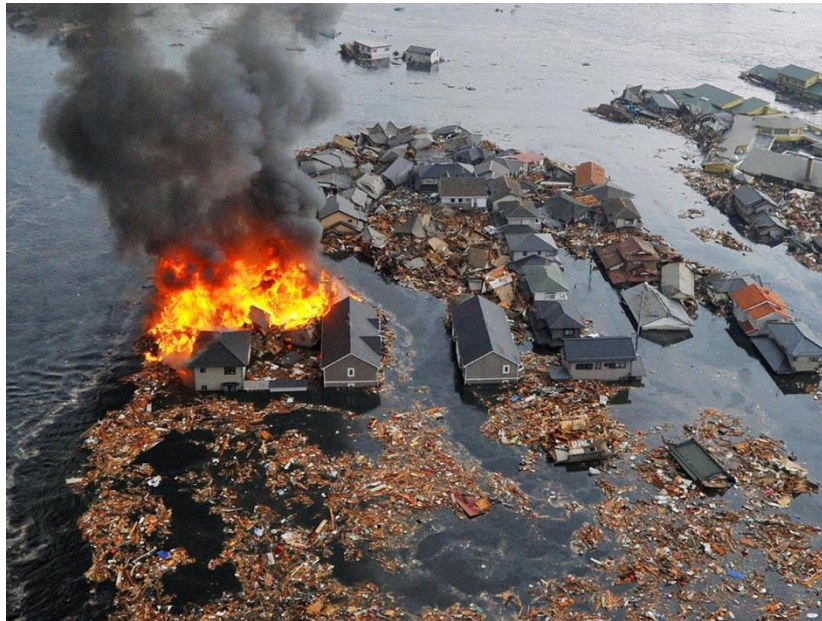
Figure 2-21 Impact of Tsunami Wave Impact in Sendai, Japan

The city of Sendai in Japan was hit by waves of the tsunami on March 11, 2011, that caused a fire between flooded houses (Figure 2-21).

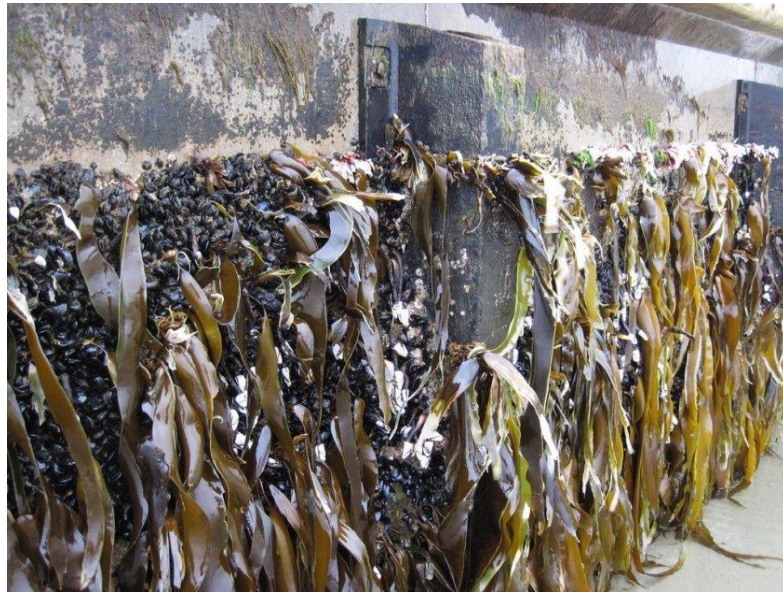
Figure 2-22 Effect of Erosion Caused by Tsunami Waves on The Japanese Dock

The March 11, 2011, tsunami in Japan left debris and marine life on an abandoned Japanese dock (Figure 2-22).

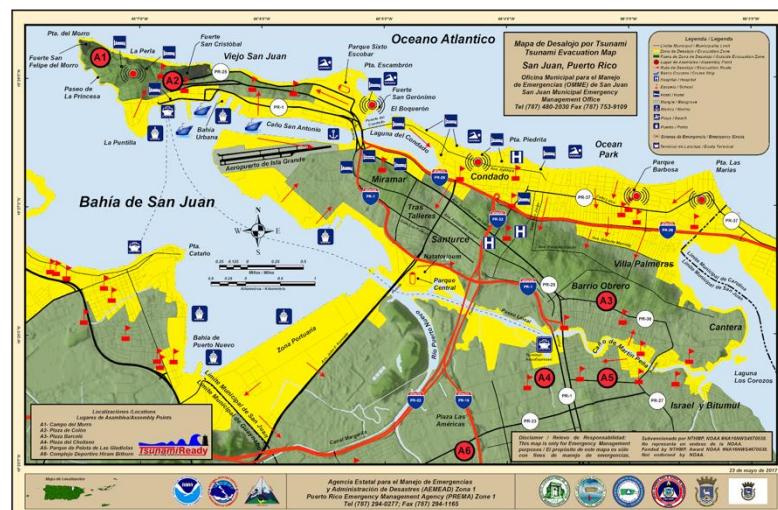
Figure 2-23 Evacuation Map of San Juan, Puerto Rico in PDF

The evacuation maps are available on the PRSN website as PDF format (Figure 2-23) and as Web maps applications (Figure 2-29). Web maps applications can be accessed from the

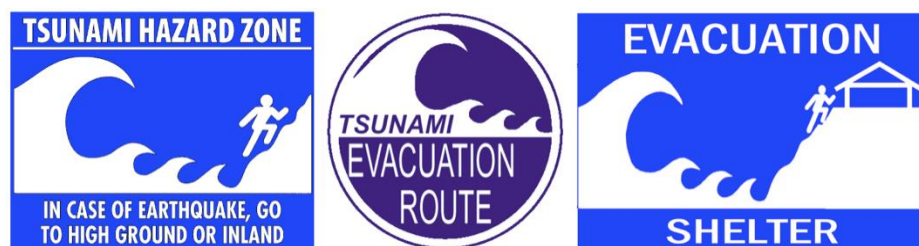
Figure 2-25 Tsunami sign in America

The Figure 2-25 shows the signs: (a) indicates the danger zone sign, (b) shows the evacuation route, (c) exposes the evacuation shelter sign.

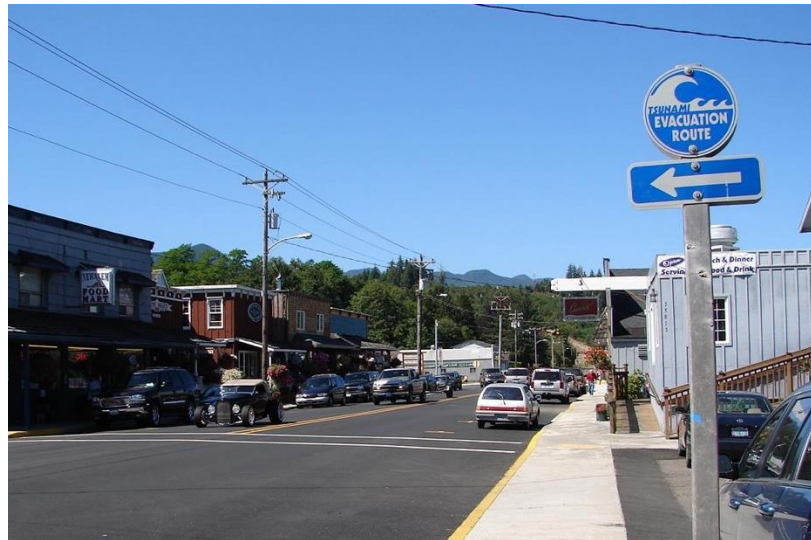
Figure 2-26 Tsunami Evacuation Route Sign in Oregon

The Figure 2-26 shows an example of a sign to indicate the tsunami evacuation route at an intersection in Nehalem, Oregon.

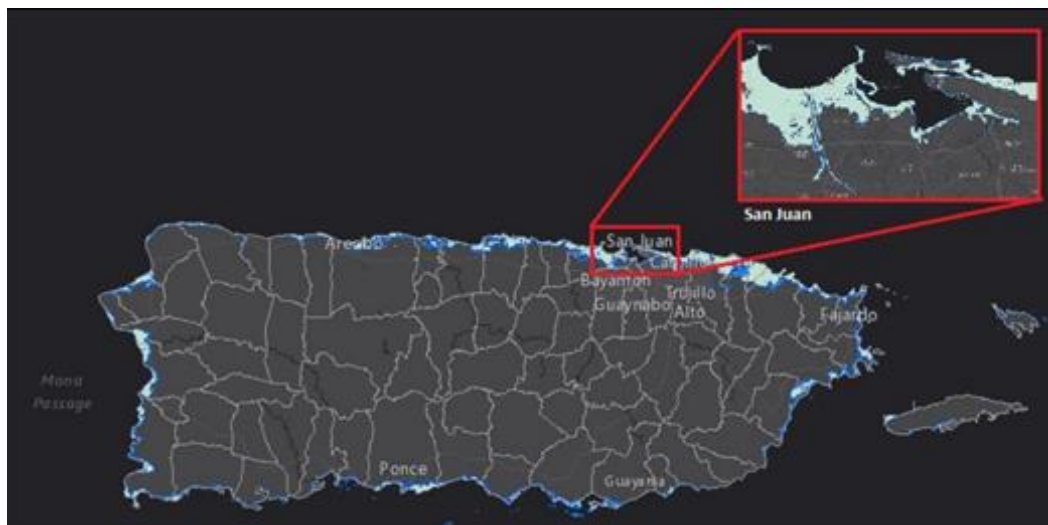
Figure 2-28 Model tsunami flood zone “MOM” (2012)

Trench north of Puerto Rico ". Based on this model, the eviction zones were delimited (Figure 2-28) under the following criteria: 2012 tsunami flood model, site topography, natural barriers, and a safety factor. Therefore, the PRSN worked on the tsunami flood and evacuation maps (Puerto Rico Seismic Network [PRSN], 2019).

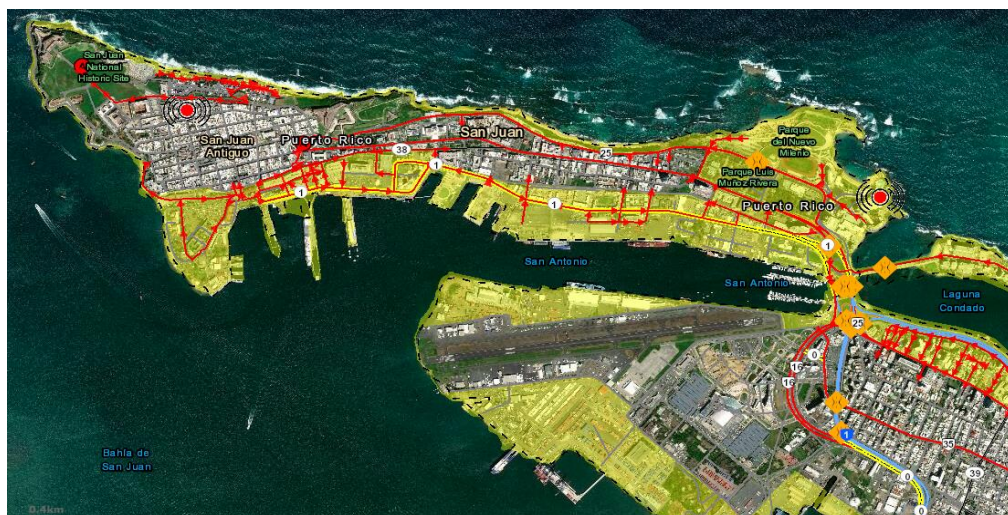
Figure 2-29 Evacuation Map of San Juan, Puerto Rico on the Web

Evacuation routes in Puerto Rico can be identified through the evacuation and tsunami flood maps discussed earlier in Zoning. These routes are represented in red by the roads ending in arrows (Figure 2-29).

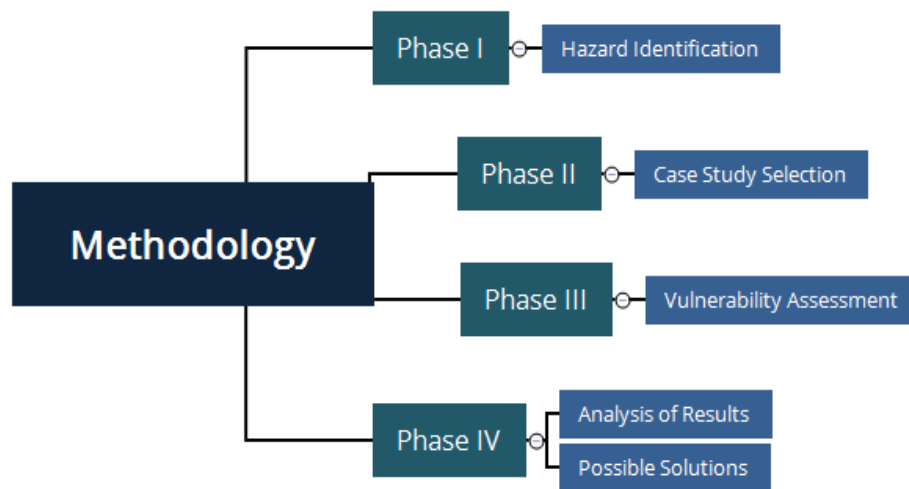
Figure 3-1 Diagram of the Methodology to be Developed in the Study

For the data collection process, databases of the “Perfil Escolar” for 2018-2019 corresponding to the Department of Education are used to find the population of the schools. In addition, the Eviction Maps studied by the University of Puerto Rico-Mayagüez Campus and the Puerto Rico Seismic Network are used, which cover the flood zones determined for the worst-case scenario due to tsunamis generated by local earthquakes. The maps are used in PDF and digital format accessed through the Puerto Rico Seismic Network browser to know the schools that are in danger zones. Likewise, the satellite map is used through the Google Maps program to locate schools. On the other hand, the 2020 list of shelters from the Puerto Rico Emergency Management Agency (PREMA) and the 2020 list of voting centers from the Puerto Rico State Elections Commission are used for the use of schools. In the data analysis process, Google Earth and ArcGIS programs are used to georeference the evacuation maps and the maps of each municipality. Figure 3-1 presents a summary of the study methodology.

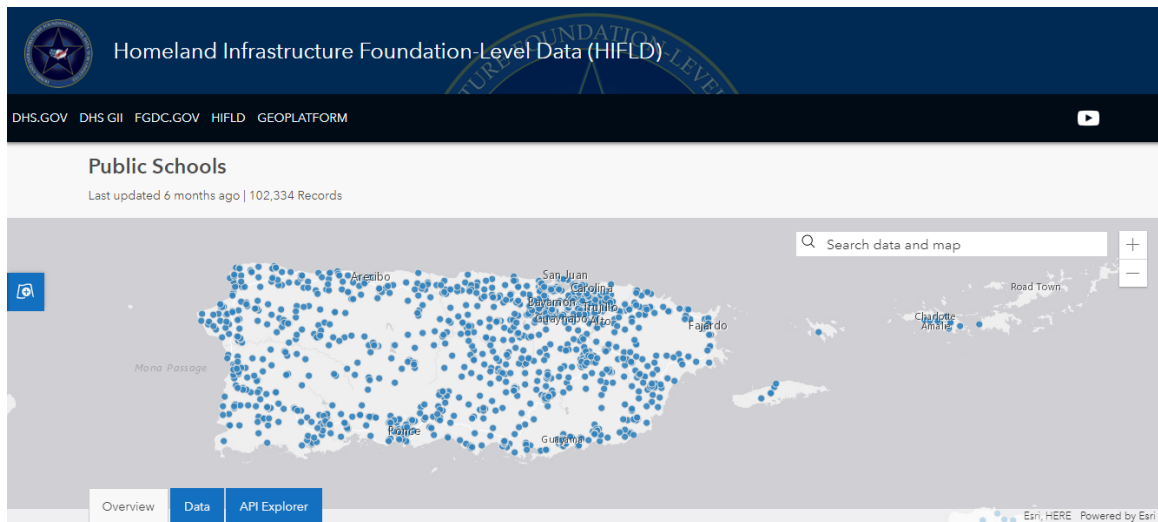
Figure 4-1 Layer of Public Schools in HIFLD Web

Geospatial data is accessible to the public domain and downloaded as CSV, KML, and Shapefile. These files are formats that contain geographic data for use, but not all, in a Geographical Information System (GIS) as mentioned above. HIFLD data (Figure 4-1) is accessed through web services that support application development and data visualization.

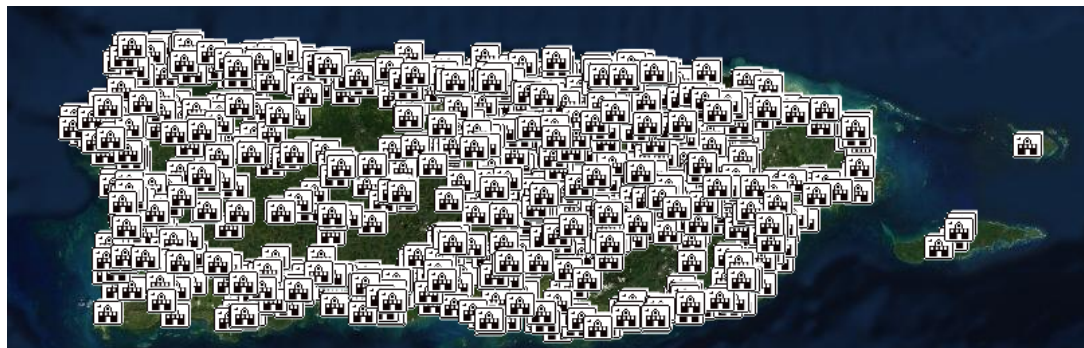
Figure 4-2 Layer of public schools in Map Viewer

Public schools are represented on a map (Figure 4-2) by compressed layer files containing their information: name, address, phone number, status, town, source date, level, latitude, longitude, and more. In a Map Viewer, the layer of the schools is displayed with icons for better representation and contrast with the rest of the geolocated elements on the map of Puerto Rico explained later.

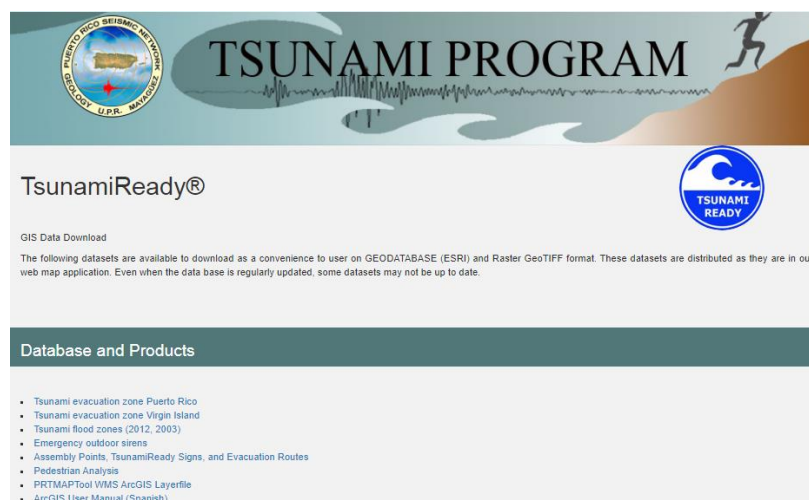
Figure 4-7 PRSN GIS Data Download

Tsunamigenic data are obtained through the Puerto Rico Seismic Network GIS Data (Figure 4-7). The Puerto Rico Seismic Network (PRSN) offers data sets available for download in GEODATABASE (ESRI) format. This Environmental Systems Research Institute (ESRI) is an international provider of GIS and the creator of ArcGIS, the mapping and spatial analysis software that we use to create layers with the tsunami data for Puerto Rico. As a reference, the evacuation and flood maps of the Puerto Rico Seismic Network are used (Figure 2-23 and Figure 2-29).

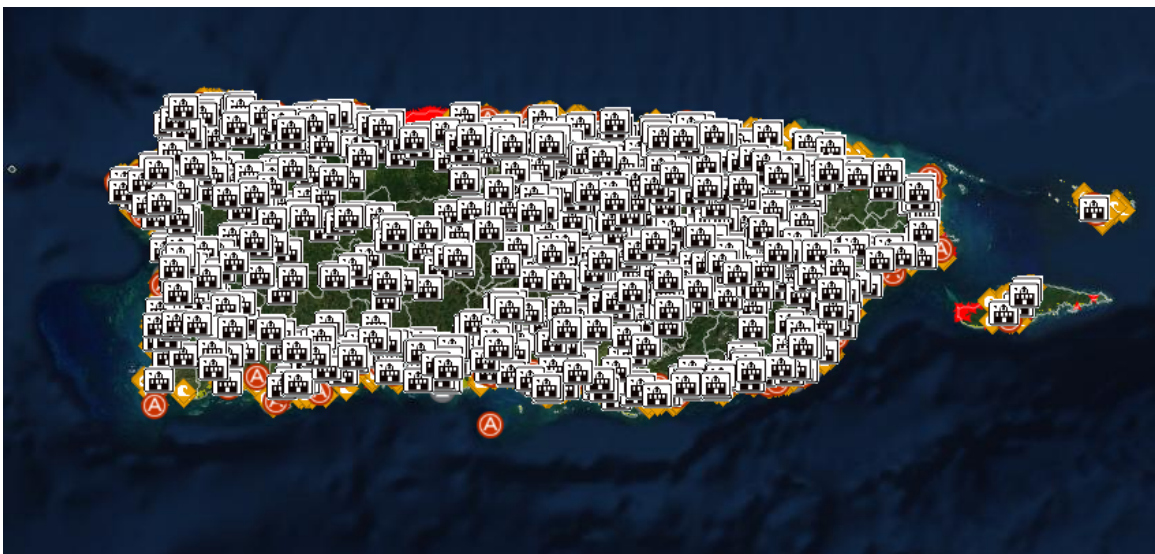
Figure 4-18 Schools in Puerto Rico in Tsunami Hazard Zones Web Map

The Web Map used in the next chapter to represent the findings by municipality contains an imagery basemap and a set of data layers (Figure 4-18). The layers that make up the map are (Figure 4-20): public schools, assembly places, evacuation route sign, sirens, evacuation zones, flood zones, municipality boundaries and roads. In Figure 4-19 the layers added to the municipality of San Juan are displayed.

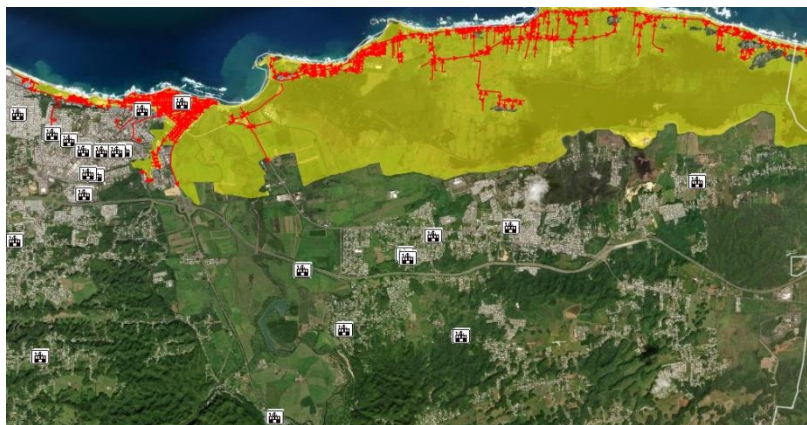
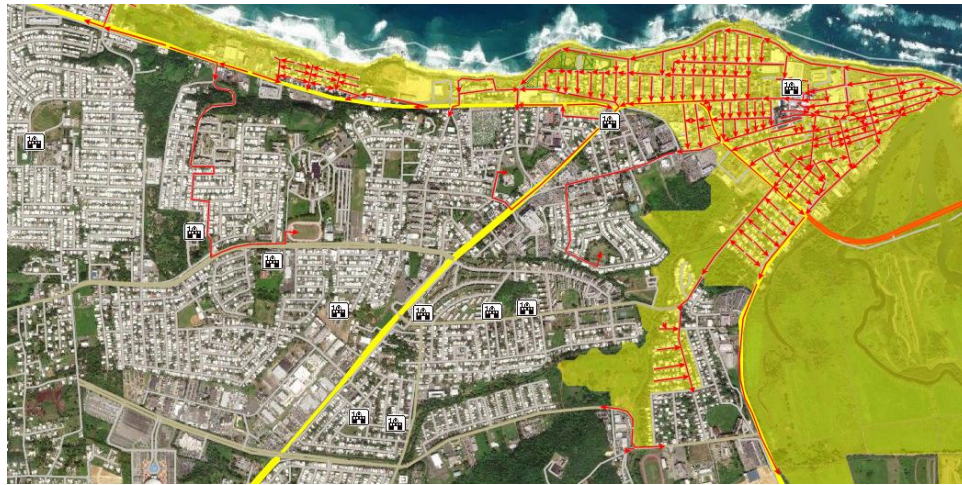
This municipality has 24 schools, of which only one is in a tsunami hazard zone. All schools are shown located in Figure 5-8 and Figure 5-9. While Figure 5-10 presents in Zoom the only school in danger.

Figure 5-8 Location of Schools in Arecibo

Figure 5-9 Schools located in tsunami hazard zones in Arecibo

Figure 5-10 Schools located in tsunami hazard zones in Arcibo [Zoom]

The school in danger is the Escuela Libre De Música (Especializada) with a population of 97 people. Therefore, the total school population that could be affected by a tsunami for this municipality is 97 people. Also, this school is not used as a polling station or refuge (Table 5-4).

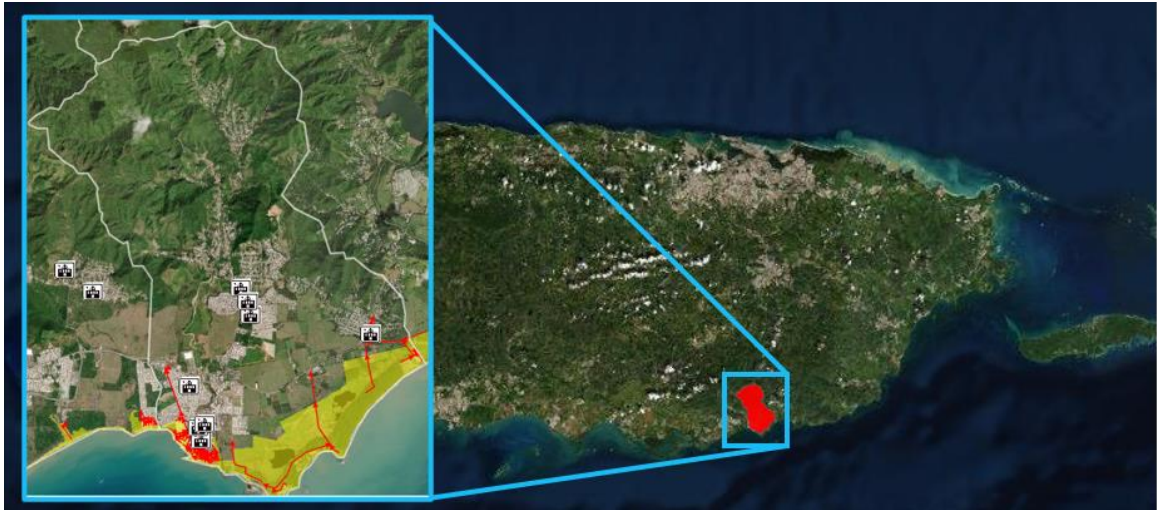
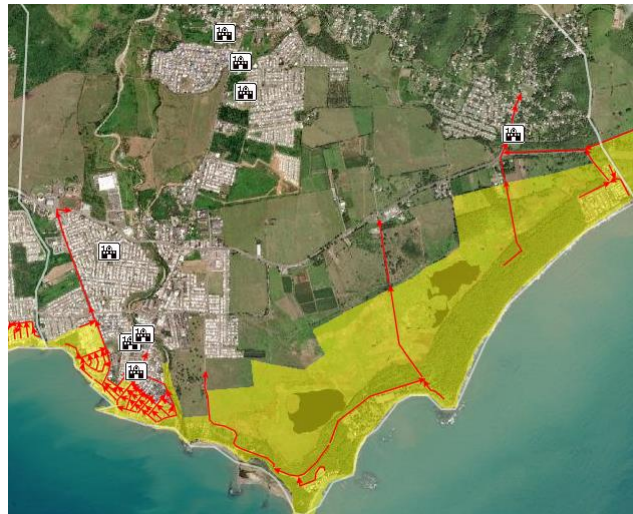
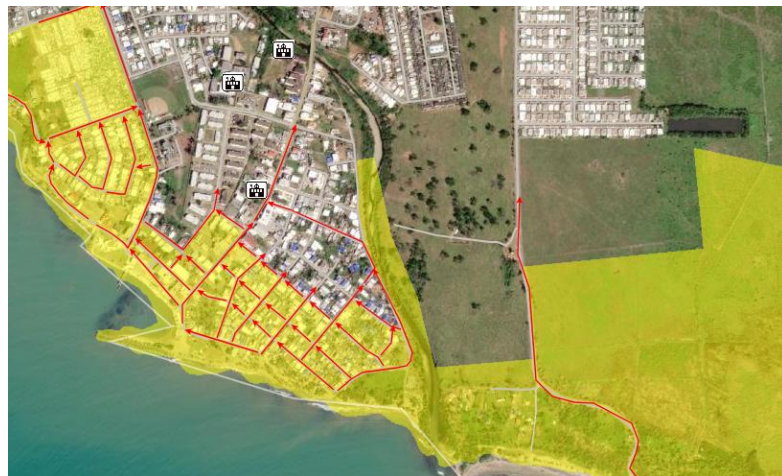
In this municipality there are 8 schools (Figure 5-11) and none of them are located in a tsunami hazard zone. This means that no school population in Arroyo could be affected by the impact of a tsunami. For this reason, for this municipality there is no table that summarizes the data of schools in hazard zone. However, Figure 5-12 and Figure 5-13 shows that there are only schools outside the tsunami hazard zone.

Figure 5-11 Location of Schools in Arroyo

Figure 5-12 Schools located outside the tsunami hazard zones in Arroyo

Figure 5-13 Schools located outside the tsunami hazard zones in Arroyo [Zoom]

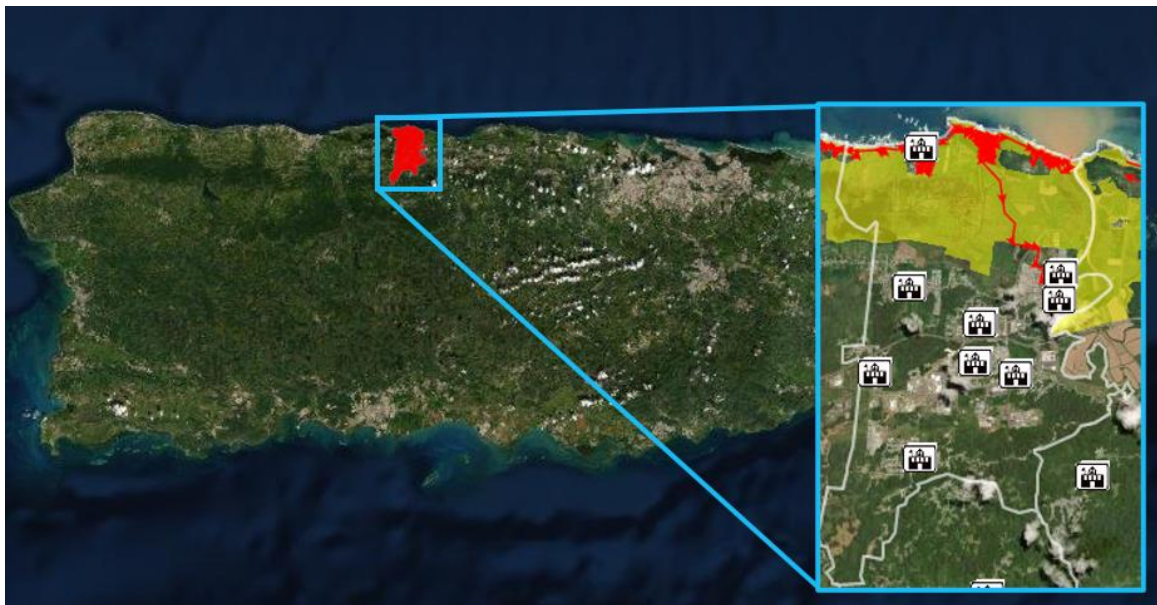
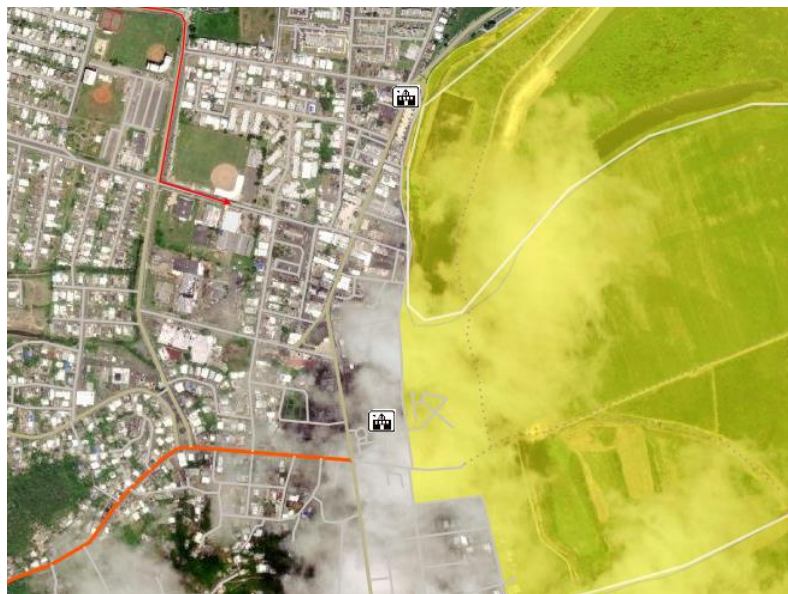
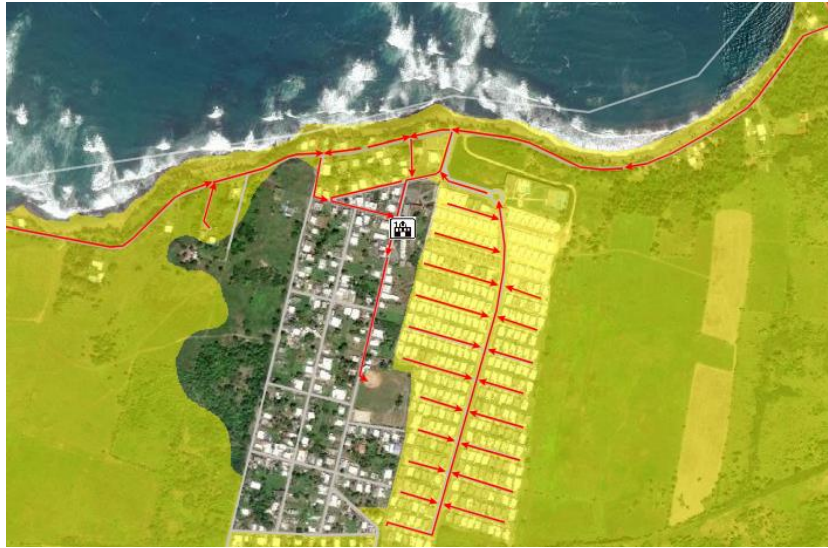
This municipality has a total of 9 schools (Figure 5-14) and none of them are in a tsunami hazard zone. Therefore, no school population in Barceloneta could be affected by the impact of a tsunami ash shown in Figure 5-15 and Figure 5-16. Because there are no schools in the hazard zone, a table with the data for the schools is not presented.

Figure 5-14 Location of Schools in Barceloneta

Figure 5-15 Schools located outside the tsunami hazard zones in Barceloneta

Figure 5-16 Schools located outside the tsunami hazard zones in Barceloneta [Zoom]

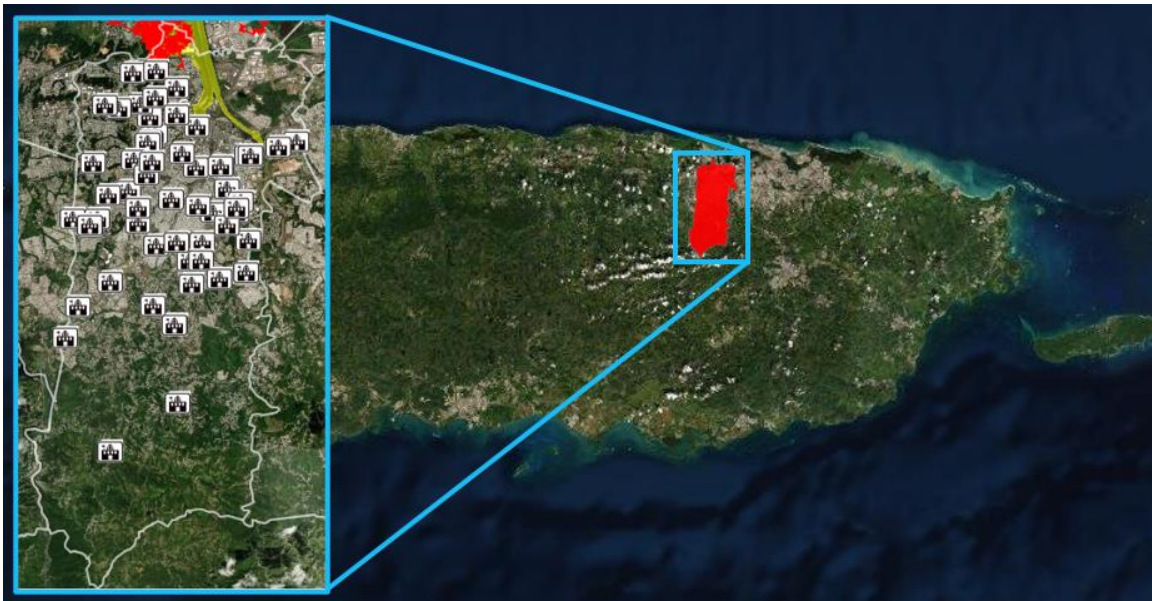
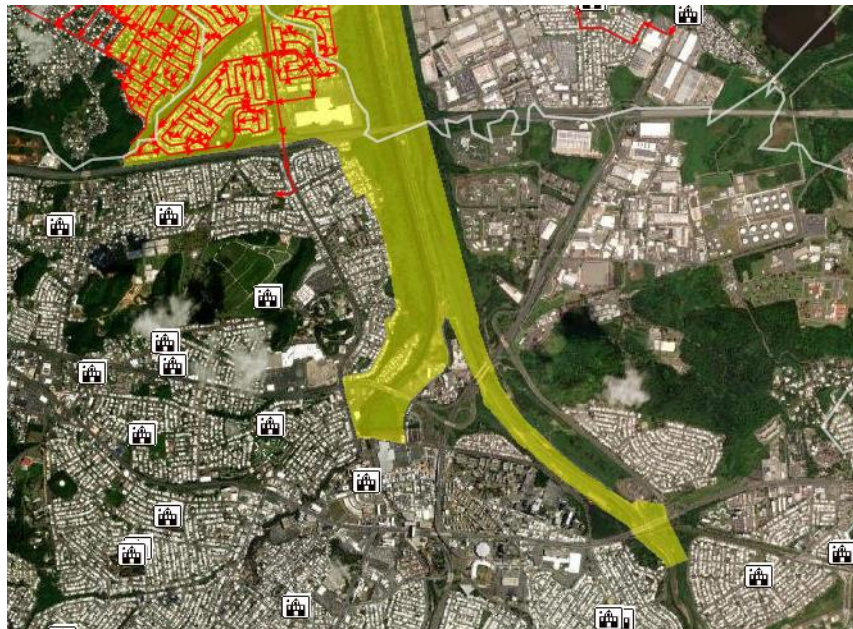
In this municipality there are a total of 56 schools as shown in Figure 5-17. No schools are in a tsunami danger zone (Figure 5-18). This means that no school population in Bayamón could be affected by the impact of a tsunami and that none has a use other than school.

Figure 5-17 Location of Schools in Bayamón

Figure 5-18 Schools located outside the tsunami hazard zones in Bayamón

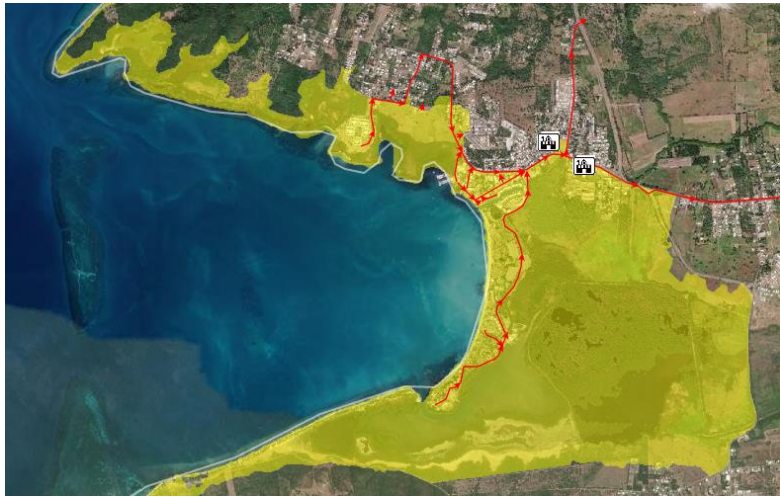
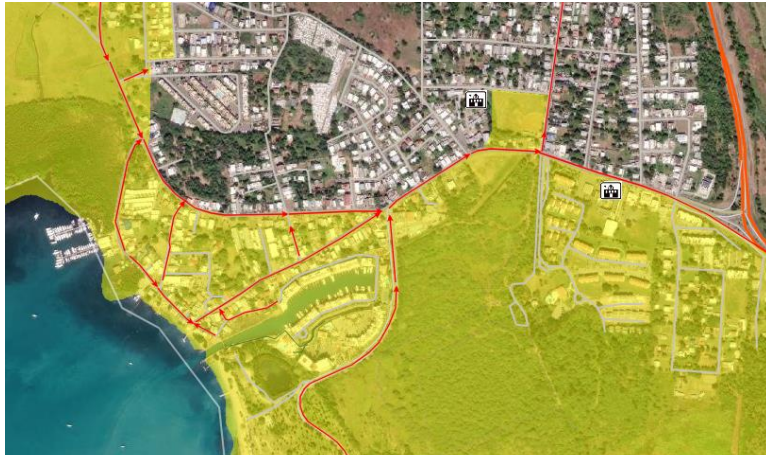
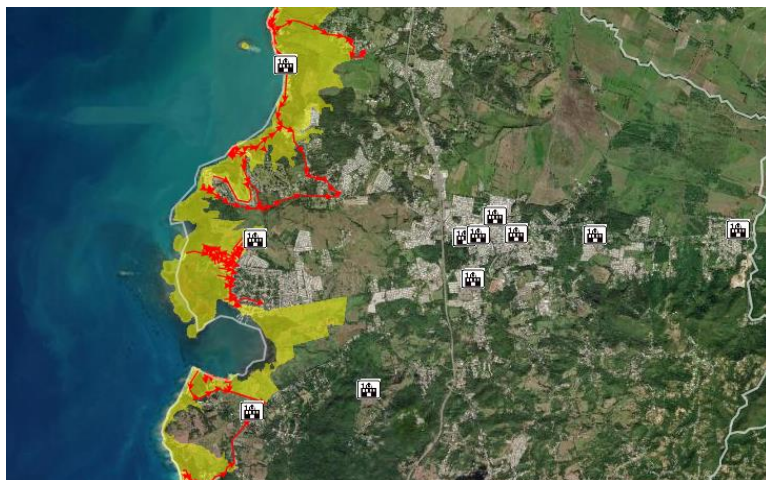
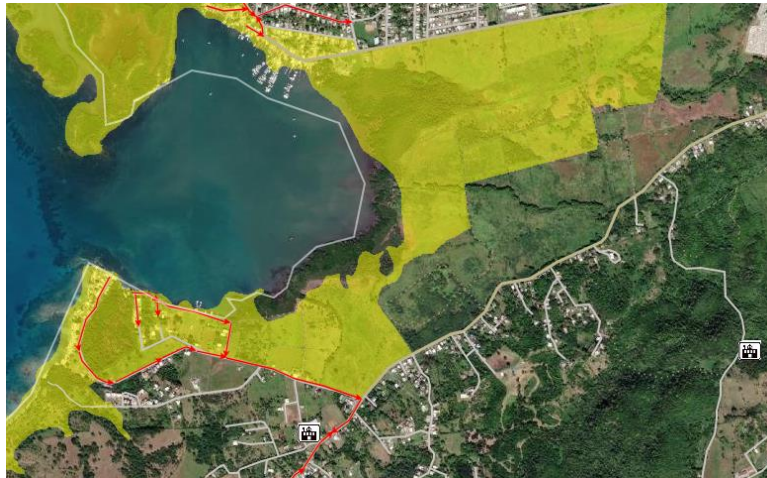
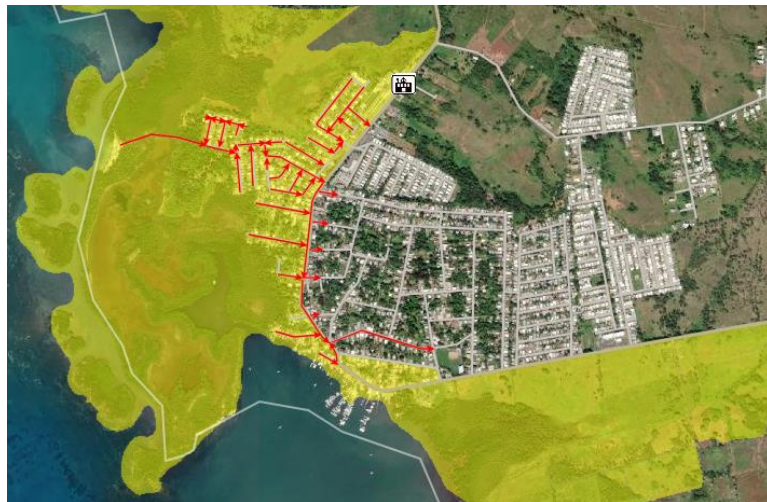
In this municipality there are 3 schools that are in a tsunami hazard zone out of 15 schools (Figure 5-19). Figure 5-20, Figure 5-21, Figure 5-22 and Figure 5-23 presents Zoom images of the west central area of the municipality. Figure 5-24 presents the northwest in Zoom with the schools in danger zone. While Figure 5-25 shows the danger zone in Zoom of the southwest of the municipality with the school in danger.

The schools in danger are: Luis Muñiz Souffront which is already permanently closed, Monserrate León De Irizarry with a population of 526 people, and Segunda Unidad Bo Puerto Real with a population of 405 people. As shown in Table 5-5, the total population that could be affected by the impact of a tsunami in the municipality of Cabo Rojo is 931 people. Of this totality, only one school is used as a voting center, but none as a refuge.

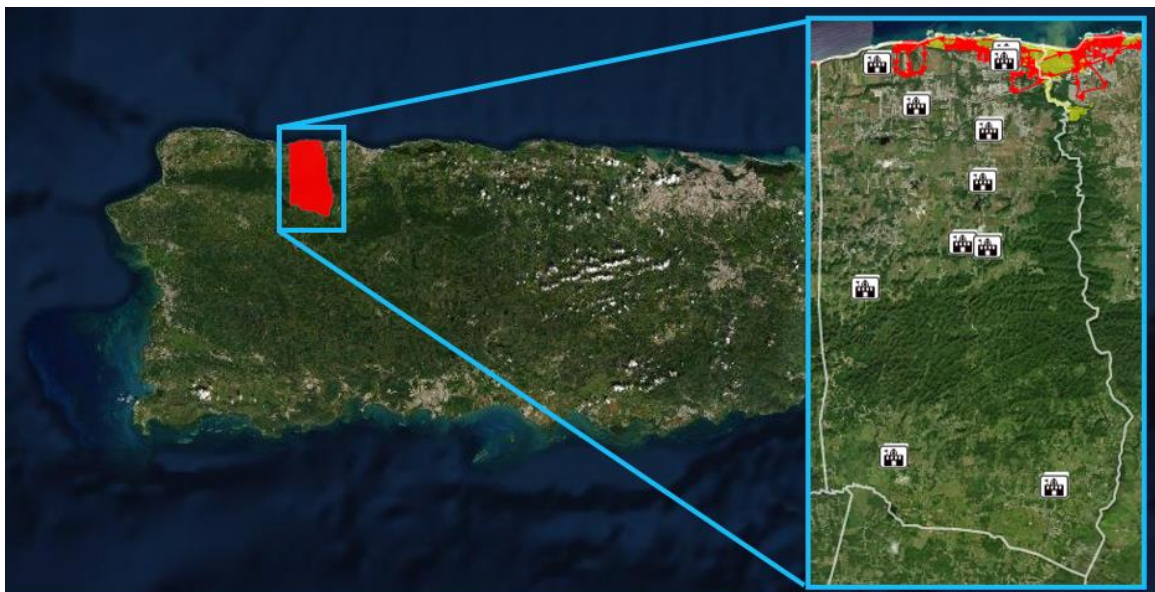
This municipality has 12 schools (Figure 5-26), and one is in a tsunami hazard zone (Figure 5-27 and Figure 5-28).

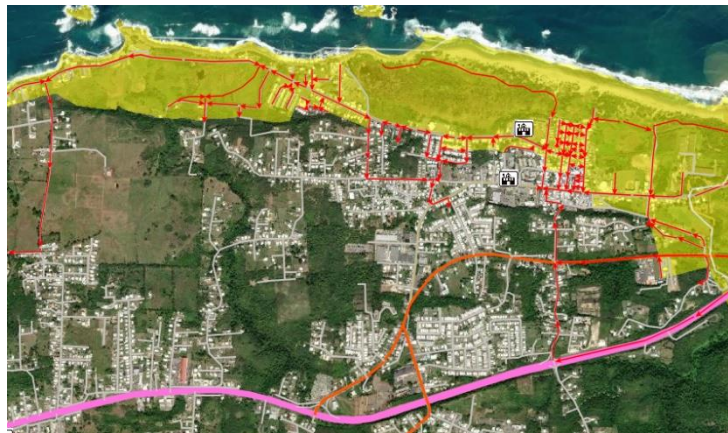
Figure 5-28 Schools located in tsunami hazard zones in Camuy

The school in danger is permanently closed, therefore, no school population in Camuy could be affected by the impact of a tsunami (Table 5-6). However, when it was open it was used as a voting center but not as a refuge.

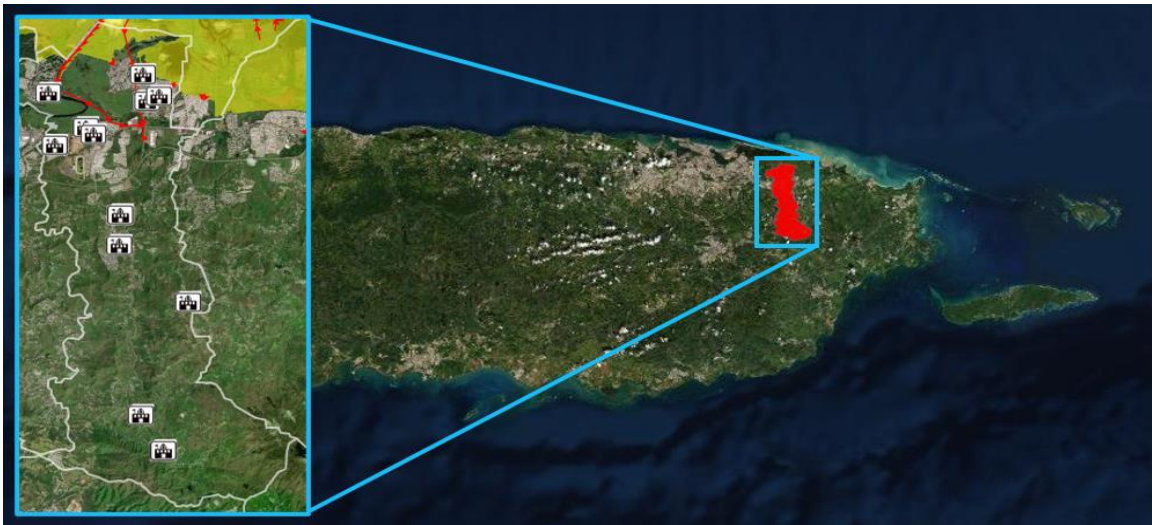
Figure 5-29 Location of Schools in Canóvanas

This municipality has 13 schools (Figure 5-29), and none are in a tsunami hazard zone as shown in Figure 5-30. Therefore, no school population in Canóvanas could be affected by the impact of a tsunami. For this reason, no tabulated data is presented with schools in a tsunami danger zone for this municipality.

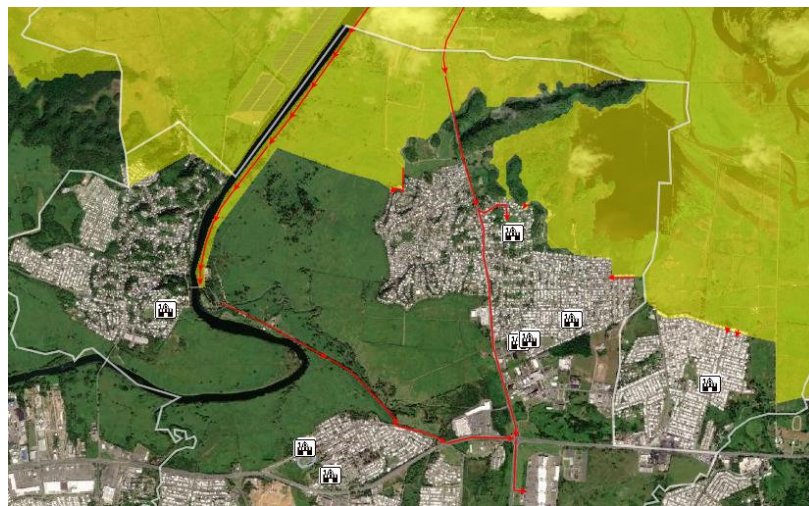
Figure 5-30 Schools located outside the tsunami hazard zones in Canóvanas

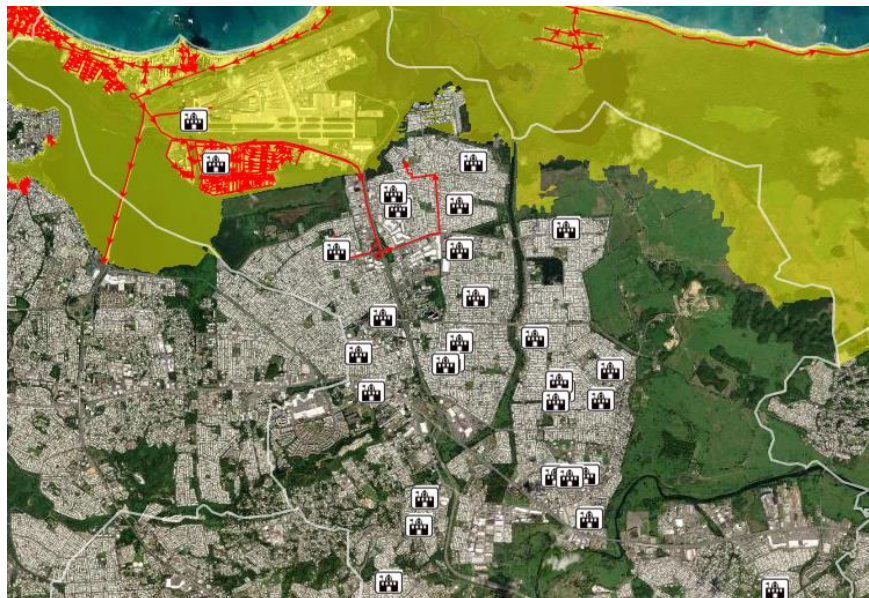
Figure 5-32 Schools located in tsunami hazard zones in Carolina

In this municipality there are a total of 36 schools (Figure 5-31), of which 2 are in a tsunami danger zone according to evacuation maps (Figure 5-32 and Figure 5-33). The schools in danger are: Roberto Alberty (Cacao Centro) and Julia de Burgos, both of which are permanently closed, therefore, no school population in Carolina could be affected by the impact of a tsunami.

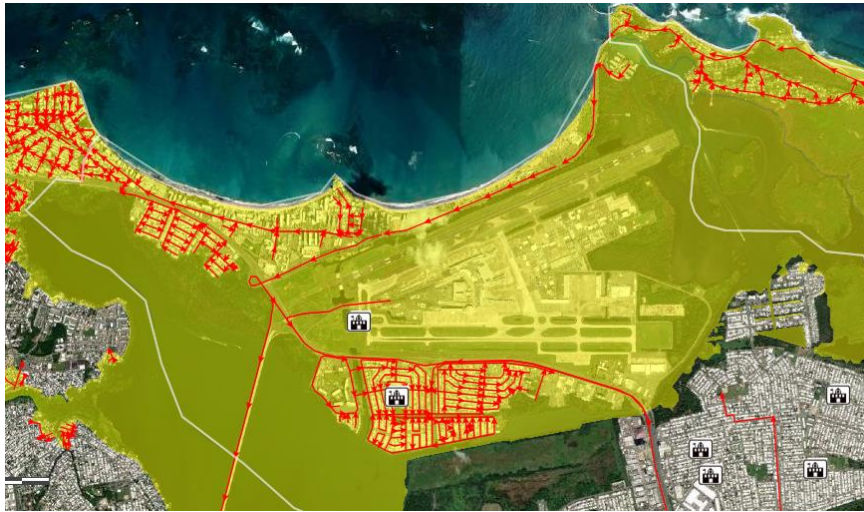
Figure 5-33 Schools located in tsunami hazard zones in Carolina [Zoom]

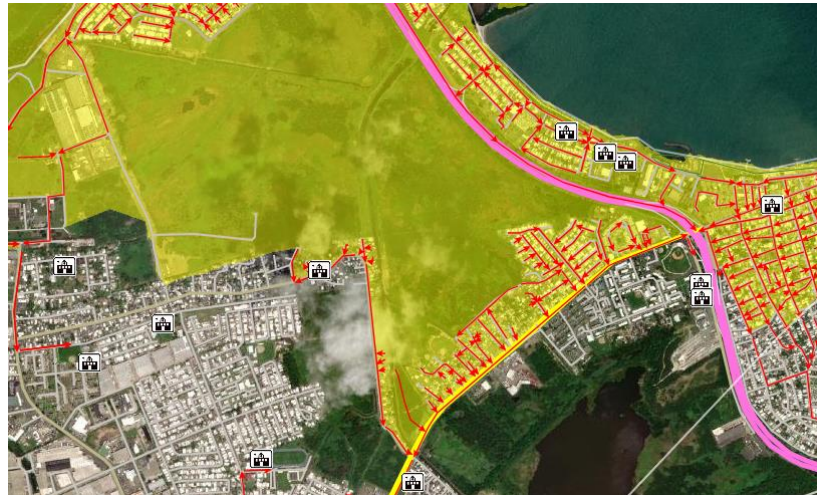
Figure 5-35 Schools located in tsunami hazard zones in Cataño

This municipality has 12 schools (Figure 5-34). The total number of schools in the tsunami hazard zone is 4 as shown in Figure 5-35 and Figure 5-36. These are: Francisco Oller with a population of 723 people, Horace Mann with a population of 201 people, Onofre Carballeira with a population of 252, Rosendo Matienzo Cintrón with a population of 289 people. Therefore, the total school population that could be affected by a tsunami for this municipality is 1,465 people. Of the totality of schools, 2 of them are used as voting centers and none as shelters. This total data is shown in detail in Table 5-8.

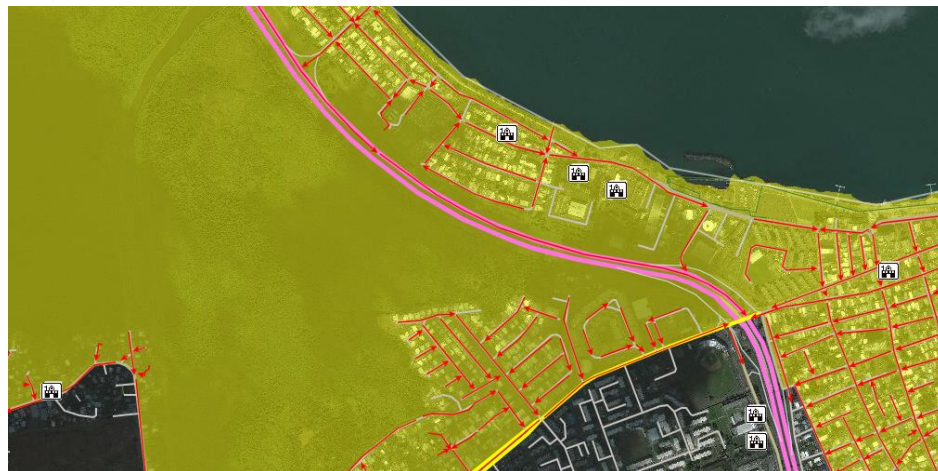
Figure 5-36 Schools located in tsunami hazard zones in Cataño [Zoom]
