VULNERABILITY OF SCHOOLS IN PUERTO RICO TO TSUNAMI EVENTS

RESEARCH FINAL REPORT

POLYTECHNIC UNIVERSITY OF PUERTO RICO

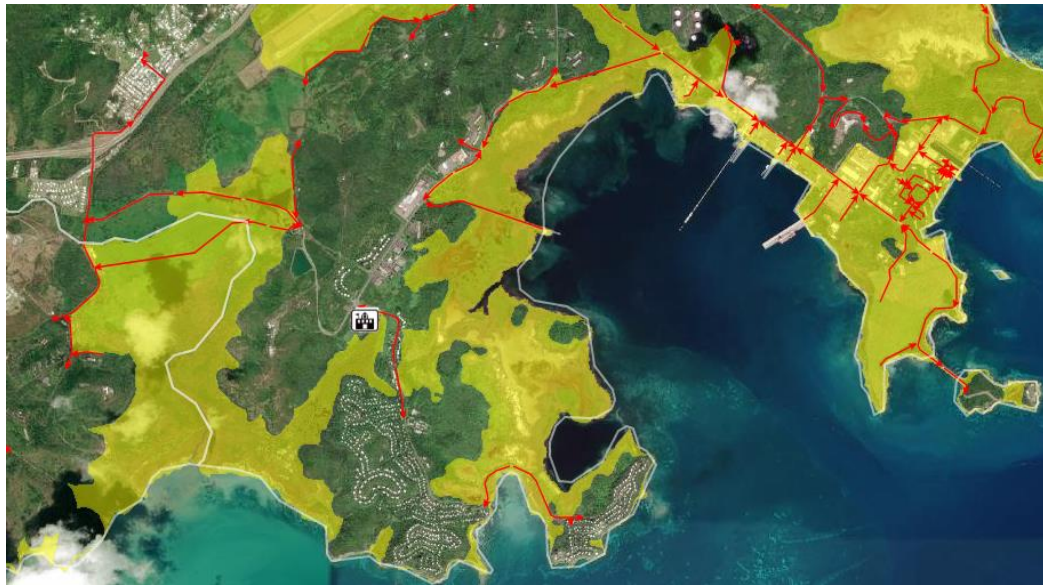
Figure 5-38 Schools located in tsunami hazard zones in Ceiba [Zoom]

In this municipality there are 5 schools and none of them are in a tsunami hazard zone. Figure 5-37 shows all the schools in the municipality, while Figure 5-38 shows the hazard zone without any schools. This means that no school population in Ceiba could be affected by the impact of a tsunami. This is the reason why there is no table that presents data for schools in the tsunami danger zone.

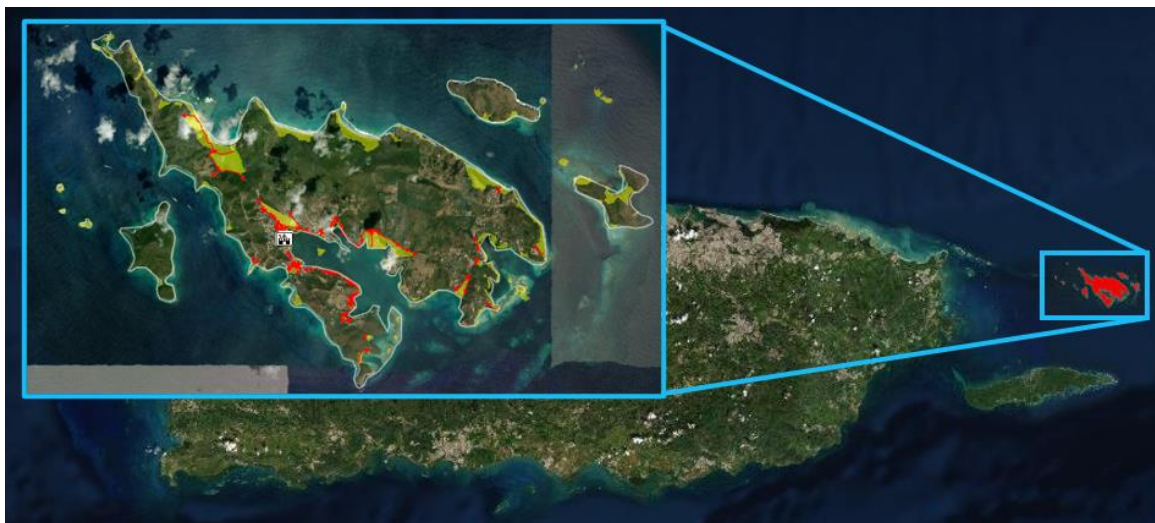
Figure 5-39 Location of Schools in Culebra

This municipality has only 1 school, which is in a tsunami danger zone. This school is Ecológica De Culebra with a school population of 190 people. Therefore, the population of the school that could be affected in Culebra is 190 people.

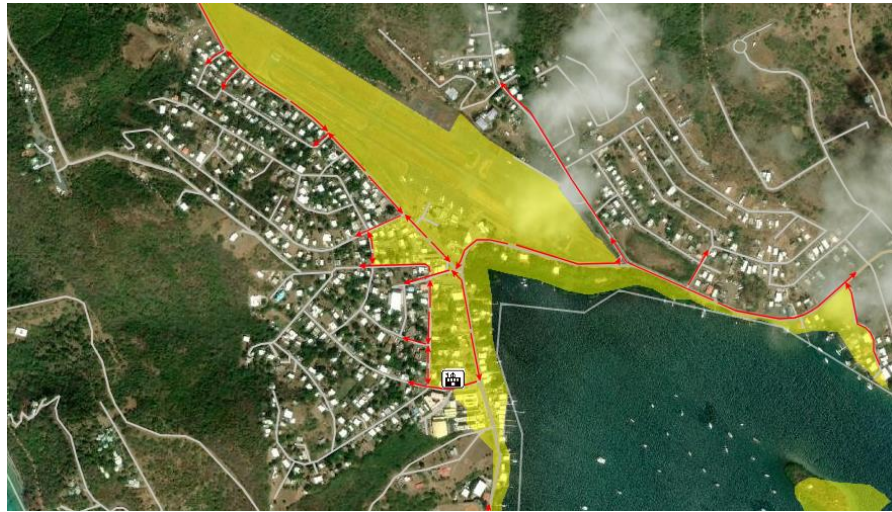
Figure 5-40 Schools located in tsunami hazard zones in Culebra [Zoom]

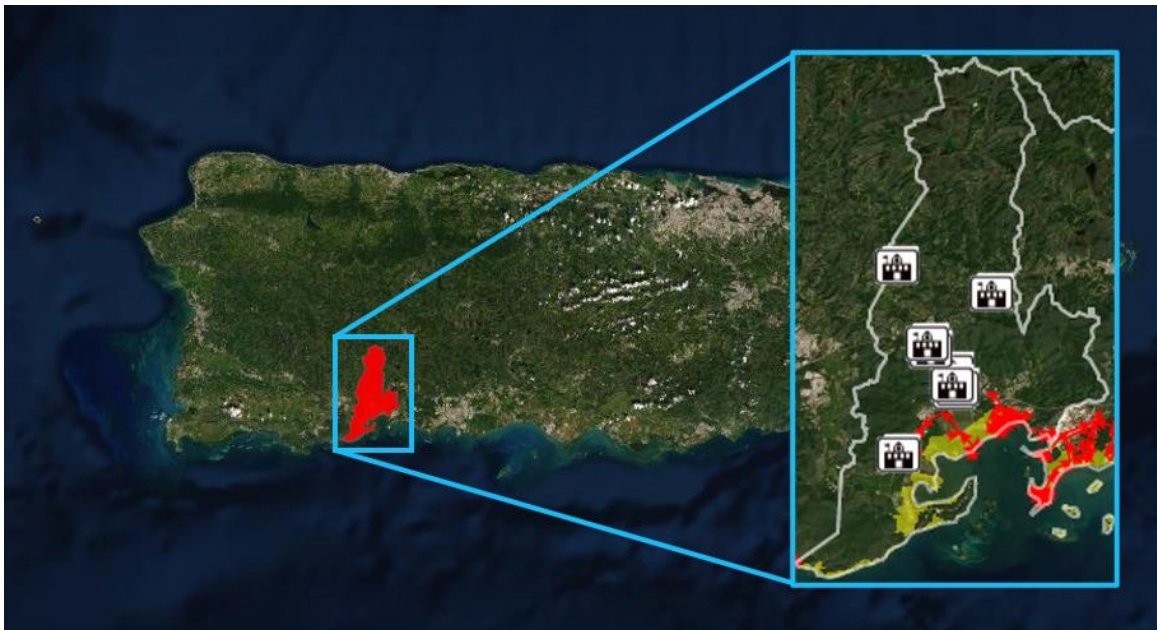
Figure 5-49 Location of Schools in Guayanilla

In this municipality there are a total of 9 schools as shown in Figure 5-49. None of these schools is in a tsunami hazard zone, and Figure 5-50 shows it. This means that no school population in Guayanilla could be affected by the impact of a tsunami.

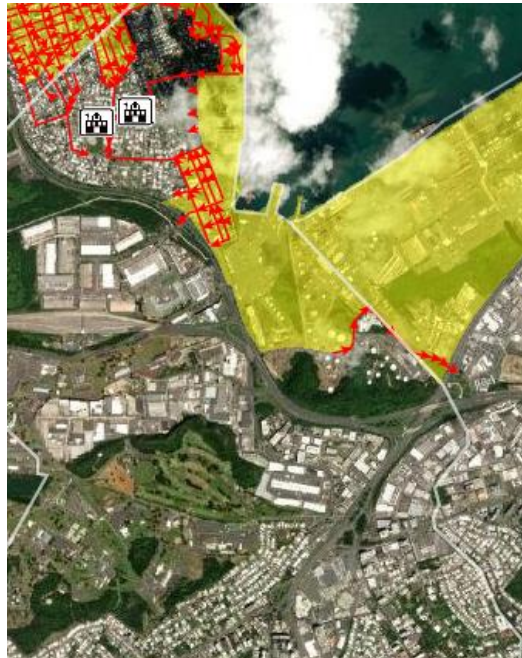
Figure 5-52 Schools located outside the tsunami hazard zones in Guaynabo

This municipality has a total of 18 schools (Figure 5-51) and none of them are in a tsunami hazard zone (Figure 5-52). This means that no school population in Guaynabo could be affected by the impact of a tsunami.

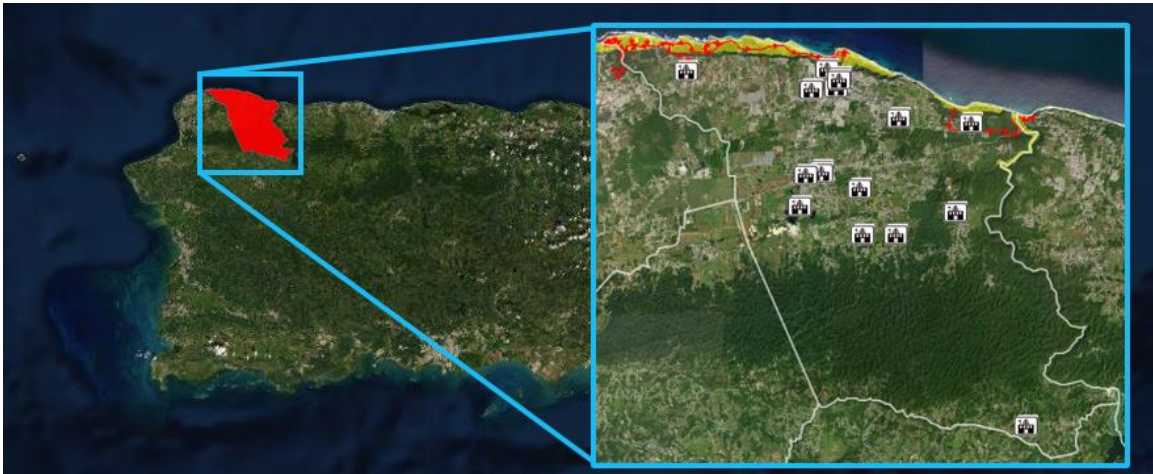
Figure 5-57 Location of Schools in Isabela

In this municipality there are a total of 18 schools (Figure 5-57). No schools are in a tsunami hazard zone as shown in Figure 5-58. This means that no school population in Isabela could be affected by the impact of a tsunami. Therefore, there is no table for this municipality.

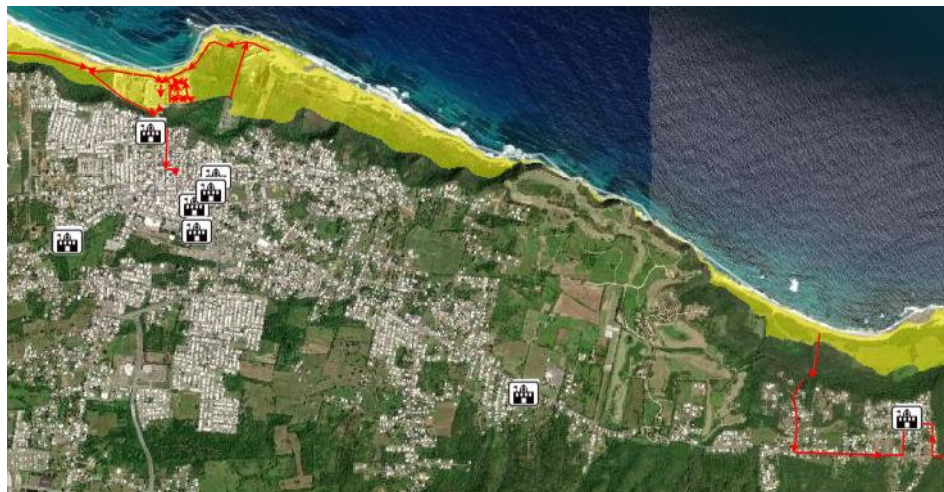
Figure 5-58 Schools located outside the tsunami hazard zones in Isabela

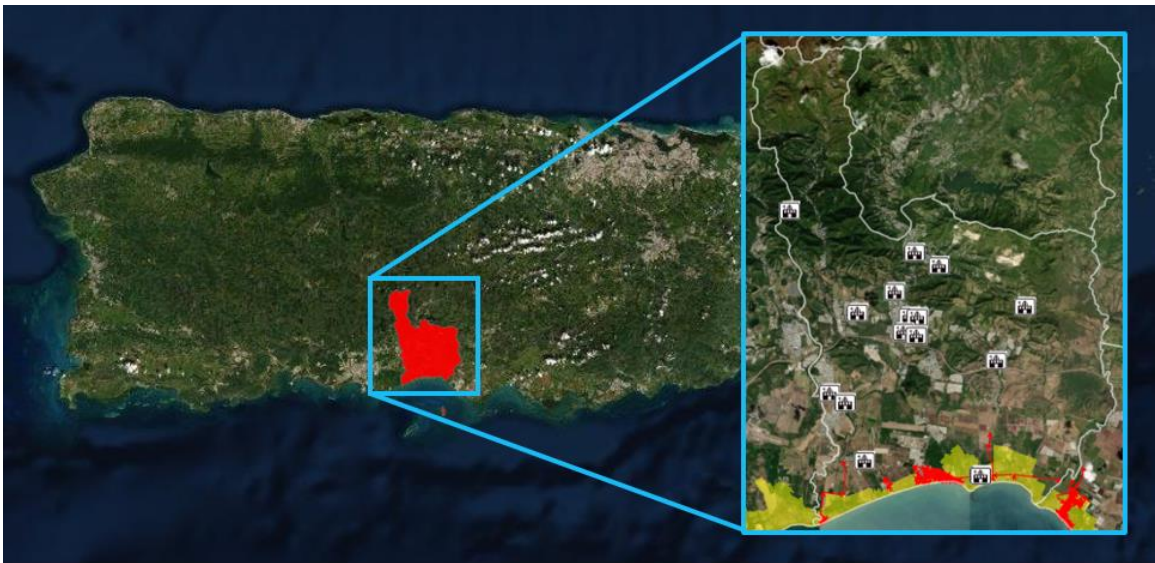
Figure 5-59 Location of Schools in Juana Díaz

In this municipality there are 2 schools that are in a tsunami hazard zone (Figure 5-59) out of 14 schools (Figure 5-60). The school in danger is Juan Serapio Mangual with a

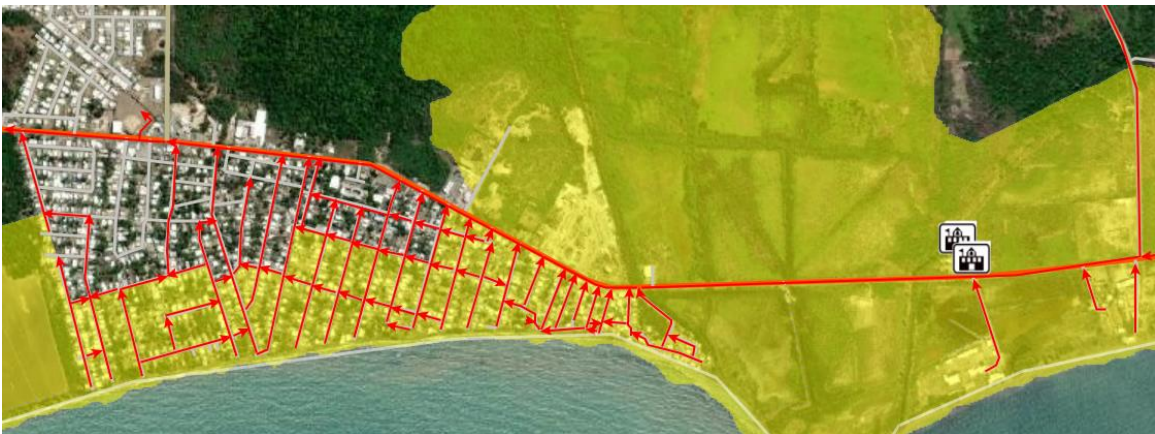
Figure 5-60 Schools located in tsunami hazard zones in Juana Díaz

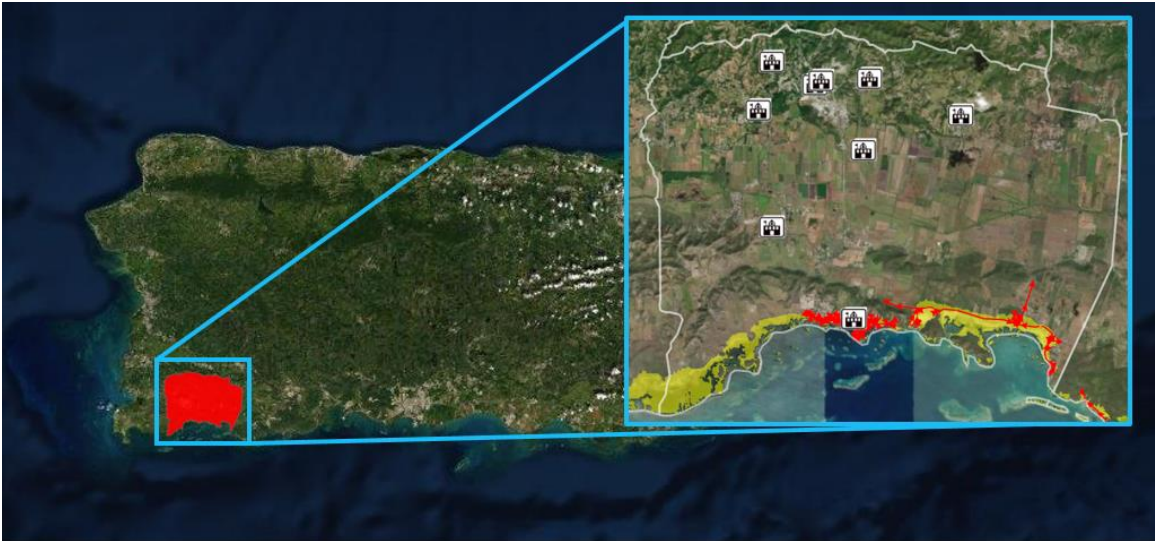
Figure 5-61 Location of Schools in Lajas

In this municipality there is one school that is in a tsunami danger zone out of 9 schools. The total number of schools is shown in Figure 5-61 and the schools in danger are shown in Figure 5-62.

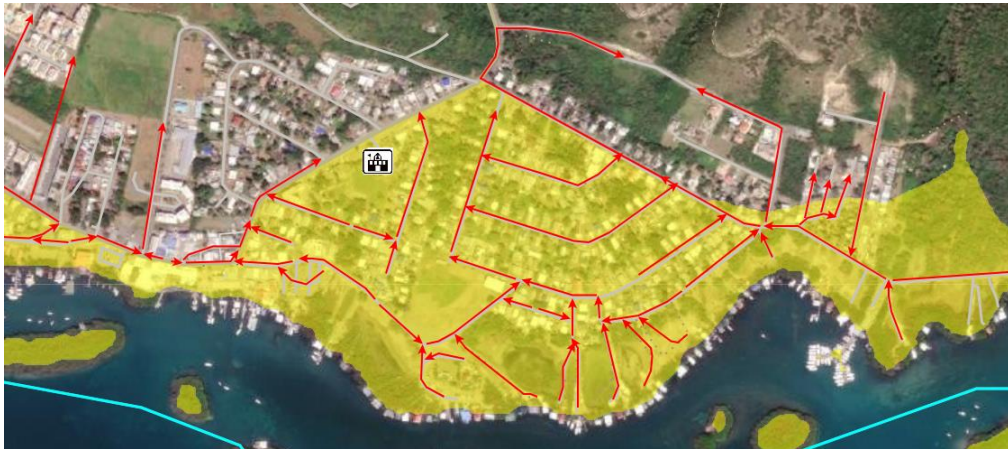
Figure 5-62 Schools located in tsunami hazard zones in Lajas

The school in danger is Alejandro Tapia y Rivera with a population of 108 people. The total population that could be affected by the impact of a tsunami in the municipality of Lajas is 108 people. The school in this municipality is not used as a shelter or voting center. This is summarized in Table 5-15.

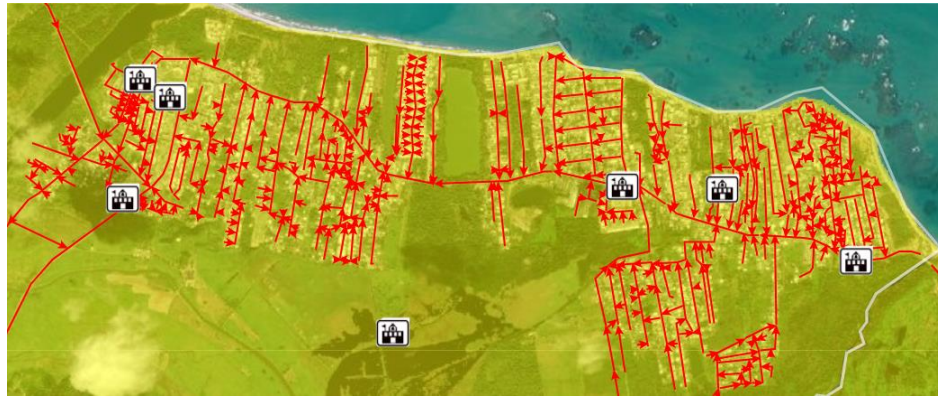
Figure 5-64 Schools located in tsunami hazard zones in Loíza

In this municipality there are 8 schools that are in tsunami hazard zones (Figure 5-64 and Figure 5-65) out of 9 schools (Figure 5-63). The school in danger is: Belén Blanco de Zequeira with a population of 192 people, Carlos Escobar López with a population of 210 people, Celso González Vaillant with a population of 349 people, Emiliano Figueroa Torres with a population of 86 people, Jobos with a population of 111 people, Mediana Alta Elemental with a population of 712 people, Nueva Superior de Loíza (Super Vocaciona) with a population of 584 people, and Parcelas Vieques with a population of 157 people.

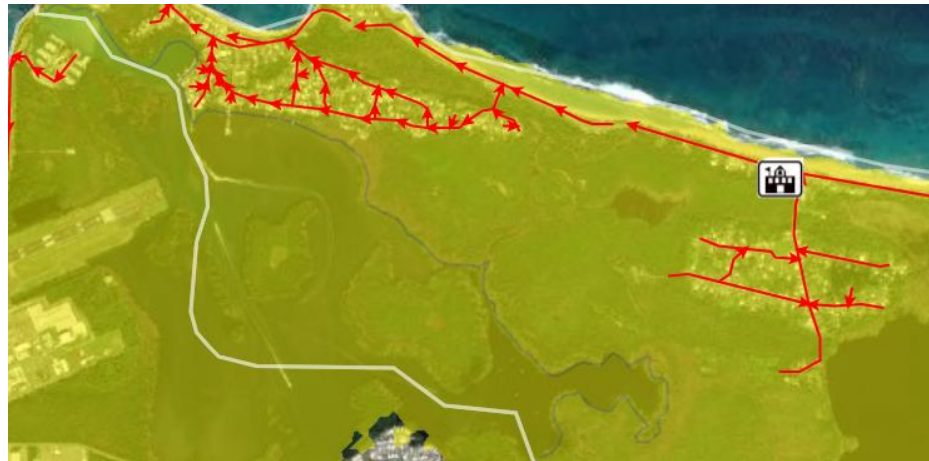
Figure 5-65 Schools located in tsunami hazard zones in Loíza [Zoom]

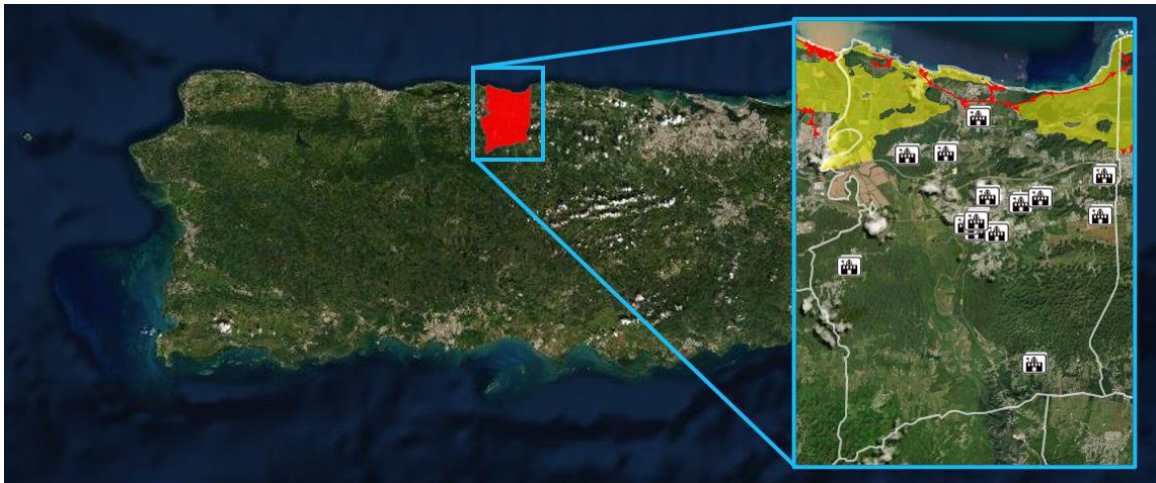
Figure 5-69 Location of Schools in Manatí

This municipality has a total of 15 schools (Figure 5-69) and none of them are in a tsunami hazard zone (Figure 5-70). This means that no school population in Manatí could be affected by the impact of a tsunami.

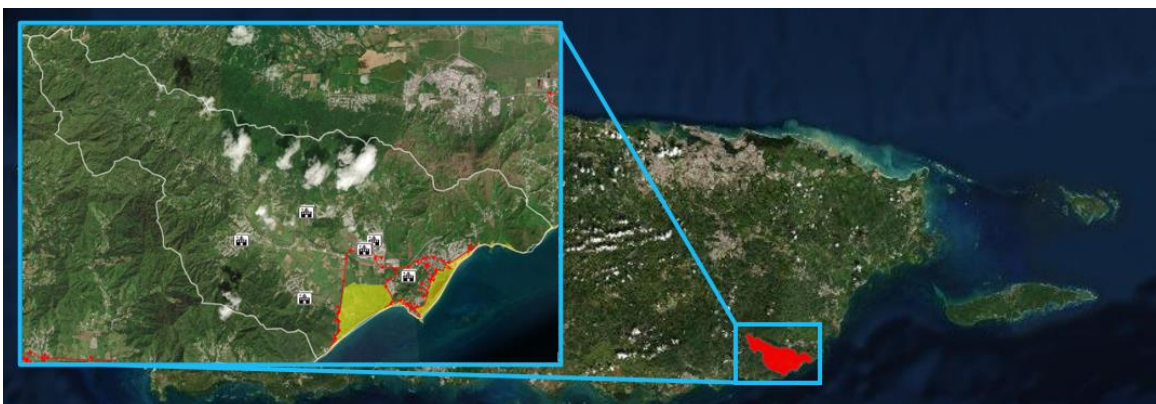
Figure 5-71 Location of Schools in Maunabo

In this municipality there are 6 schools (Figure 5-71) and none of them are in a tsunami hazard zone.

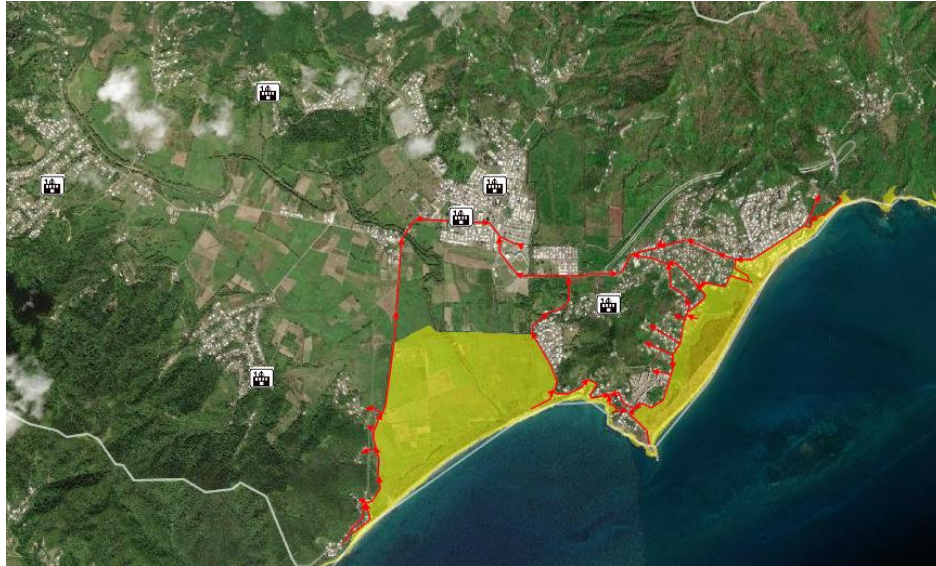
Figure 5-72 Schools located outside the tsunami hazard zones in Maunabo

Therefore, no school population in Maunabo could be affected by the impact of a tsunami. Figure 5-72 evidence that there are no schools in a tsunami hazard zone for this municipality.

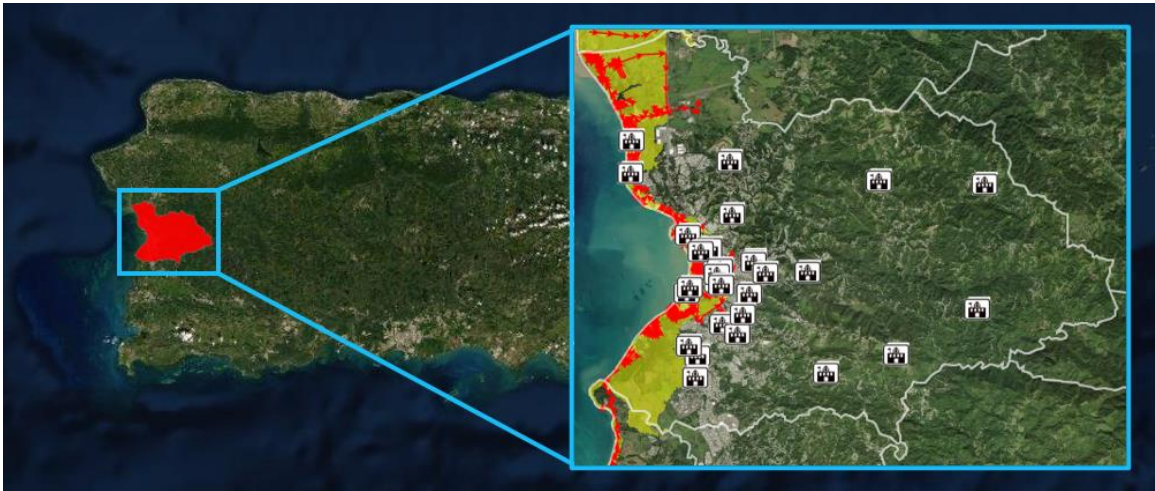
Figure 5-73 Location of Schools in Mayagüez

This municipality has 31 schools that are shown in Figure 5-73. Of this total, 9 are in the tsunami hazard zone (Figure 5-74, Figure 5-75, Figure 5-76 and Figure 5-77). The schools are: Concordia, which is already permanently closed, Dr. Pedro Perea Fajardo with a population of 1,019, Esteban Rosado Báez with a population of 306, Eugenio María De Hostos (Superior) with a population of 945, Libre De Música y Bellas Artes Ernesto Ramos Antonini with a population of of 36, María Dolores Faría with a population of 214, Mariano Riera Palmer with a population of 271, Sabanetas Mani with a population of 213, and Segundo Ruiz Belvis with a population of 243. Therefore, the total school population that could be affected by a tsunami for Mayagüez is 3,247 people. Of the total of 9 schools that are in danger, 5 are used as voting centers and one is used as a shelter. All the data for this municipality are summarized in Table 5-18.

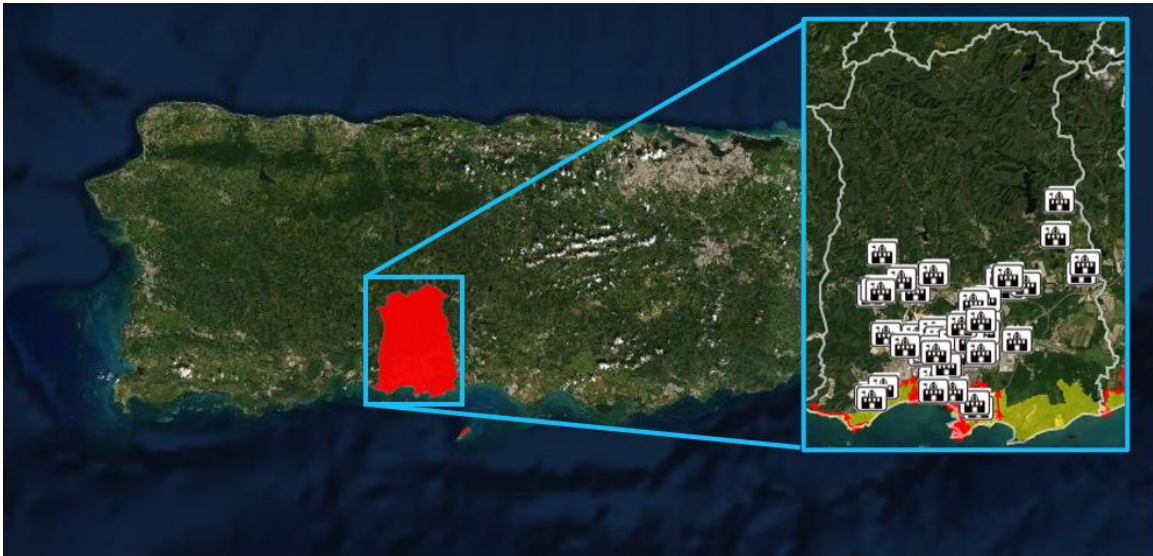
Figure 5-87 Location of Schools in Ponce

There are 59 schools in this municipality (Figure 5-87). Of this total, only 4 are in a tsunami hazard zone according to evacuation maps (Figure 5-86 and Figure 5-88). The schools in danger are: Angela Cordero Bernard with a population of 648 people, Dr. Alfredo M. Aguayo with a population of 272 people, Lucy Grillasca with a population of 258 people, and Sor Isolina Ferré (Villa Del Carmen) with a population of 399 people. This means that, for this municipality, the total population that could be affected by the impact of a tsunami is 1,577 people. In addition, Table 5-20 shows that 2 schools are used as voting centers and none as shelters of the total of 4 schools in this municipality.

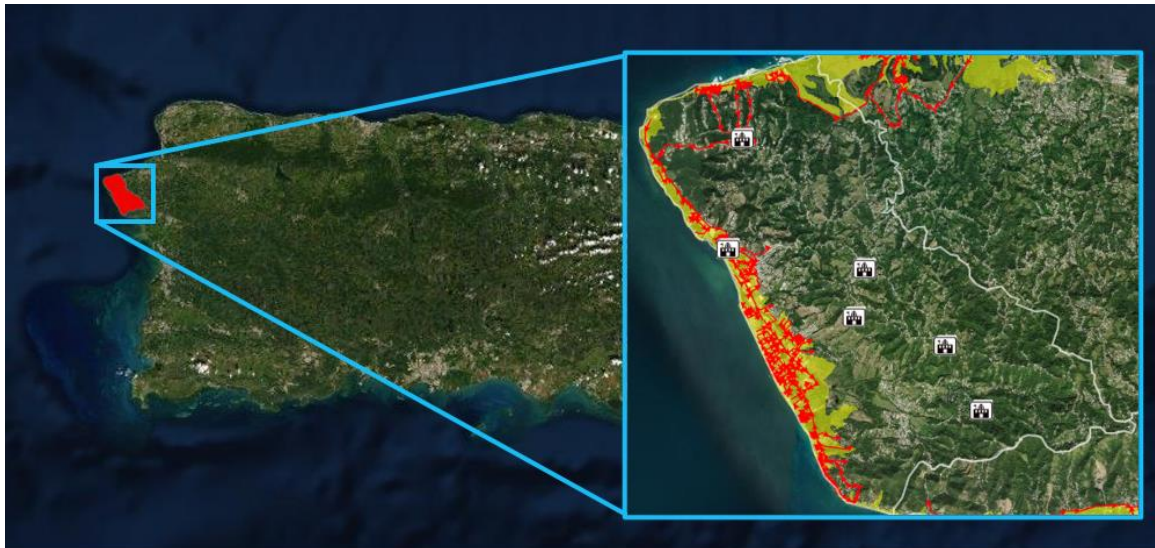
Figure 5-91 Location of Schools in Rincón

This municipality has 6 schools in total (Figure 5-91). Only one is in the tsunami hazard zone (Figure 5-92). This school in danger is Jorge Seda Crespo with a population of 183 people. This means that the total school population that could be affected by a tsunami for Rincón is 183 people. This school has no other additional use (Table 5-21).

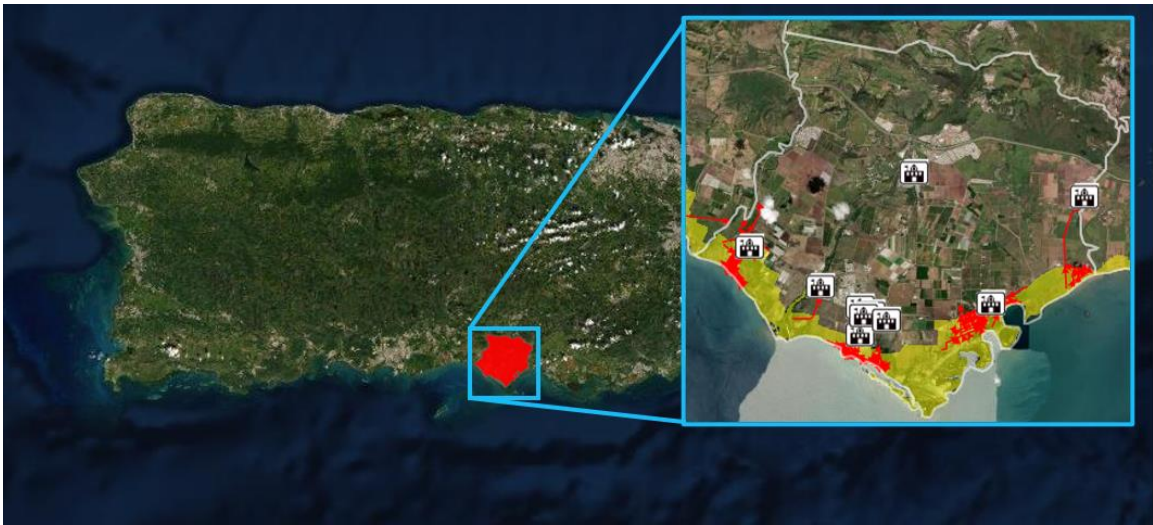
Figure 5-105 Location of Schools in Santa Isabel

In this municipality there is one school that is in a tsunami hazard zone (Figure 5-105) out of 10 schools (Figure 5-104). The school in hazard is Pedro Meléndez Santiago with a population of 486 people. The total population that could be affected by the impact of a tsunami in the municipality of Santa Isabel is 486 people.

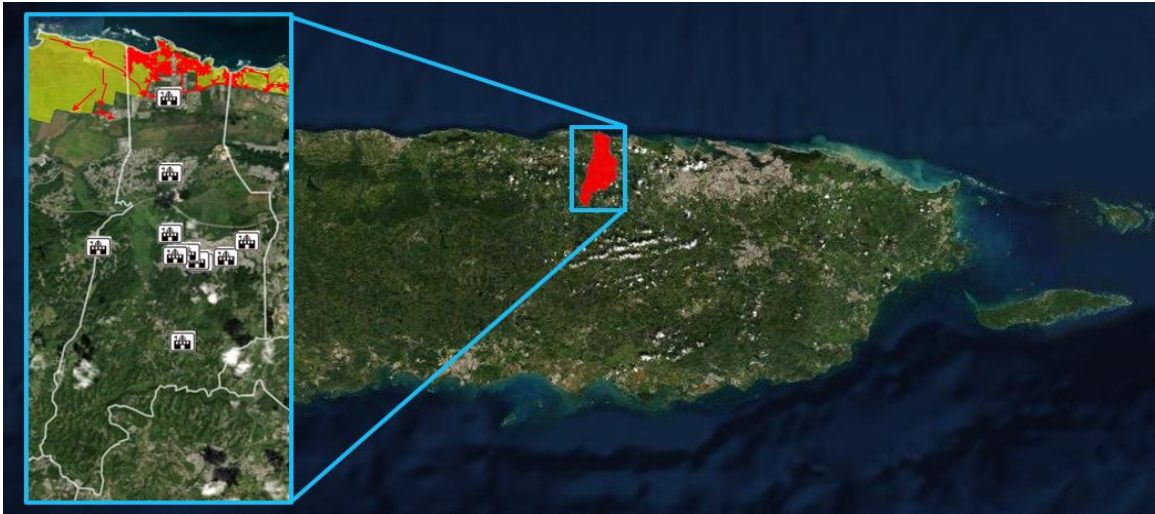
Figure 5-108 Location of Schools in Vega Alta

This municipality has a total of 11 schools and none of them are in a tsunami hazard zone as shown in Figure 5-108. Therefore, no school population in Vega Alta could be affected by the impact of a tsunami.

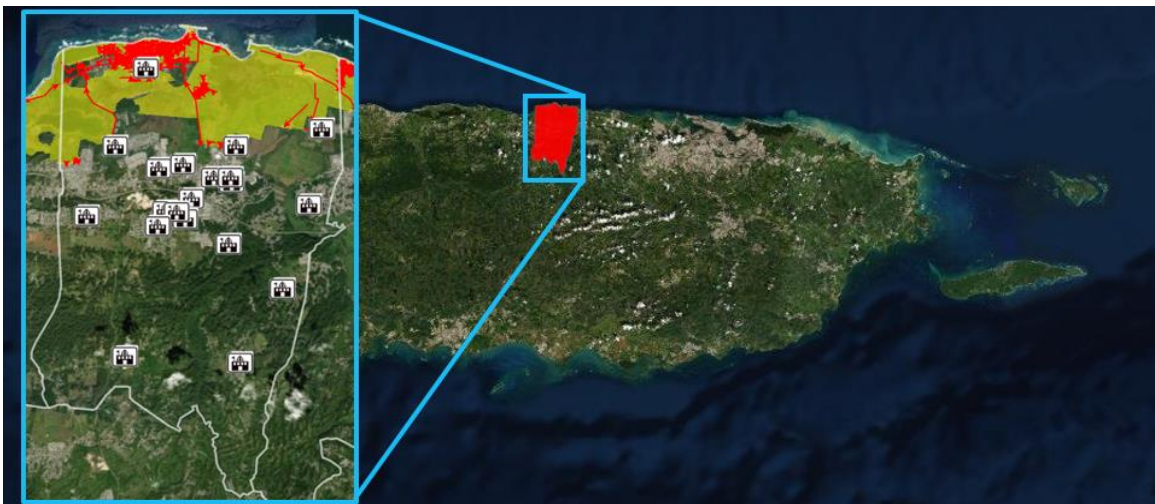
Figure 5-109 Location of Schools in Vega Baja

This municipality has a total of 20 schools (Figure 5-109) and none of them are in a tsunami danger zone as shown in Figure 5-110.

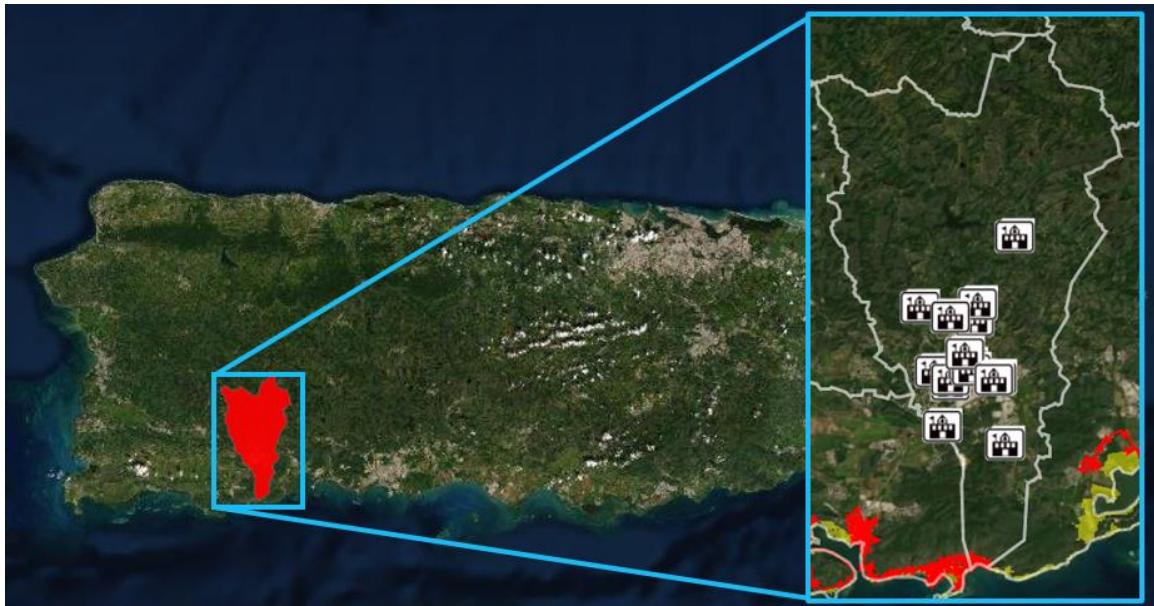
Figure 5-115 Location of Schools in Yauco

This municipality has a total of 4 schools and none of them are in a tsunami hazard zone as shown in Figure 5-115. Therefore, no school population in Yauco could be affected by the impact of a tsunami.

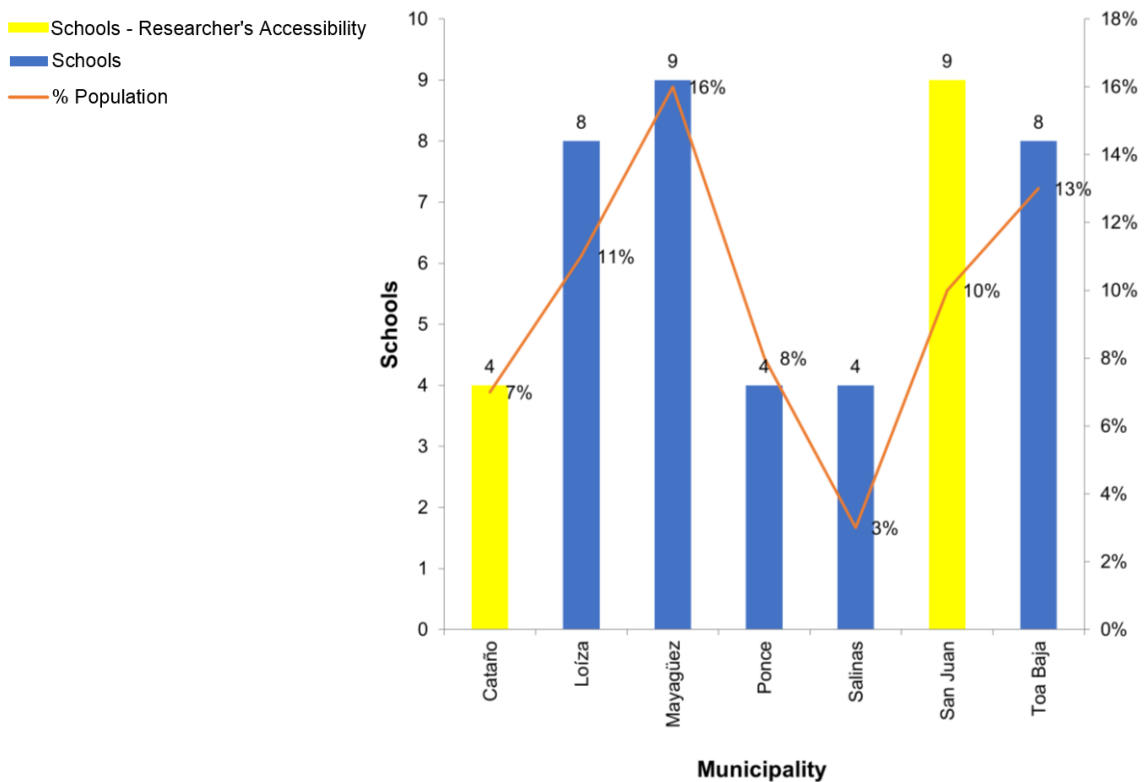
Figure 5-116 Schools and Population of Municipalities for Case Study

Figure 5-116 shows the number of schools that are in the tsunami hazard zone in blue bars and the municipalities selected for this project are shown with yellow bars. The orange line corresponds to the percentage of the population between students and teachers that could be affected by the impact of a tsunami.

Although there are other municipalities with a large number of schools that are in a tsunami hazard zone and with a large population that could be affected, they do not comply with the accessibility of the researchers. This is the case of the municipalities in blue bars shown in Figure 5-116 such as Mayagüez, which has 9 schools in a tsunami hazard zone, just like San Juan. And that in addition, Mayaguez has 6% more population that could be affected

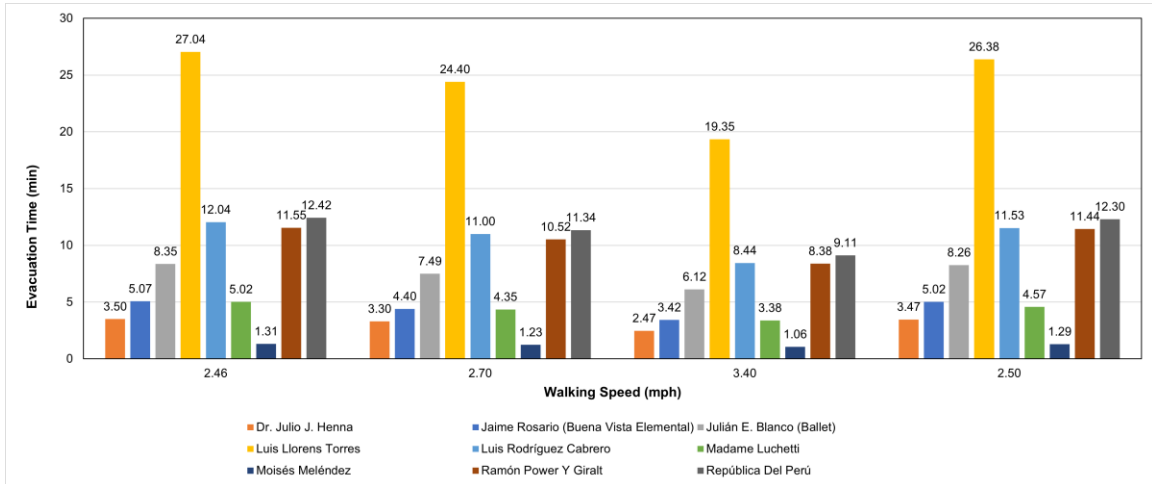
Figure 6-56 Evacuation Times Chart for San Juan Schools

Figure 6-56 shows both times for the municipality of San Juan.

From graphs of both municipalities the following is summarized for an average walking speed of 2.50 mph:

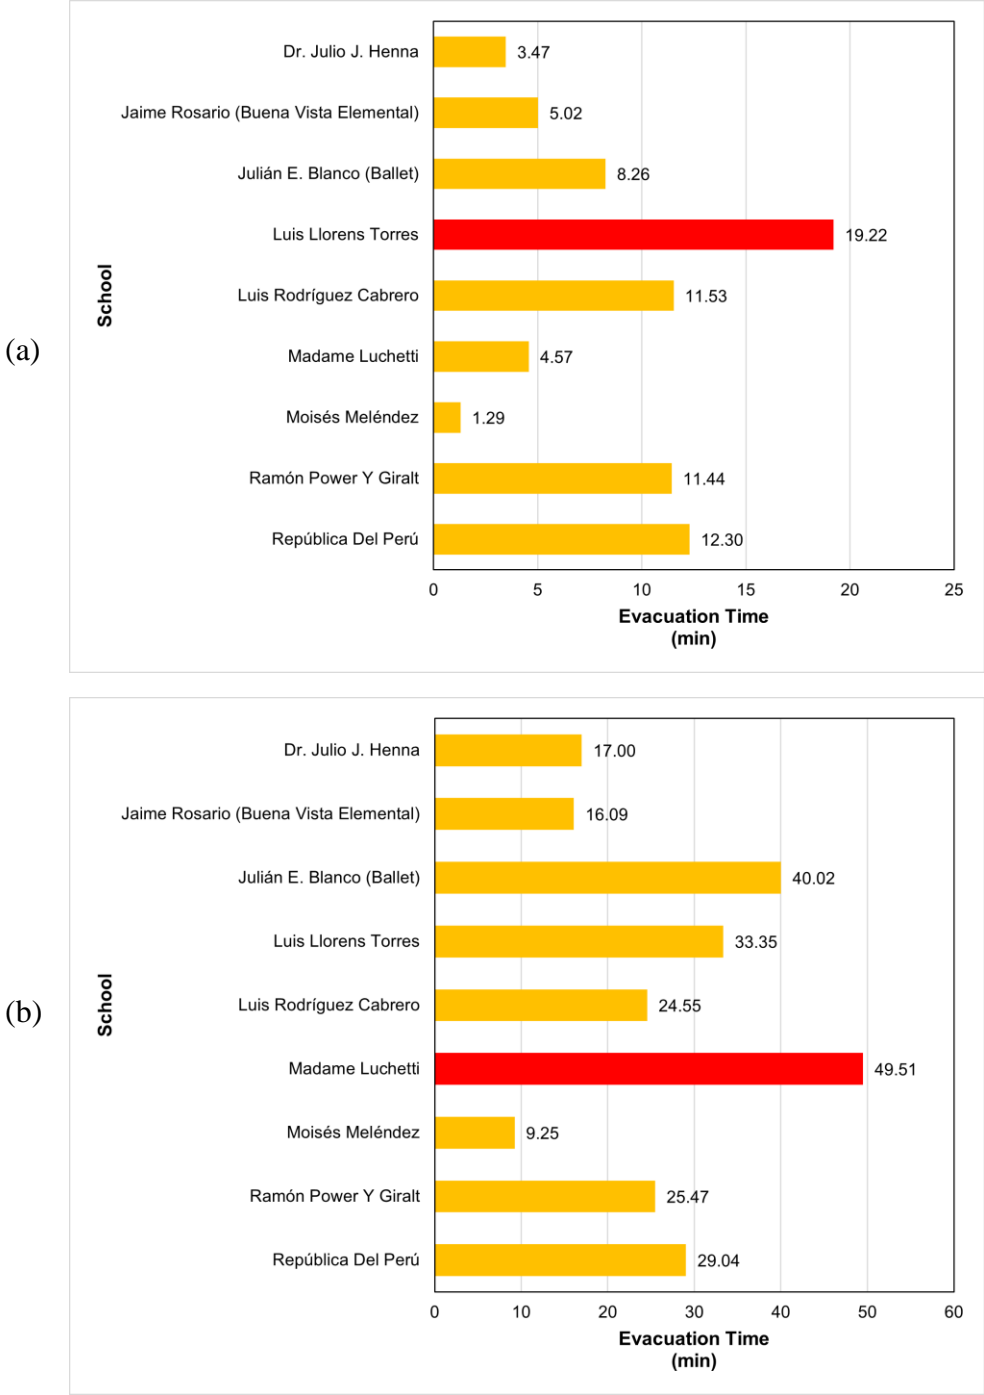
Figure 6-58 Evacuation Times Graph for Average Walking Speed for Cataño Schools

- For the primary evacuation time elapsed until reaching the assembly site (2), the subcritical schools were Francisco Oller school for Cataño and Madame Luchetti school for San Juan, with times of 17.29 min and 49.51 min respectively (Figure 6-58).
- Because the potential hazard of vulnerability for schools lies in leaving the tsunami hazard zone, those schools with the largest evacuation times until they leave the tsunami evacuation zone are considered critical; the evacuation time until reaching assembly site was considered a secondary condition, since although they are outside

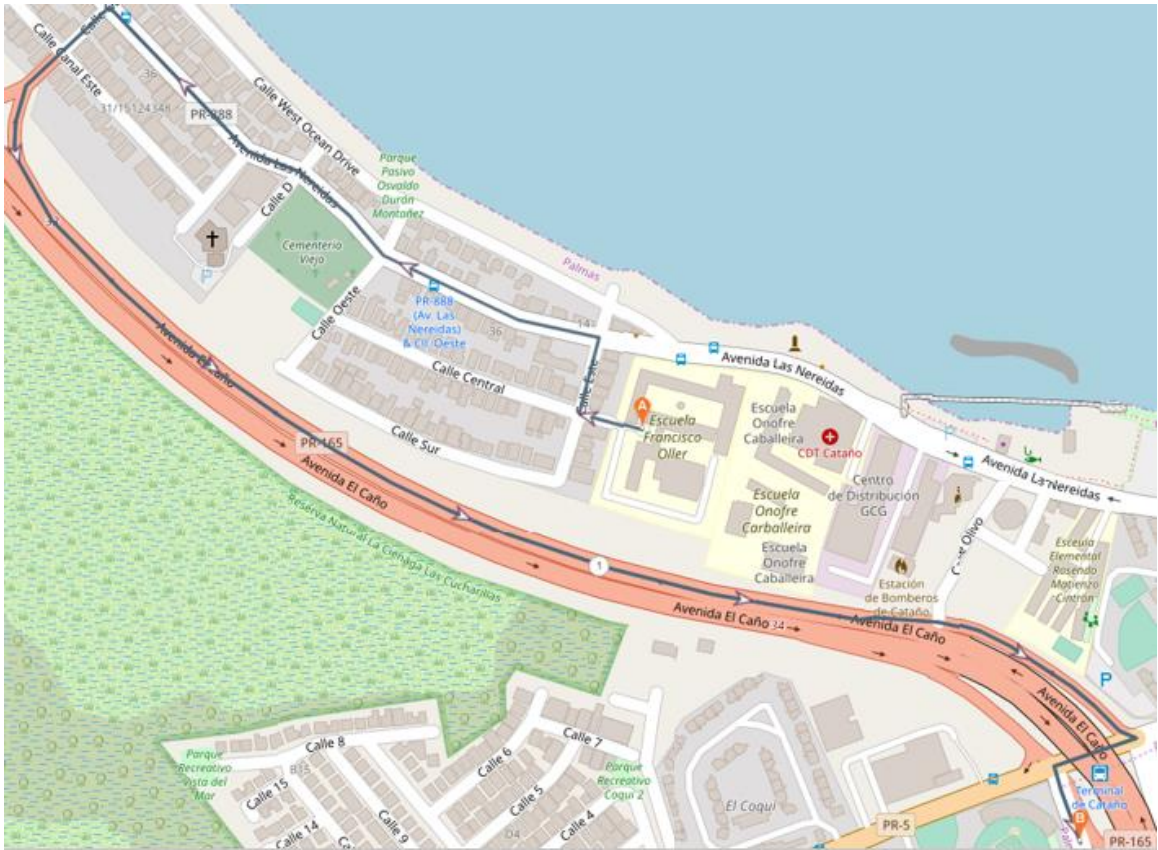
Figure 6-64 Streets of Second Alternate Route of Francisco Oller School

This route turns right onto East Street towards PR-88 along Las Nereidas Avenue. Then, turn onto Otero Street in direction to PR-165 along El Caño Avenue until it reaches PR-5 in direction to José Celso Barbosa Avenue. Eventually, it arrives at the predestined assembly place (Figure 6-64).

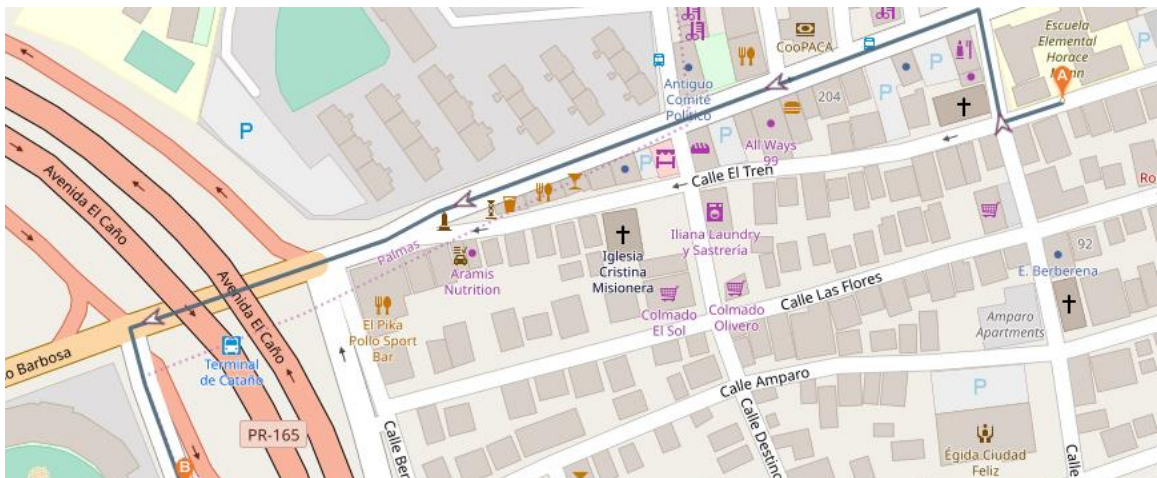
Figure 6-70 Streets of Second Alternate Route of Horace Mann School

This route leaves from El Tren Street and turns onto Santa Marta Street in direction to José Celso Barbosa Avenue. Later, it joins the PR-5 until it reaches the assembly place (Figure 6-70).

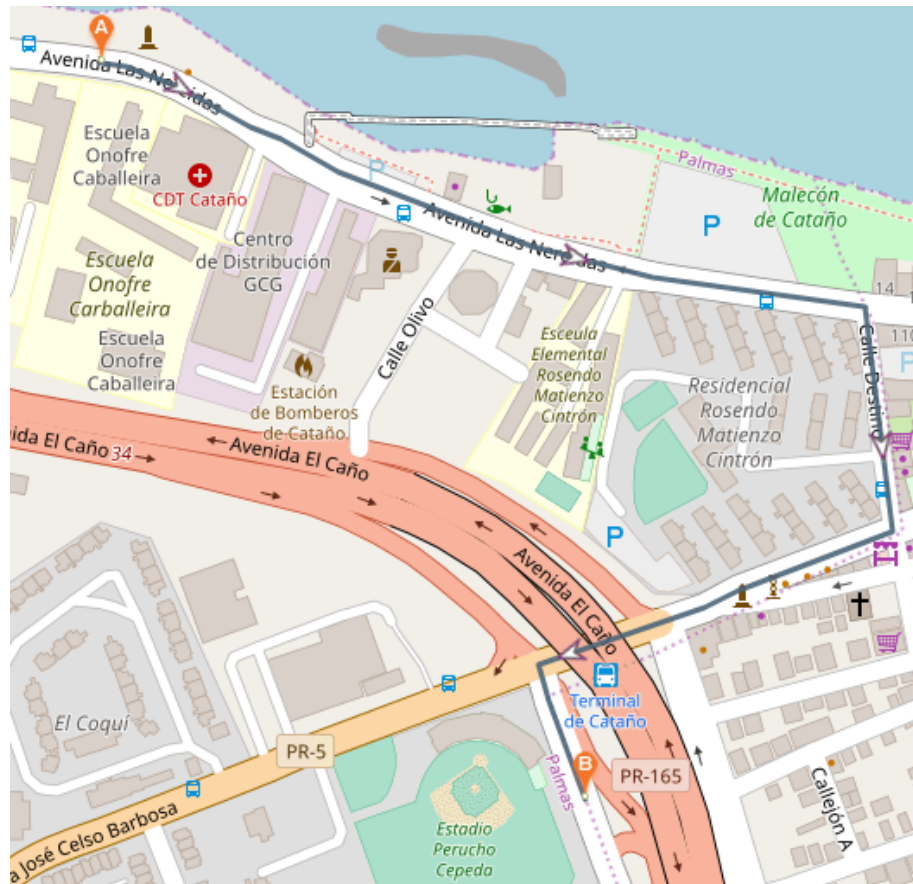
Figure 6-73 Streets of First Alternate Route of Onofre Carballeira School

This route leaves from PR-88 along Las Nereidas Avenue. Then, like the first alternate route of Francisco Oller school, it turns onto Destino Street in direction to PR-5 along José Celso Barbosa Avenue until it reaches the predestined assembly place (Figure 6-73).

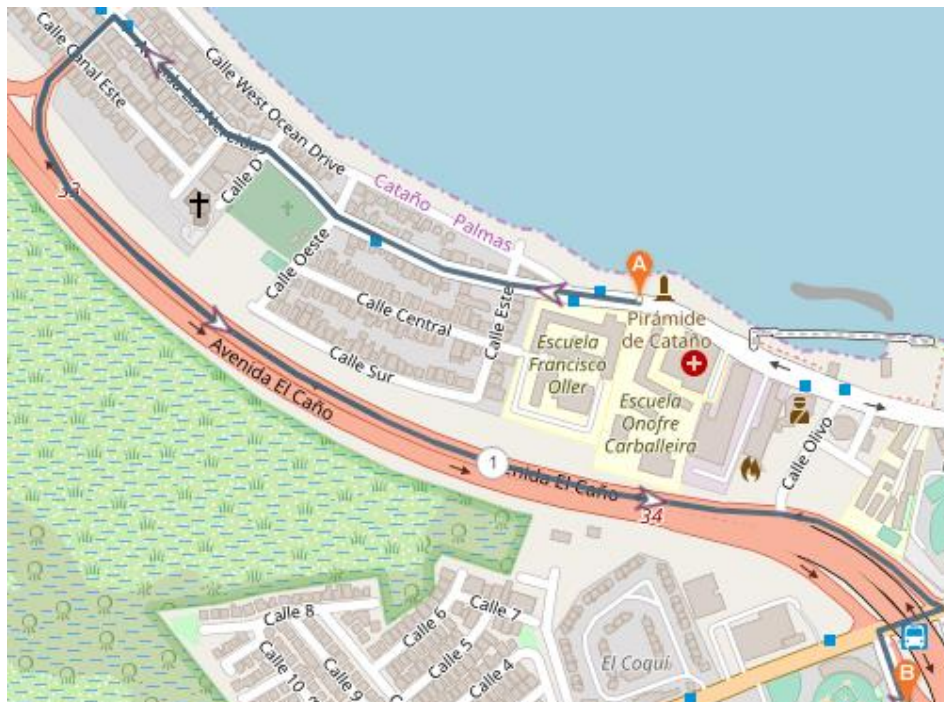
Figure 6-76 Streets of Second Alternate Route of Onofre Carballeira School

This route leaves from PR-88 along Las Nereidas Avenue. Then, like the Francisco Oller School's second alternate route, turn onto Otero Street in direction to PR-165 along El Caño Avenue until it reaches PR-5 in direction to José Celso Barbosa Avenue. Later, it arrives at the predestined assembly place (Figure 6-76).

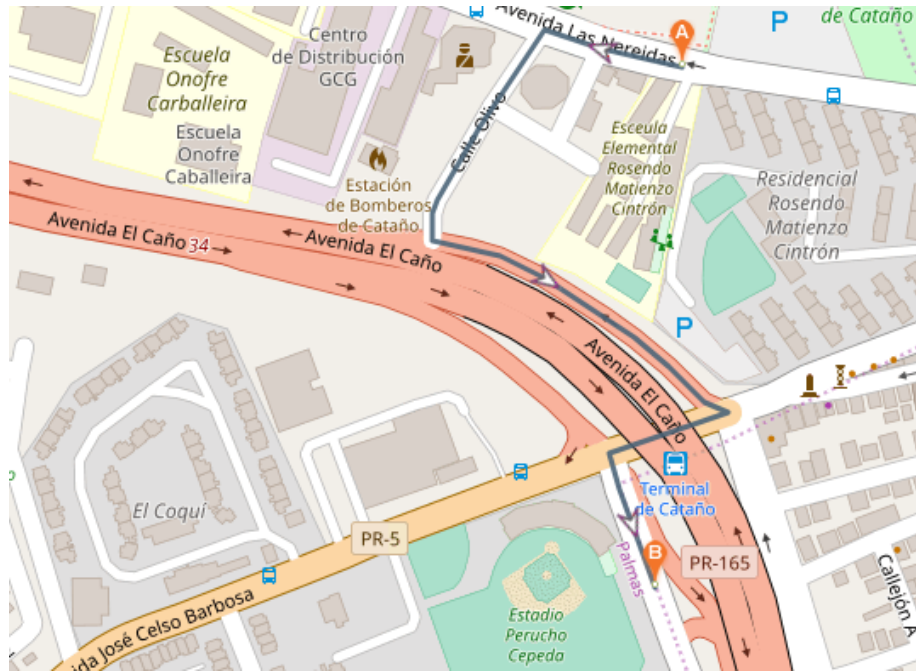
Figure 6-79 Streets of First Alternate Route of Rosendo Matienzo Cintrón School

This first route leaves from PR-88 along Las Nereidas Avenue and turns onto Olivo Street towards the exit of PR-165 at El Caño Avenue. Then, it reaches the PR-5 in direction to José Celso Barbosa Avenue to the predestined assembly place (Figure 6-79).

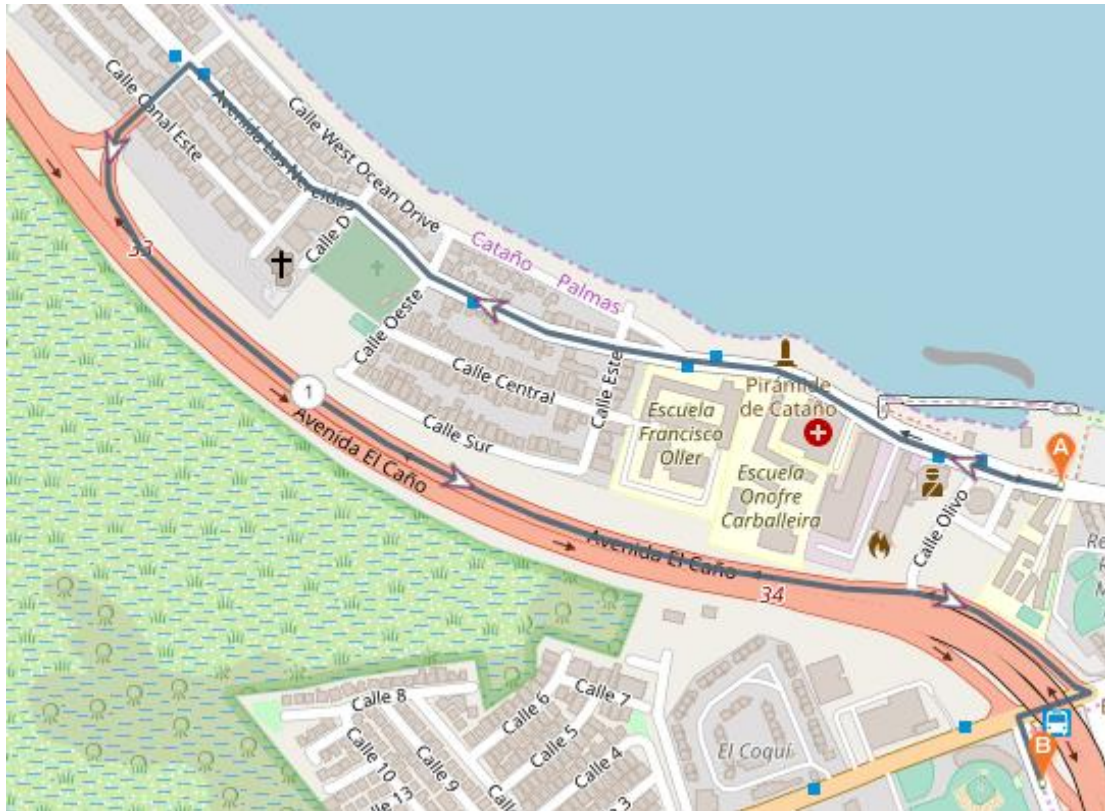
Figure 6-85 Streets of Third Alternate Route of Rosendo Matienzo Cintrón School

This route for Rosendo Matienzo Cintrón school leaves from PR-88 along Las Nereidas Avenue. Then, like the second alternates routes of the Francisco Oller and Onofre Carballeira schools, it turns onto Otero Street in direction to PR-165 along El Caño Avenue until it reaches PR-5 in direction to José Celso Barbosa Avenue. Then, it arrives at the predestined assembly place (Figure 6-85).
