VULNERABILITY OF SCHOOLS IN PUERTO RICO TO TSUNAMI EVENTS

RESEARCH FINAL REPORT

POLYTECHNIC UNIVERSITY OF PUERTO RICO

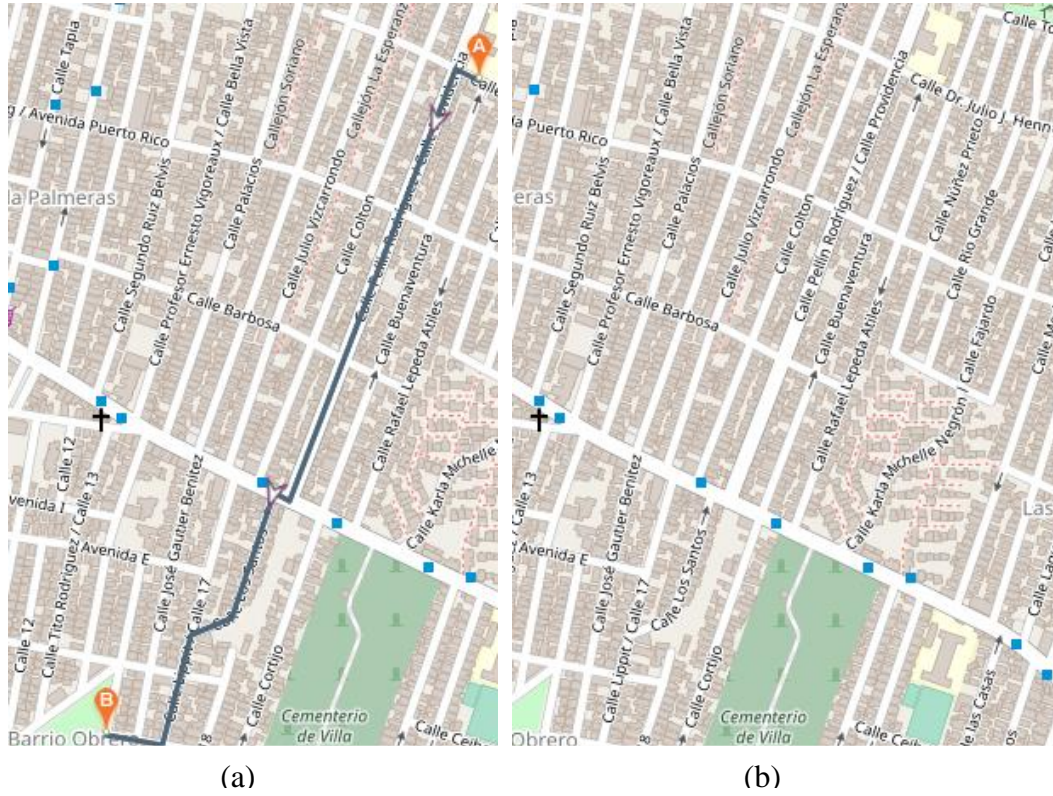
Figure 6-88 Streets of First Alternate Route of Dr. Julio J. Henna School

This first route leaves from Dr. Julio Henna Street and turns onto Pellín Rodríguez Street. Then, it turns onto Eduardo Conde Avenue towards Los Santos Street. It turns down Lippit Street and turns onto Hermanas Mirabal Avenue until it reaches Felipe R. Goyco Street, which is where the assembly place, Plaza Antonio R. Barceló is located. Figure 6-88 shows

(a) the first route for Dr. Julio J. Henna school and (b) the map of the area to visibly identify the streets and avenues of the route.

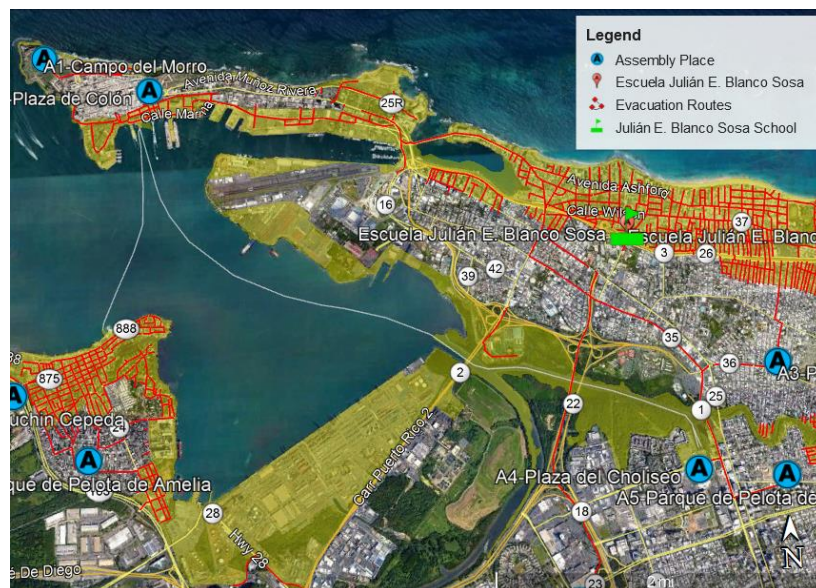
Figure 6-105 Location of Assembly Places with Respect to Julián E. Blanco School

This school has two other possible routes to get to the assembly site. For reasons of proximity, the possible alternative routes use the assembly place closest to the school, “Plaza Barceló”. The rest of the assembly locations are within 2 miles to 4 miles of the school location (Figure 6-105). This represents a very long evacuation time compared to previous schools whose times are kept between 10 min to 20 min.

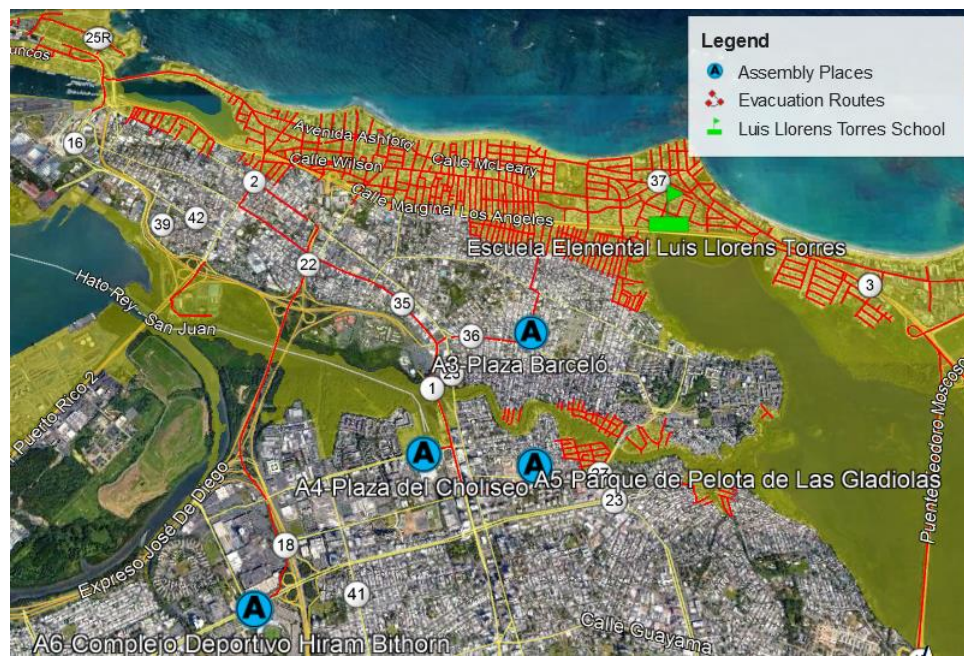
Figure 6-112 Location of Assembly Places with Respect to Luis Llorens Torres School

Luis Llorens Torres school has two other possible routes to get safe to the assembly site with the same place of assembly “Plaza Barceló”. Like the previous Julián E. Blanco school, at first glance the rest of the assembly places are far from this school (Figure 6-112). This represents a danger for the school, as the ideal is to get out of the coast and the tsunami hazard zone as soon as possible. However, a third route is presented with the nearest assembly place after “Plaza Barceló” as a comparison of the long evacuation times.

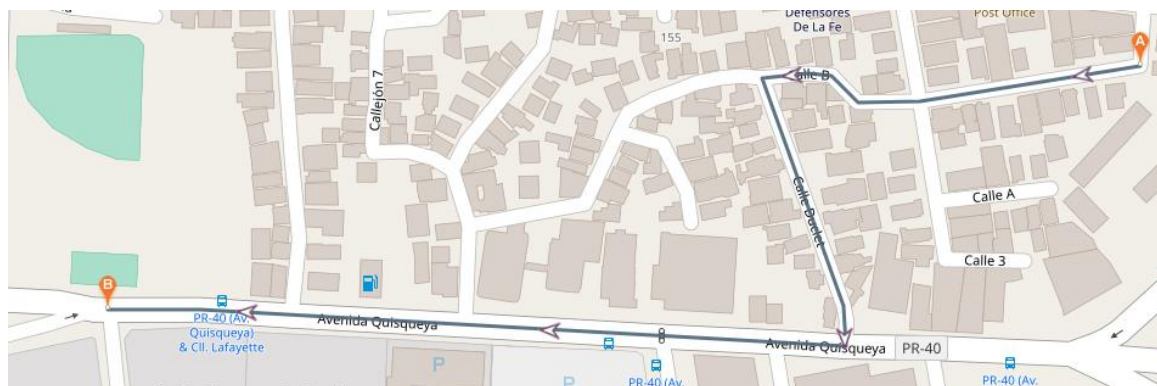
Figure 6-145 Streets of First Alternate Route of Moisés Meléndez School

This route leaves from Street B and turns onto Duclet Street in direction to Quisqueya Avenue (PR-40) until it reaches the assembly place, “Parque de Pelota de Las Gladiolas” (Figure 6-145).

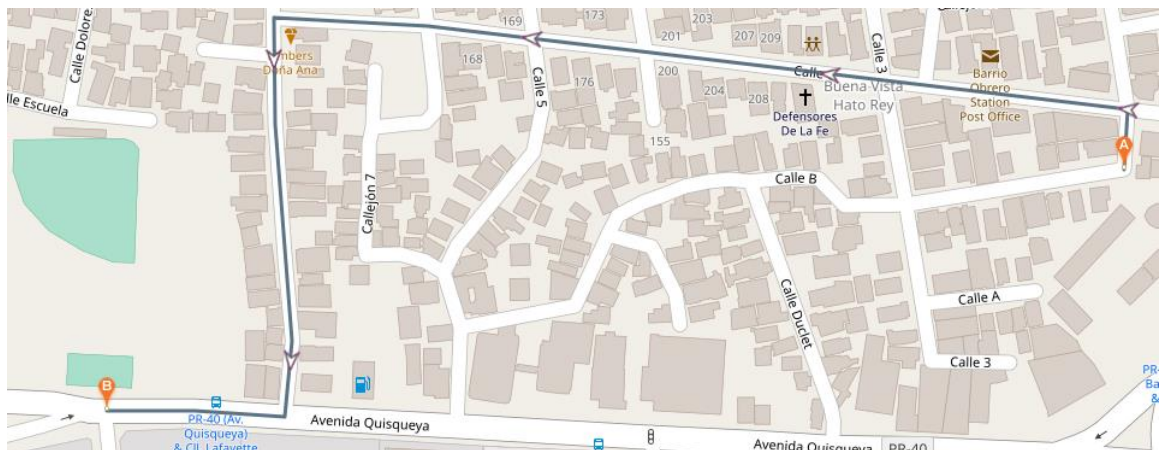
Figure 6-148 Streets of Second Alternate Route of Moisés Meléndez School

This second alternate route leaves from Street B, turns onto Street C, and then onto Lieutenant Francisco Gonzalo “Pachín” Marín Street. Afterwards, turn onto Quisqueya Avenue (PR-40) until it reaches the assembly place “Parque de Pelota de Las Gladiolas” (Figure 6-148).

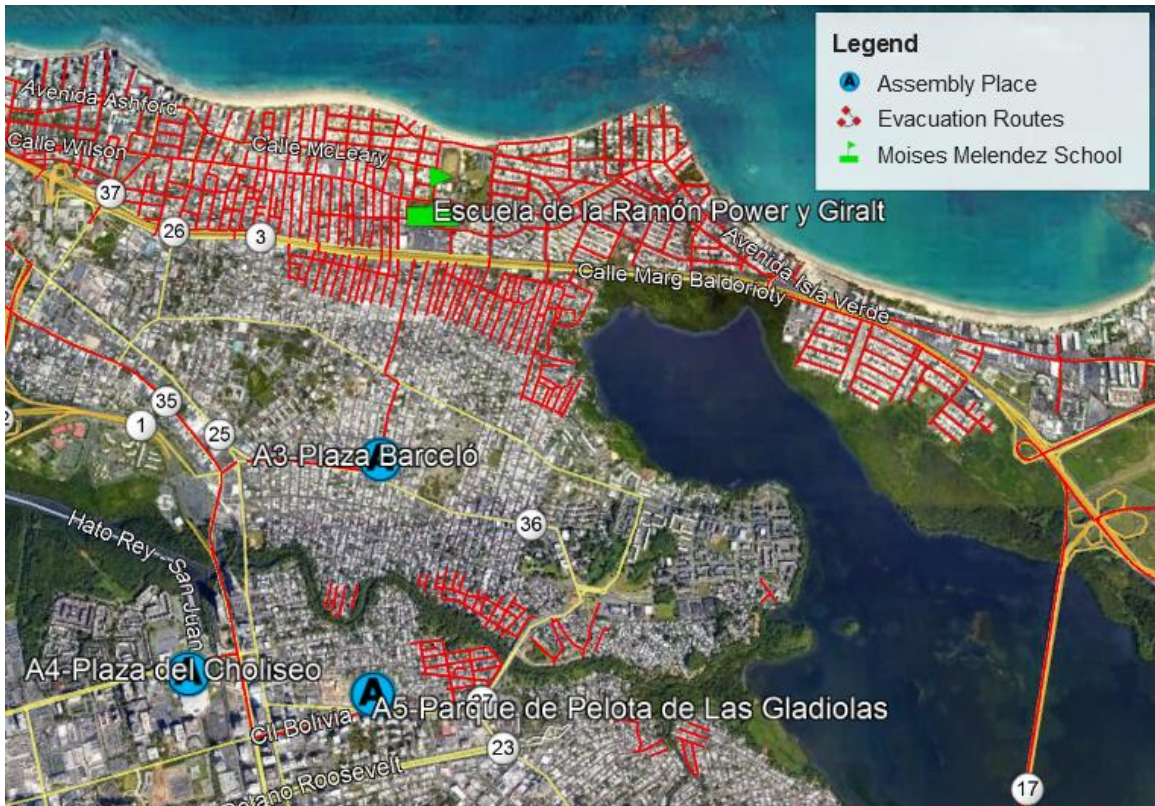
Figure 6-161 Location of Assembly Places with Respect to Ramón Power Y Giralt School

Like Luis Rodríguez Cabrero school, this school could reach other distant assembly places with evacuation times that double the time it takes to reach the nearest assembly place (Figure 6-161). For this reason, the rest of the assembly places in San Juan are not recommended for this school. They are not shown as a comparison either because in the case of the second closest assembly place, corresponding to the “Parque de Pelota de Las Gladiolas”, the distance and evacuation time would be approximately equal to Luis Rodríguez Cabrero school because they are in the same Street.

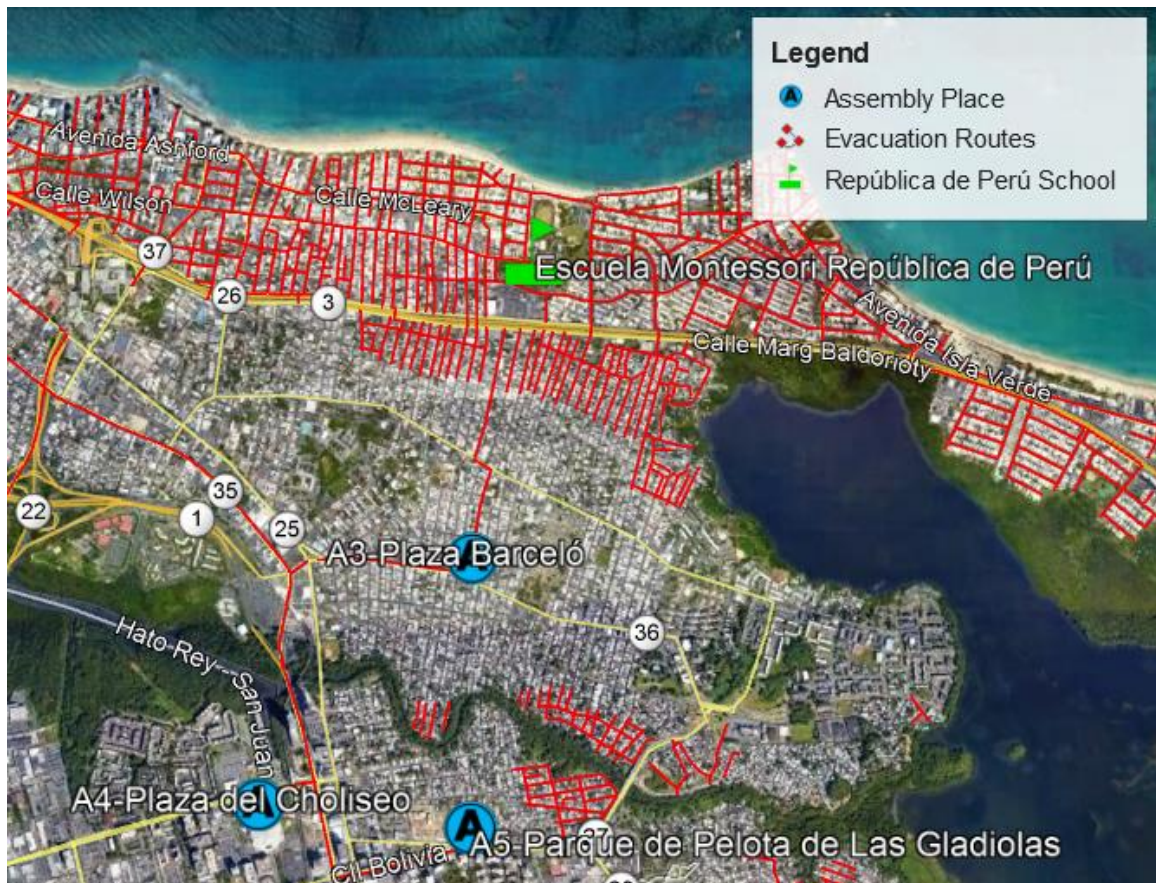
Figure 6-162 Location of Assembly Places with Respect to República Del Perú School

This school has two alternate routes out of the tsunami hazard zone during the evacuation process. Both arrive at the same assembly place (“Plaza Barceló”) due to its proximity (Figure 6-162). On the other hand, for the evaluation of the routes of the previous section, this is the same place of assembly. Like the Ramón Power Y Giralt school, this school does not compare routes with other assembly places due to the similarity of distances with respect to its respective establishment to the assembly place with those previously obtained for the Luis Rodríguez Cabrero school.

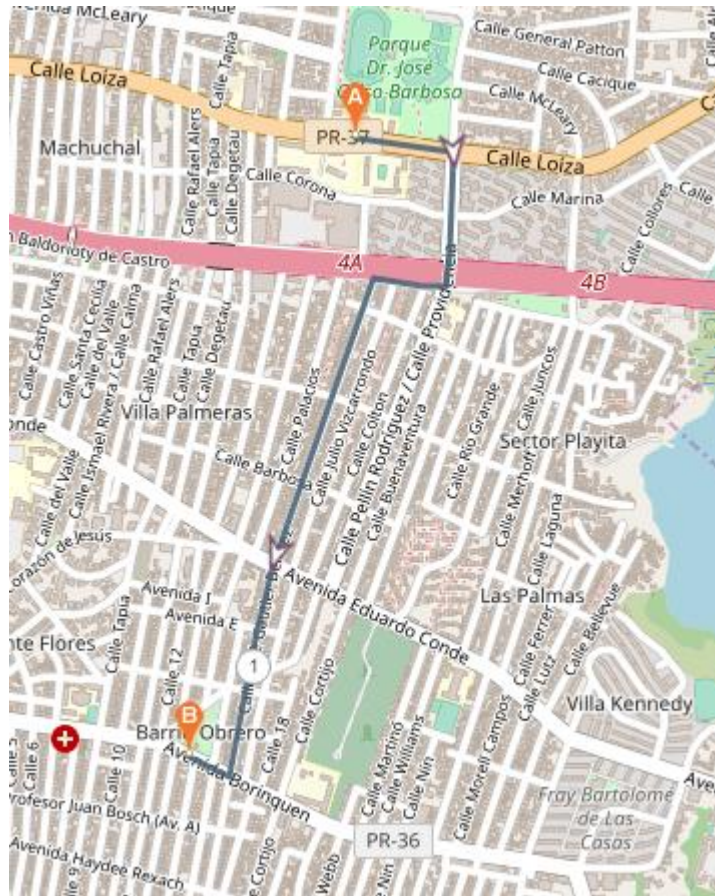
Figure 6-165 Streets of First Alternate Route of República Del Perú School

This route follows the same path as the first alternate route of Ramón Power Y Giralt school. But this route starts from Loíza Street, turns onto Pellín Rodríguez Street (Providencia Street) and onto Román Baldorioty de Castro Avenue. Then, turns onto José Gautier Benítez Street and turns onto Borinquen Avenue until it reaches the “Plaza Barceló” assembly place (Figure 6-165).

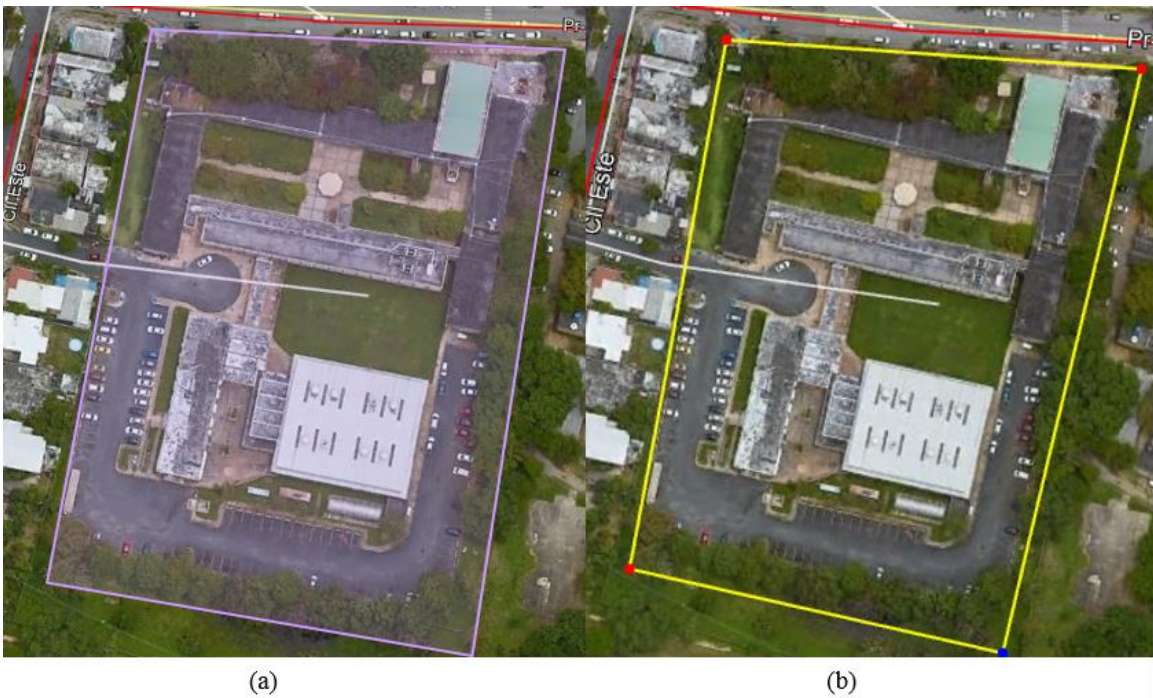
Figure 6-170 Estimated Total Floor Area for Francisco Oller School (Google Earth – 2016)

This school covers an area of approximately 19,500 square meters according to measurements estimated in Google Earth. Figure 6-170 represents through a polygon the delimitation of said area with (a) shaded fill and (b) marked edge.

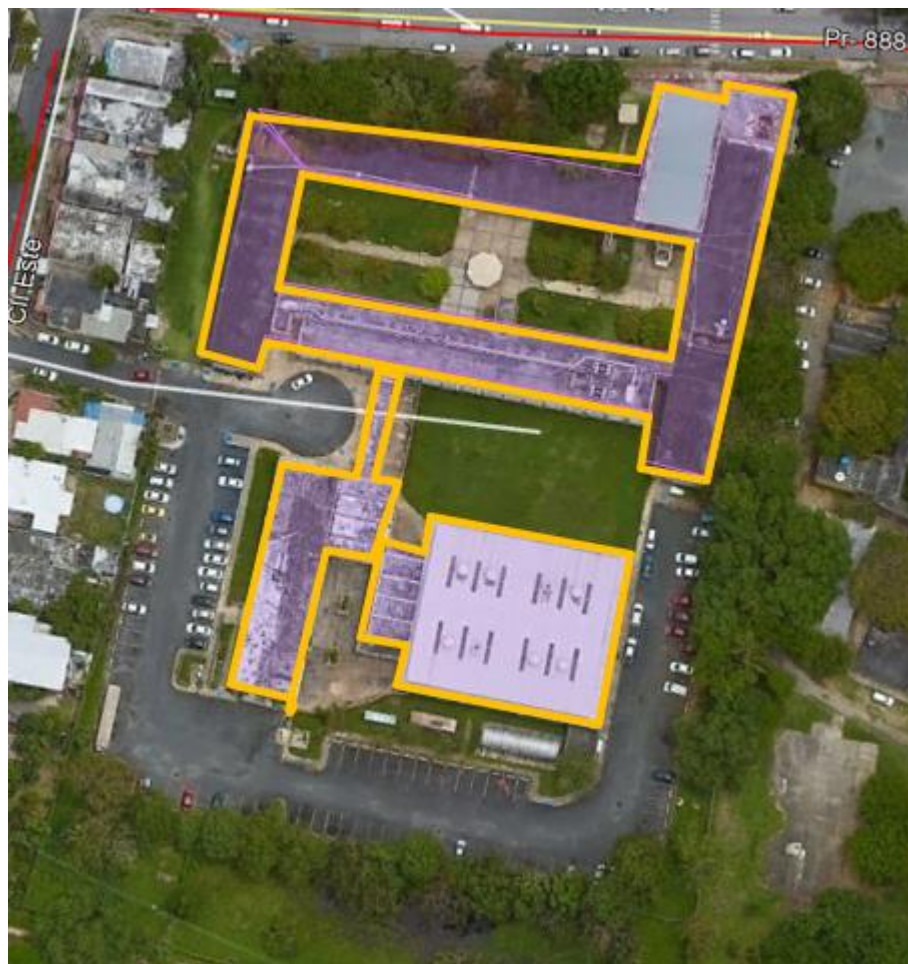
Figure 6-171 Structure Geometry in Plan of Francisco Oller School

Francisco Oller school has an irregularity in plan since it has a complex geometric shape. This is made up of more than one independent structural framing system divided by joints. A “box” type structure that connects to an “L” shaped structure and to two other rectangular shaped structures. This represents a risk and a seismic vulnerability of the building, since the ideal is that the geometry is a simple and redundant one, both in plan and elevation. Complex, irregular, or asymmetric shapes can cause poor behavior when the building is subjected to seismic loading. Irregular geometry allows the structure to twist or try to rotate out of order. The lack of uniformity makes it easier for some corners to have intense concentrations of force, which can be difficult to resist.

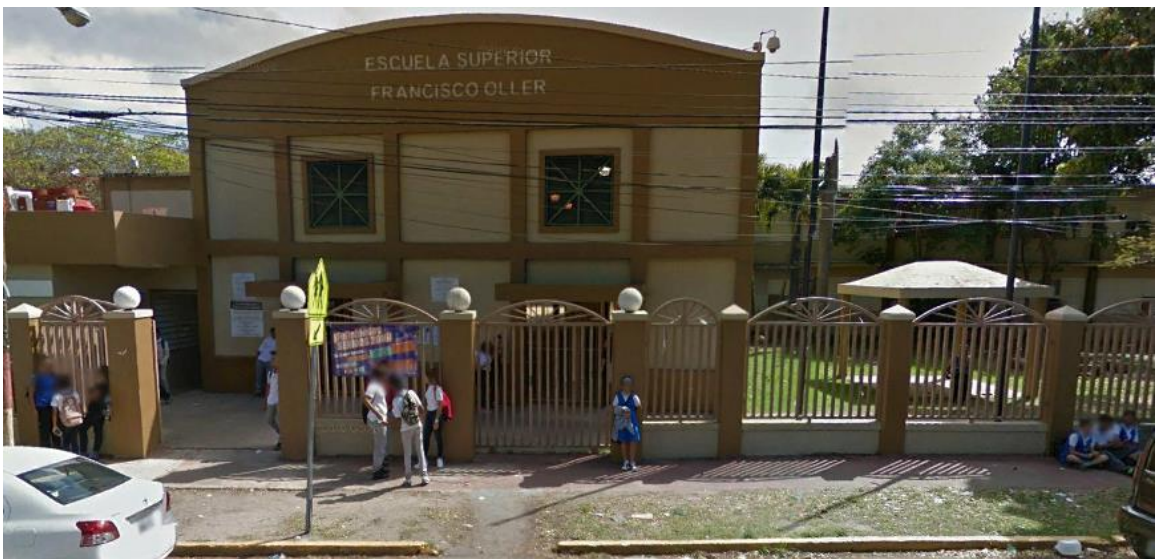
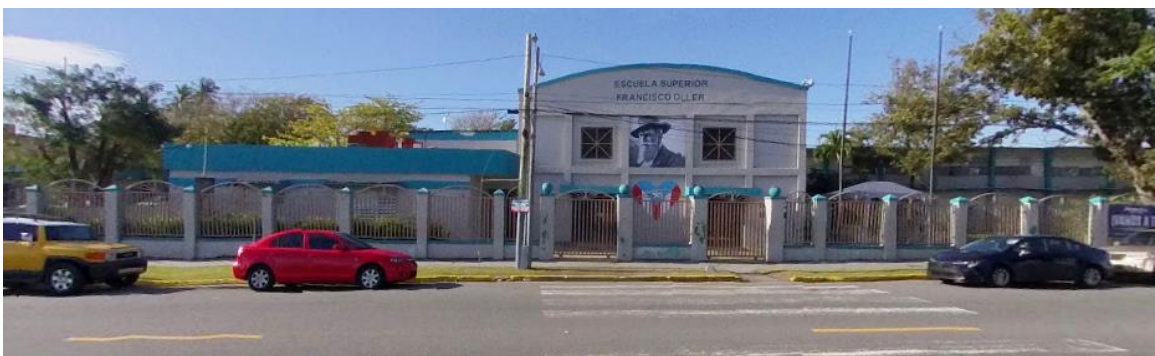
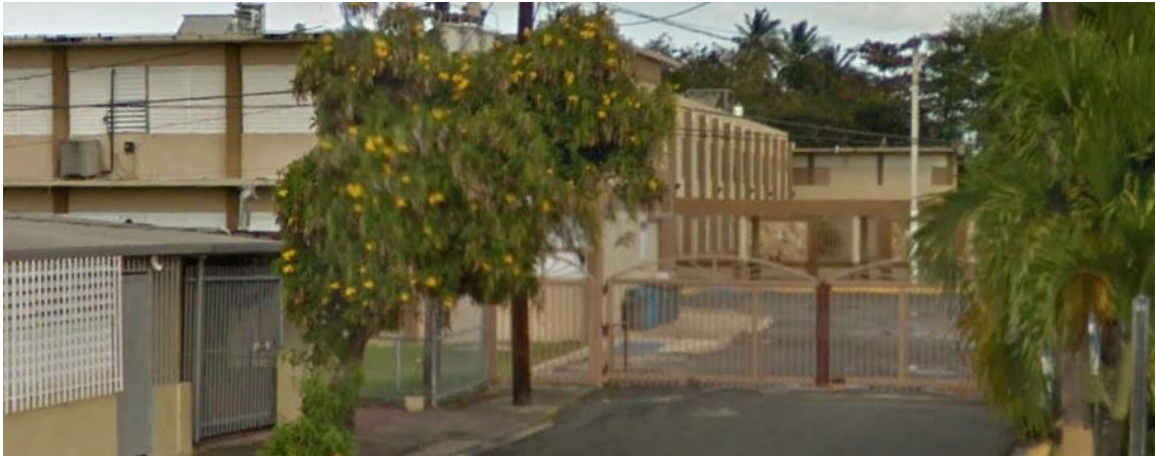
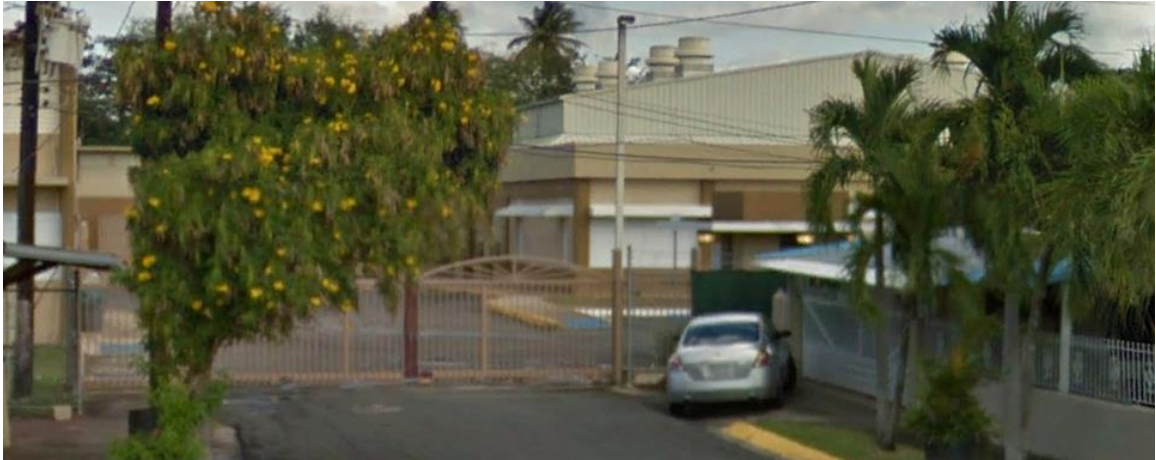
The structure of this school has a simple elevation. Therefore, it does not have any elevation irregularities. On the other hand, this school has two levels as can be seen in the images from the front of the school (just to the North of it) and from the sides (to the West of the structure). Figure 6-172 shows the front and the floors that the school has with an imagery date from Google Earth 2016. While Figure 6-173 shows the same front, but with a more updated version of the 2020 image. Also, the floors and elevations of the school shown by west side images in Figure 6-174 and Figure 6-175 based on 2016 imagery date.

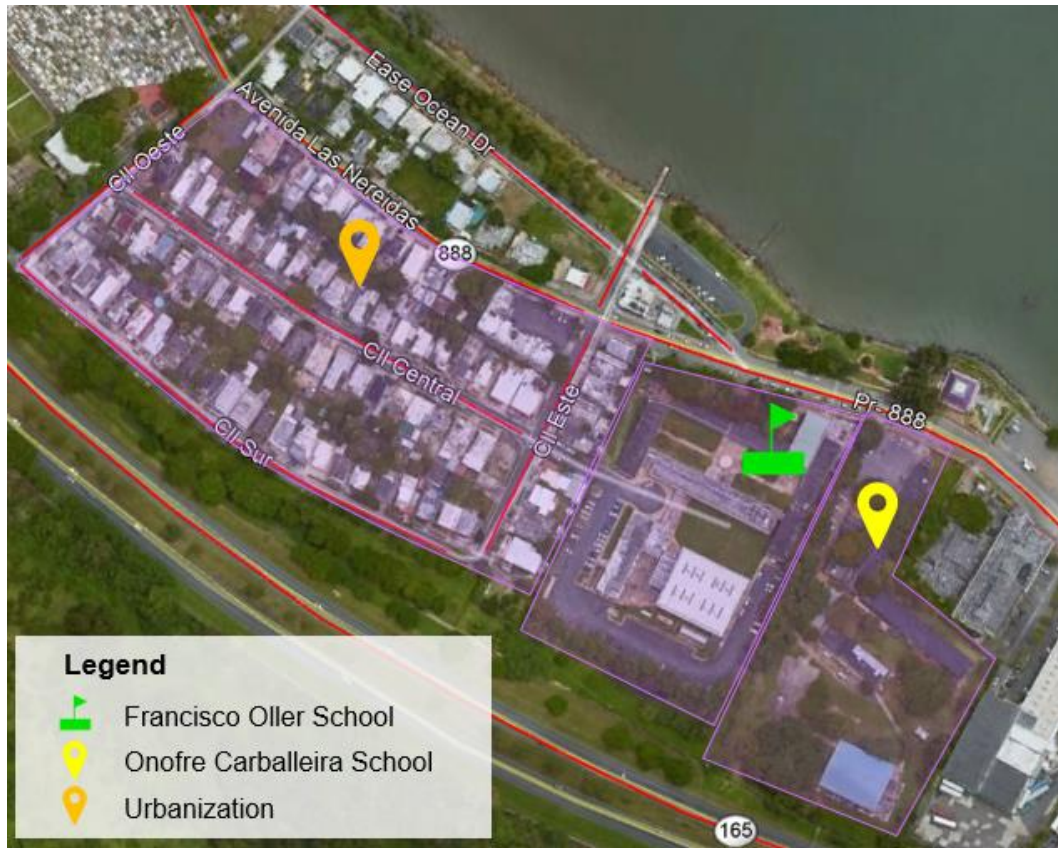
Figure 6-176 Position of Francisco Oller School in Urban Block

The position in the urban block of this school is in the middle. This means that Francisco Oller school may have a critical neighboring building that surrounds it. Precisely, this school is located between two existing buildings. One is the Onofre Carballeira middle school on your right (East) and another is the Bahía Urbanization on your left (West) as shown in Figure 6-176.

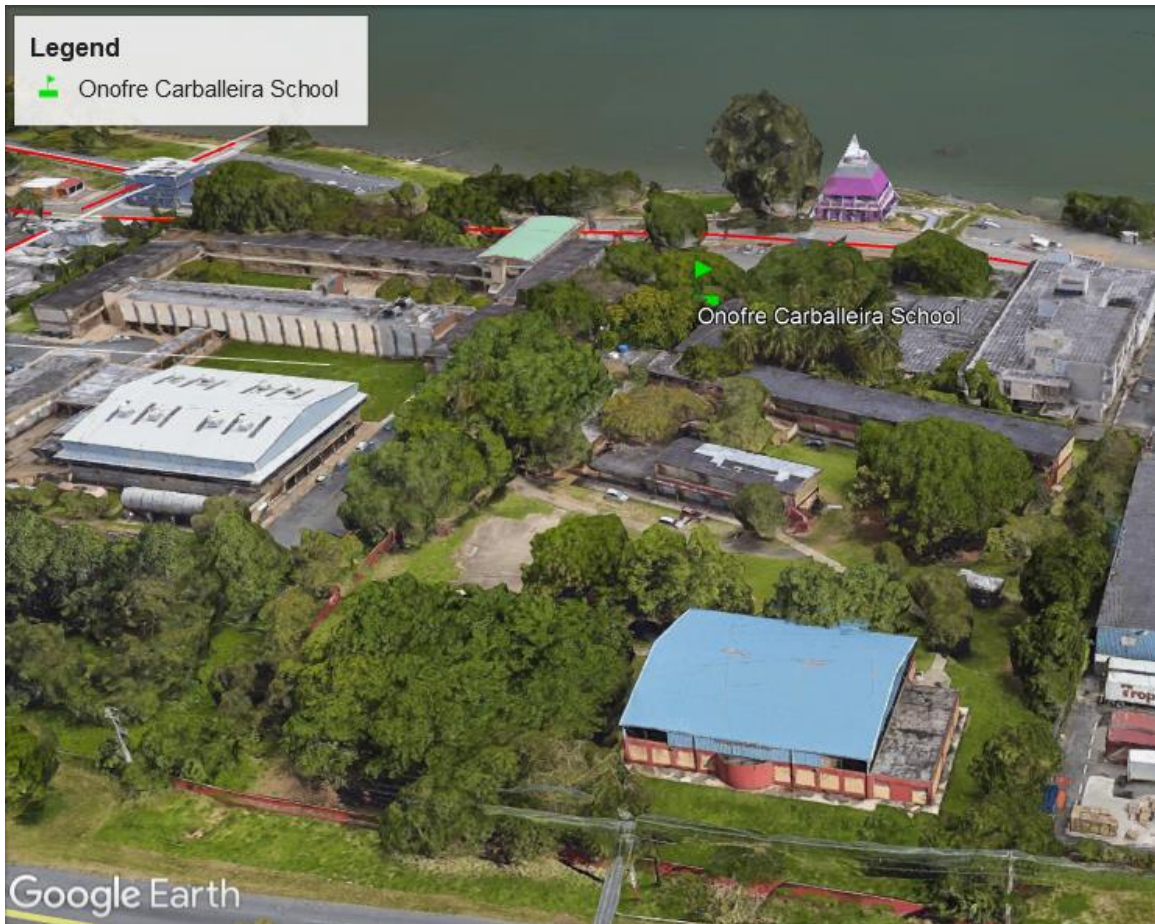
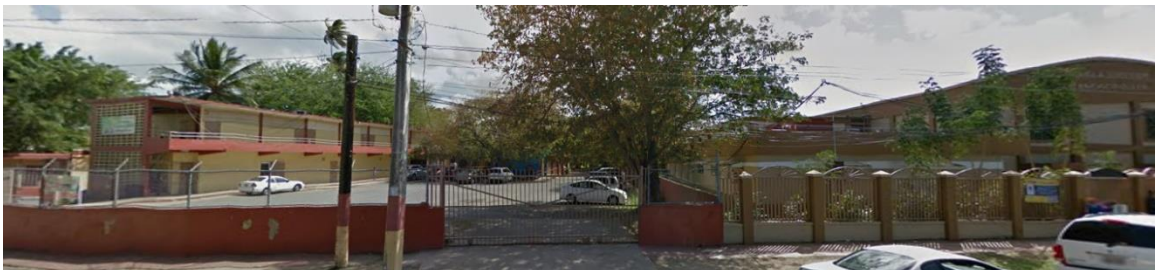
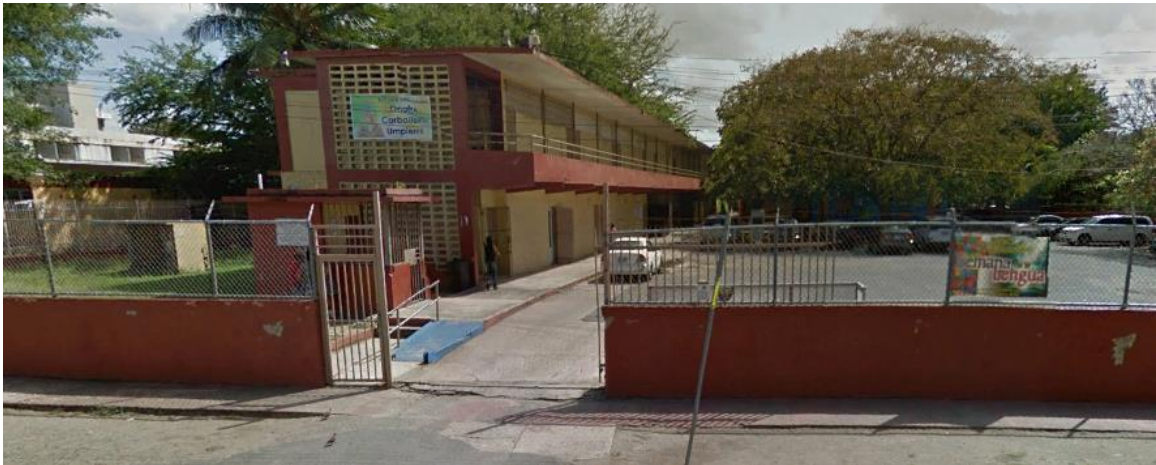
The Onofre Carballeira school structure is less than 0.01 miles away from the Francisco Oller school structure as shown in Figure 6-178 and Figure 6-177Figure 6-179. In Figure 6-177Figure 6-179, Francisco Oller School is on the right and Onofre Carballeira School is on the left according to the frontal shot of the image. This means that the neighboring building is close to the Francisco Oller school. In this way, it represents a potential vulnerability for the school in this study since the interaction between adjacent buildings causes various types of damage during earthquakes.

The neighboring building, Onofre Carballeira school, is also a school structure used as a voting center and not as a shelter. It has two floors (Figure 6-179) and independent structures with classrooms and parking facilities. On the other hand, it has a total population of 252 people between 236 students and 16 teachers. This is the amount of population to evacuate during a tsunami event via evacuation routes. As the Onofre

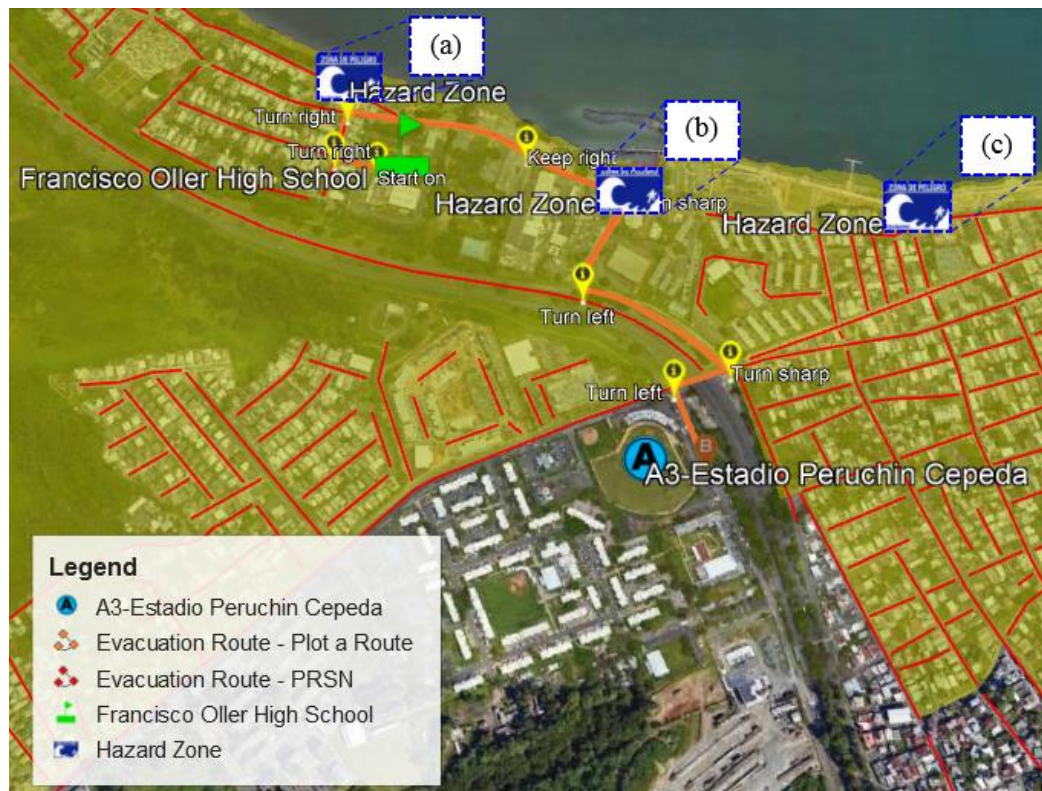
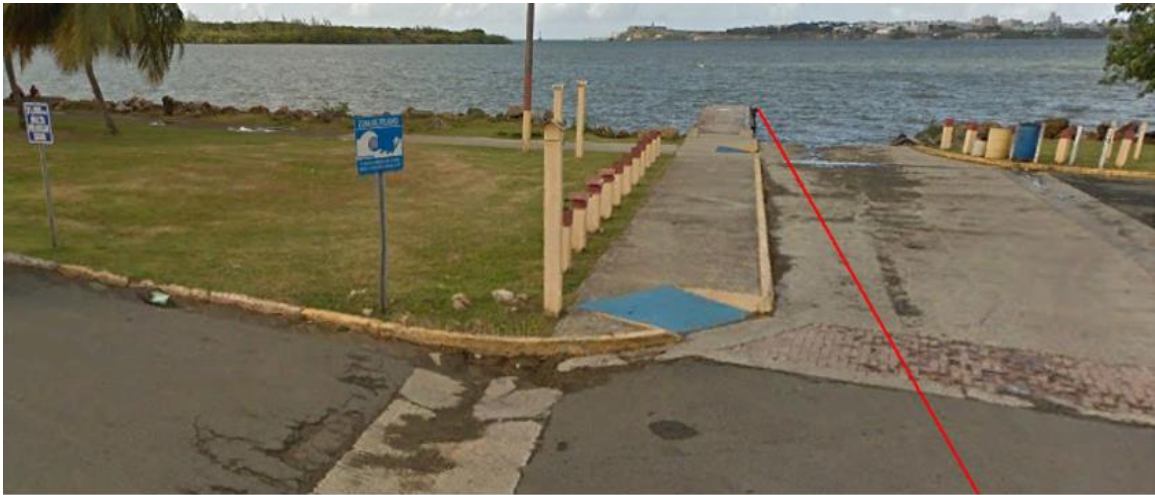
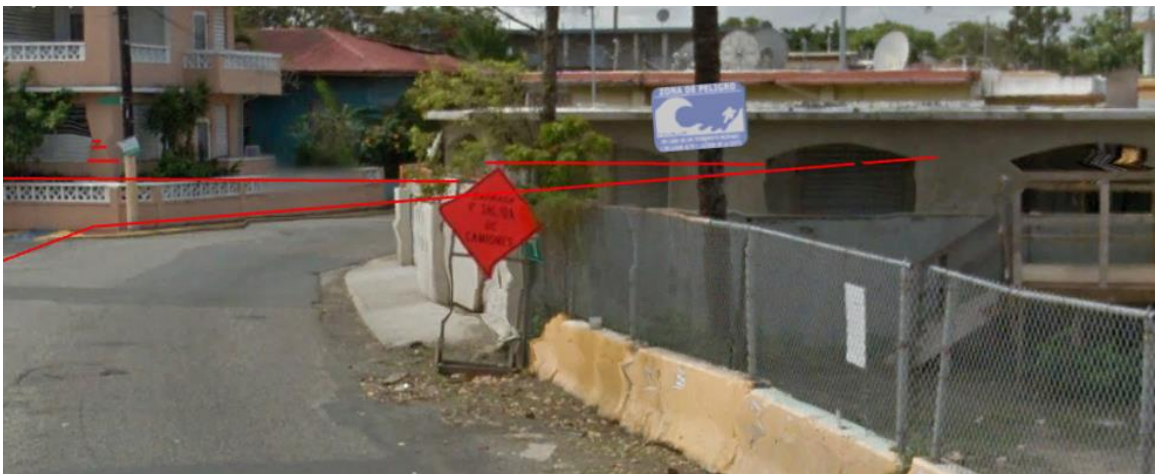
Figure 6-184 Hazard Zone Signs Near the Perimeter of Francisco Oller School – Continue (Google Earth – 2016)

The tsunami endangered zones correspond to the yellow tsunami evacuation zones developed by the Puerto Rico Seismic Network (PRSN). These are indicated by two signs that indicate these zones as shown in Figure 6-183. In Figure 6-183 and Figure 6-184, (a) one located on West Ocean Drive Street and (b) the other on PR-888 (Las Nereidas Avenue). These two signs (a and b) are the closest to the Francisco Oller school. However, there is another third sign (c) that is further away on the same PR-888 (Las Nereidas Avenue) and that could be considered for one of the alternate evacuation routes of this school and not the one found in orange.

Figure 6-184 represents the continuation of Figure 6-183. This shows an image of each hazard zone sign near the perimeter of Francisco Oller school according to their respective location.

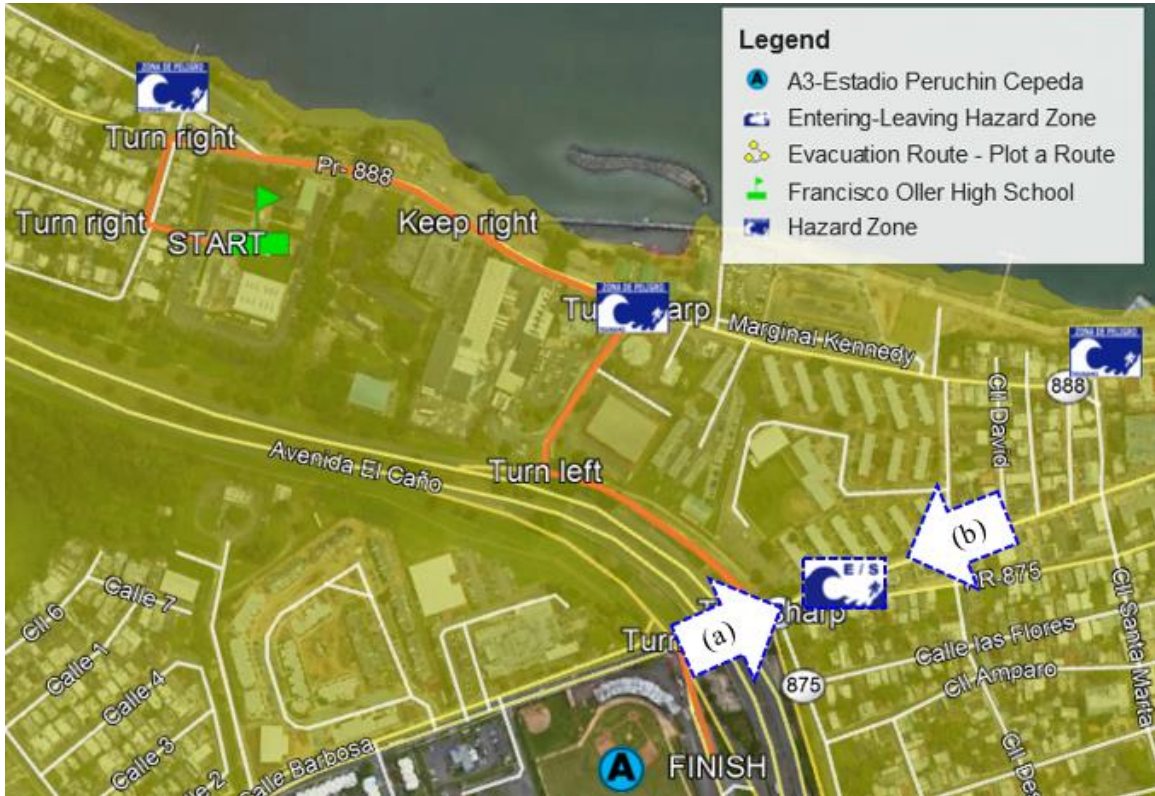
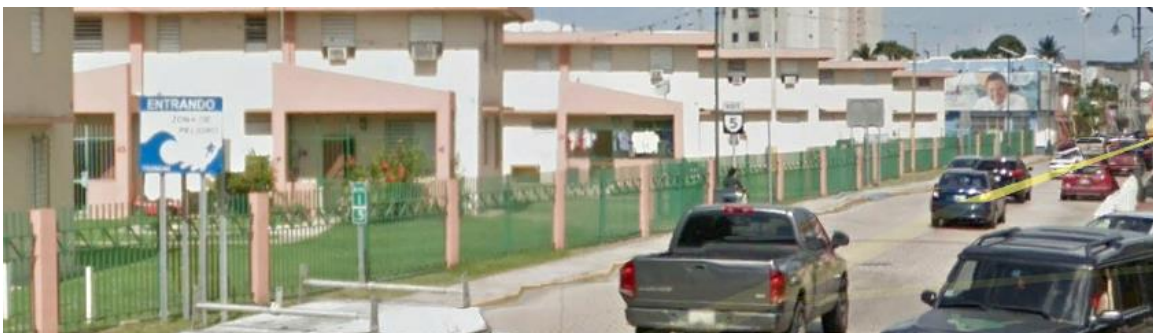
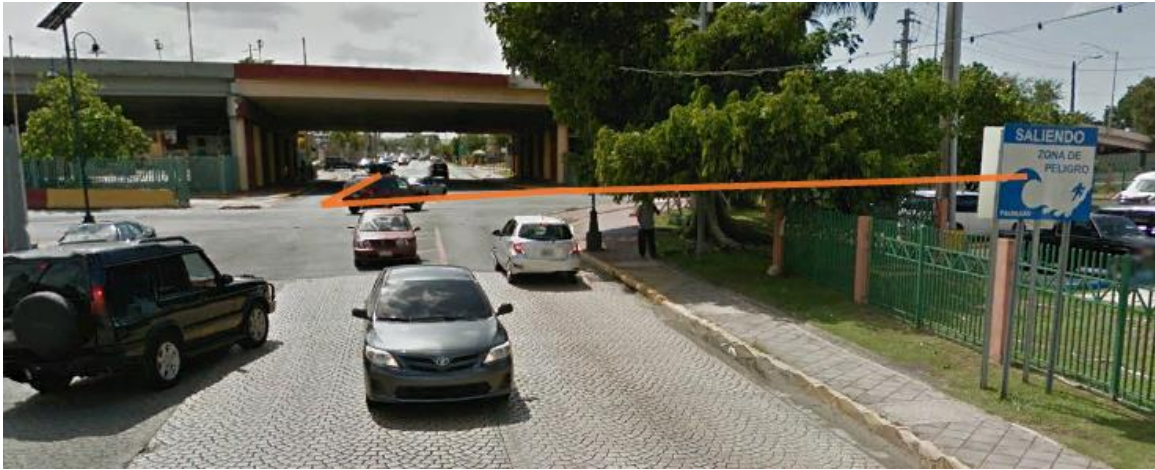
On PR-5 (José Celso Barbosa Avenue) there are two other signs that show the entrance and exit of the tsunami hazard zone as shown in Figure 6-186. Both signs are located on the same avenue, their difference lies in the direction in which they are directed. The sign (a) represents the entering to the hazard zone in a northeast direction (Figure 6-185). While the sign (b) indicates the leaving from the hazard zone (Figure 6-187).

The rest of the evacuation route signs can be found at: (c) by Las Nereidas Avenue (PR-888) towards Olivo Street (Figure 6-248), (d) by Olivo Street (Hernández Street) towards the marginal of El Caño Avenue (Figure 6-249), (e) El Caño Avenue (PR-165) (Figure 6-250), and (f) by José Celso Barbosa Avenue (PR-5) (Figure 6-251). This evacuation route sign (f) is located along the same avenue as the entering and leaving hazard zone signs in Figure 6-186.

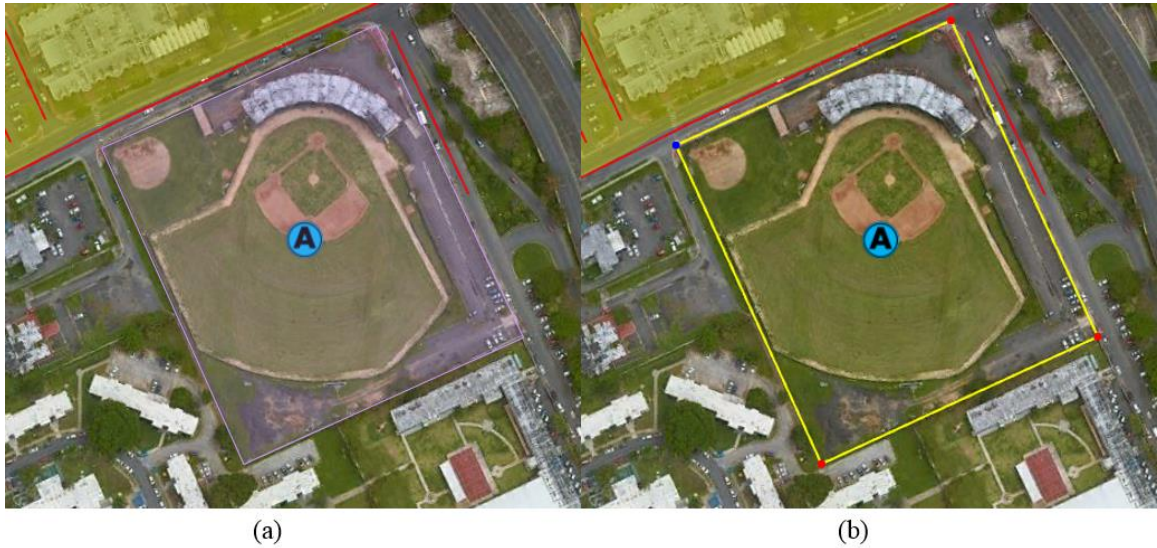
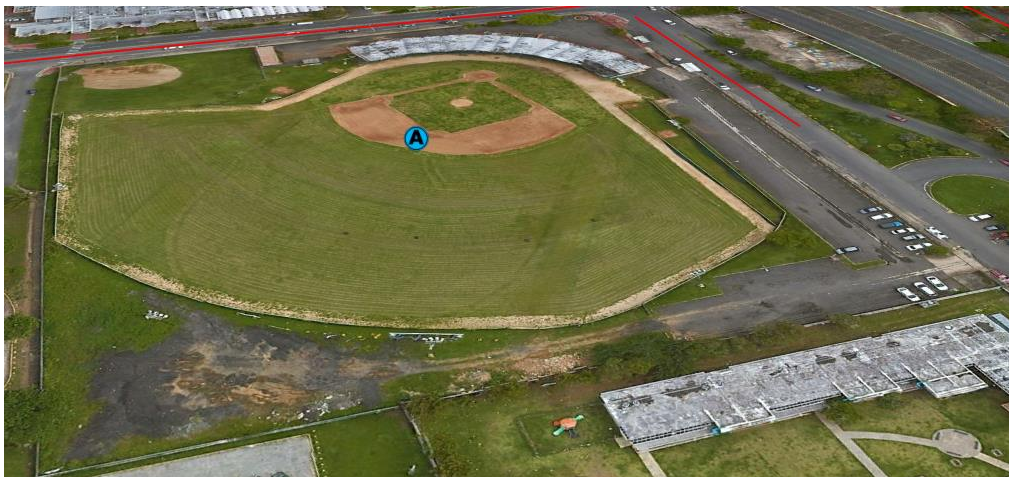
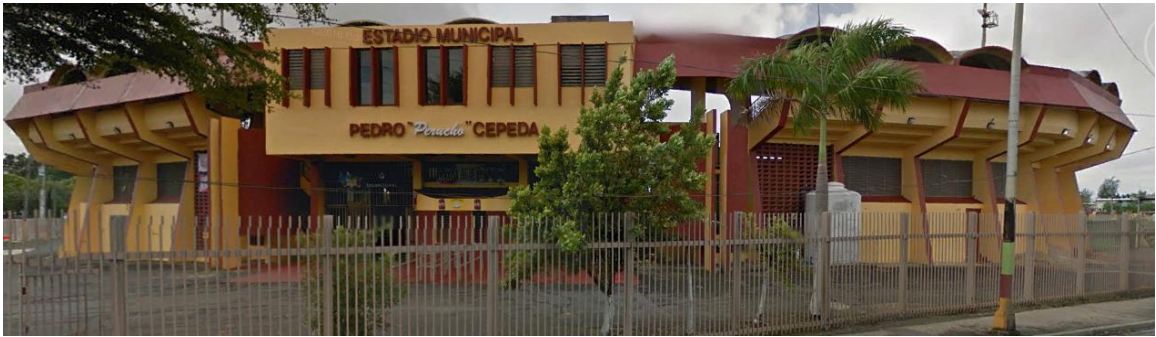
For this school, the safe zone corresponds to the assembly site. Francisco Oller school goes to the “Estadio Municipal Pedro (Perucho) Cepeda”, better known by the community as “Estadio Peruchín Cepeda”. This is the same place of assembly assumed in the previous evaluation of the evacuation routes. This assembly place covers an area of approximately 24,000 square meters according to measurements estimated in Google Earth. The delimitation of said area with (a) shaded fill and (b) marked edge are presented through a polygon in Figure 6-189.

This assembly place is shown in plan (Figure 6-188) and in Street View (Figure 6-190).

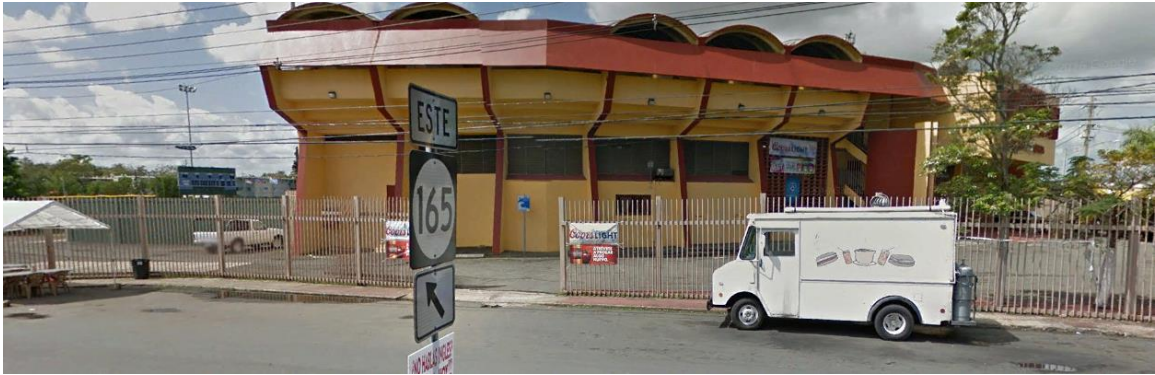
The sign showing the safe zone as an assembly location is shown in plan in Figure 6-191. In addition, it is presented in Street View just in front (at the entrance) of the “Estadio Peruchín Cepeda” in Figure 6-190.

The fact that this assembly place has a safe zone sign assigned for this area implies that the assumption used for the evaluation of evacuation routes is feasible and effective according to the proximity of the school to this place.

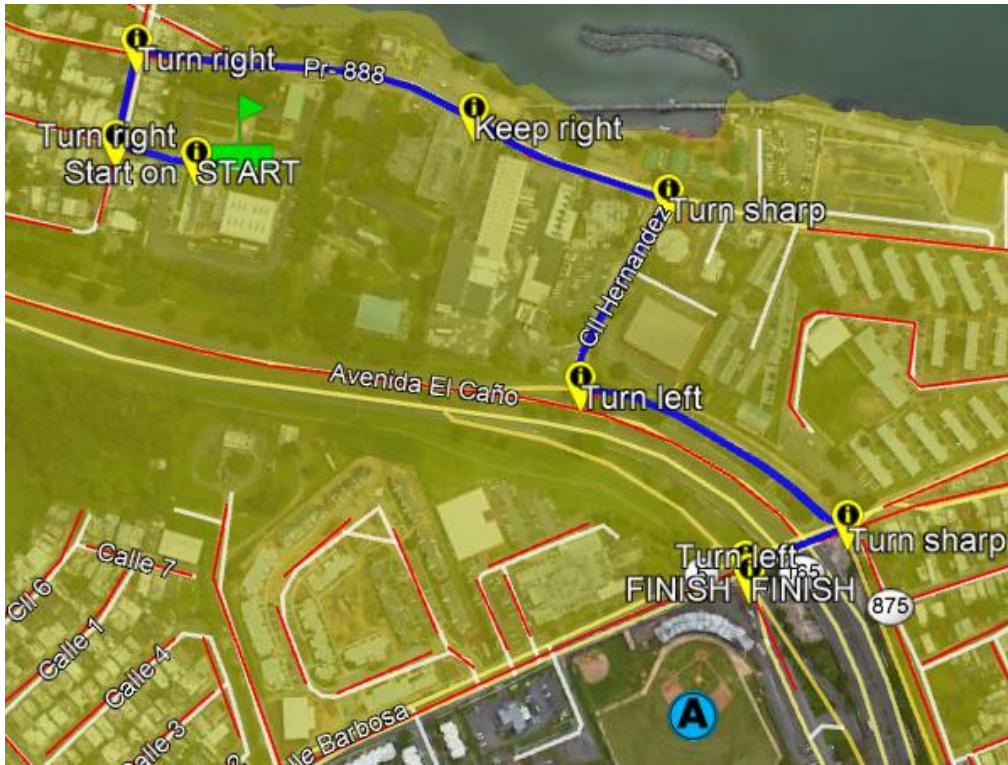
Figure 6-193 Evacuation Route until Leaving the Hazard Zone for Francisco Oller School (Google Earth – 2016)

The first condition of early departure from the coast is reflected in the evacuation time it takes for the population to leave the tsunami danger zone obtained for the Francisco Oller school of 16 minutes and 4 seconds (Figure 6-193). And with the evacuation time it takes for the school population to reach the assembly place or meeting point in a safe zone of 17 minutes and 29 seconds (Figure 6-194).

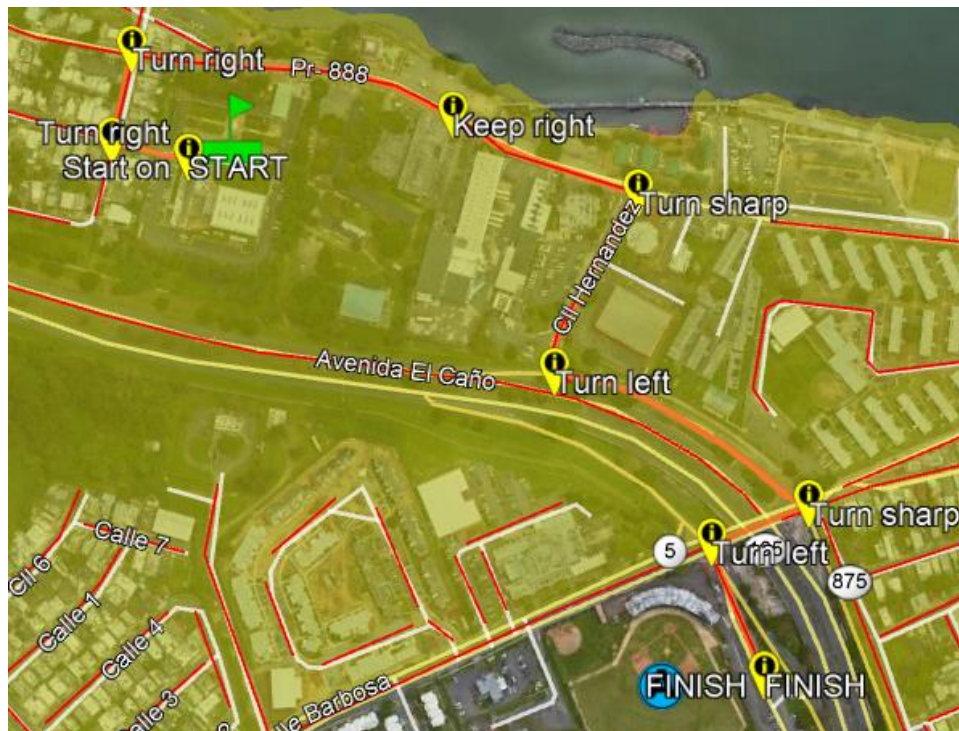
Figure 6-194 Evacuation Route until Reaching the Assembly Place for Francisco Oller School (Google Earth – 2016)

This evacuation route corresponds to the same route evaluated in the evacuation routes of the previous section. In which it starts from Central Street, turn East Street towards Las Nereidas Avenue (PR-88). Then, turn down Olivo Street and along the marginal of El Caño Avenue (PR-165). Eventually, turn onto José Celso Barbosa Avenue (PR-5) until you reach the “Estadio Peruchin Cepeda” assembly place.
