VULNERABILITY OF SCHOOLS IN PUERTO RICO TO TSUNAMI EVENTS

RESEARCH FINAL REPORT

POLYTECHNIC UNIVERSITY OF PUERTO RICO

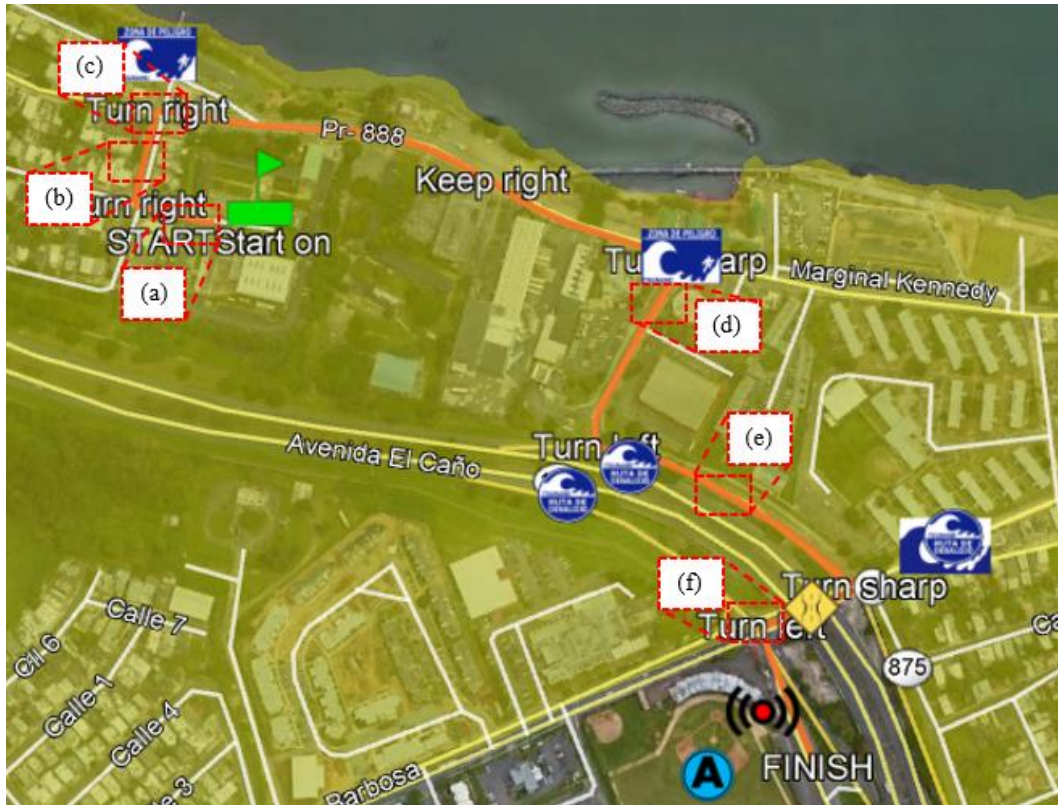
Figure 6-196 Power Lines on the Evacuation Route of Francisco Oller School (Google Earth – 2016)

If this is the only route available to the school, it could be disastrous to have power lines obstructing the path. When considering that in a tsunami event, people could be affected by these elements as possible obstructions, it is very important to identify them. For this reason, Figure 6-196 shows the image locations of power lines arbitrarily located along the evacuation route.

There is a Street View image of each segment of the highway on the road showing the power lines. These are named with a series of letters for easy identification. Likewise, these correspond to the possible obstructions that the school population of this school could be facing. For what is mentioned and specified the name of the street to ensure the viability of the information regarding the power lines.

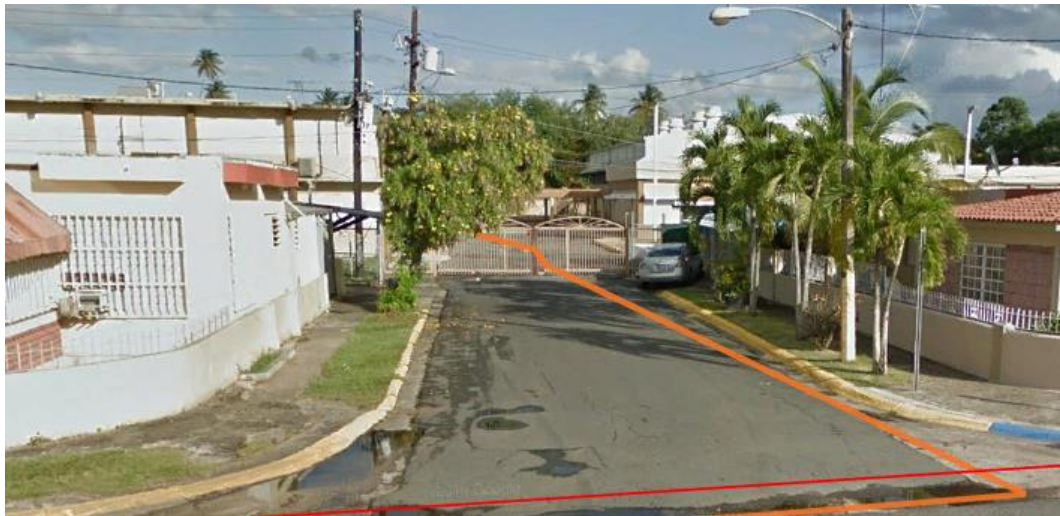
Figure 6-197 Power Lines on the Evacuation Route of Francisco Oller School through Central Street (Google Earth – 2016)

Figure 6-197 shows the power lines (a) along Central Street at the entrance and exit of the Francisco Oller school.

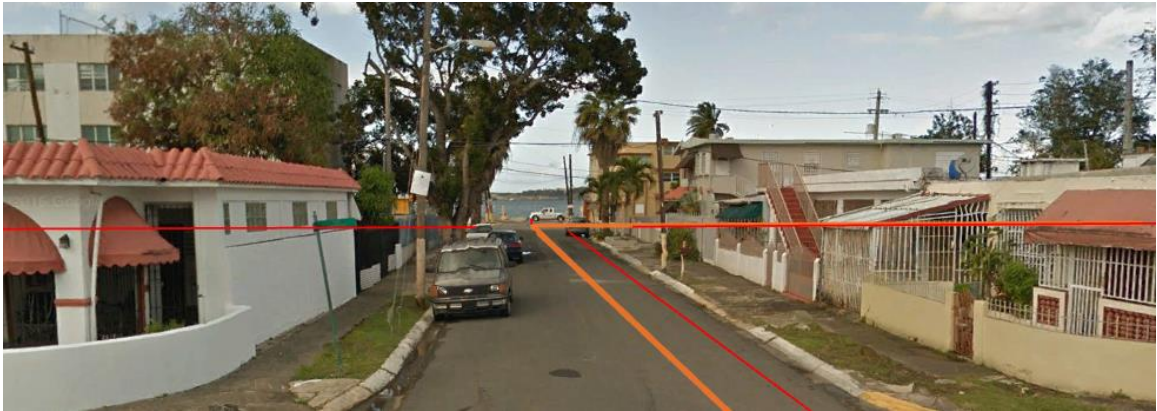
Figure 6-198 Power Lines on the Evacuation Route of Francisco Oller School through East Street (Google Earth – 2016)

Figure 6-198 shows the power lines (b) found on East Street.

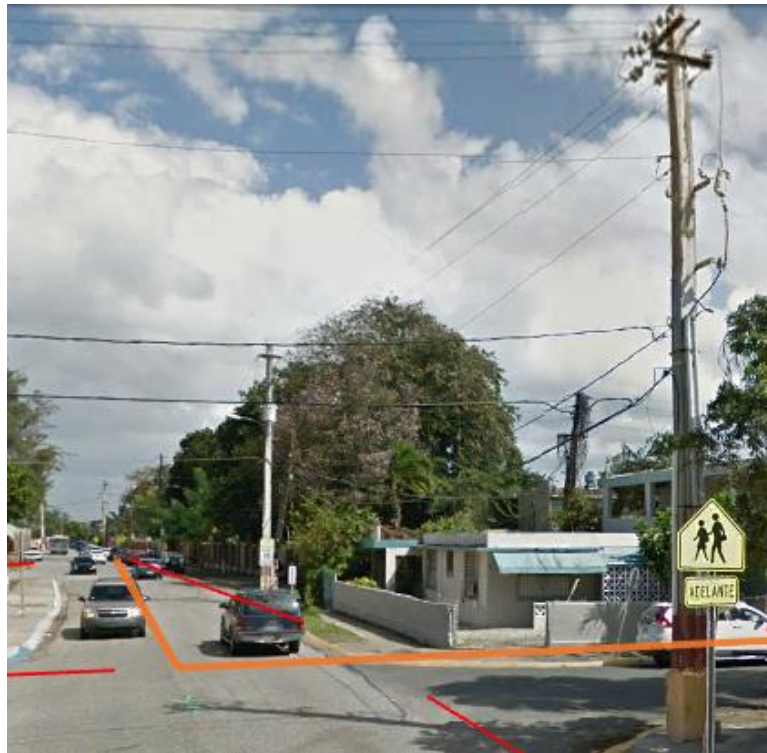
Figure 6-199 Power Lines on the Evacuation Route of Francisco Oller School through Las Nereidas Avenue (Google Earth – 2016)

Those that are located (c) by Las Nereidas Avenue (PR-88), are presented in the following Figure 6-199.

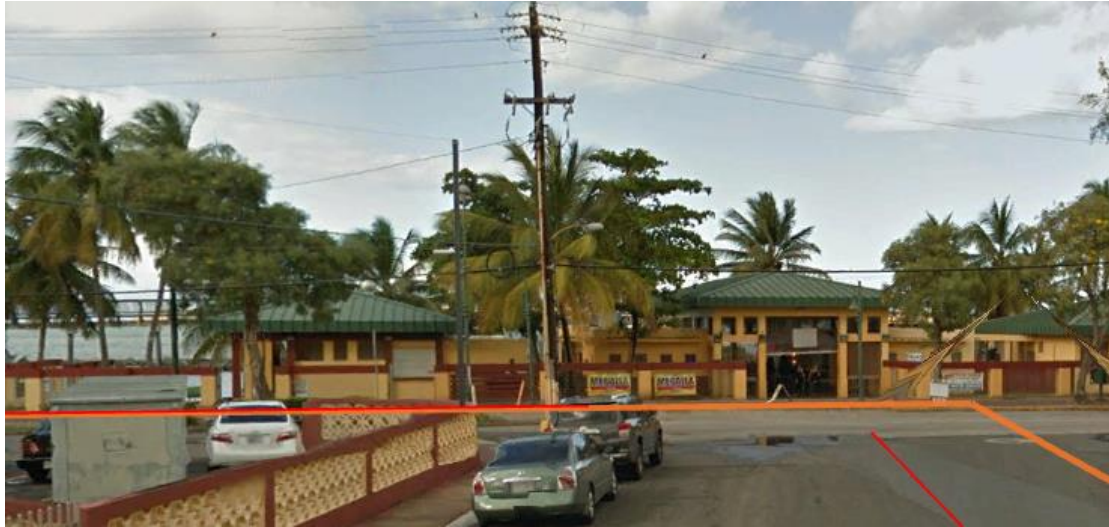
Figure 6-200 Power Lines on the Evacuation Route of Francisco Oller School through Olivo Street (Google Earth – 2016)

The power lines that are located by (d) Olivo Street (Figure 6-200), by (e) El Caño Avenue (Figure 6-201), and by (f) José Celso Barbosa Avenue (Figure 6-202) are shown according to their respective images taken from Google Earth.

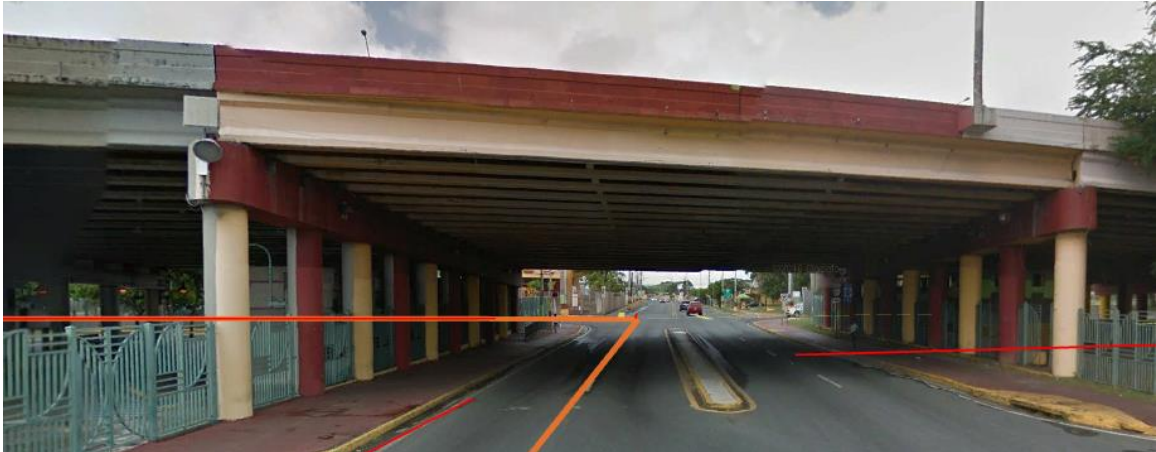
Figure 6-204 Bridge on the Evacuation Route of Francisco Oller School (Google Earth – 2016)

The following Figure 6-204 shows the bridge where the evacuation route passes in Google Earth Street View mode.

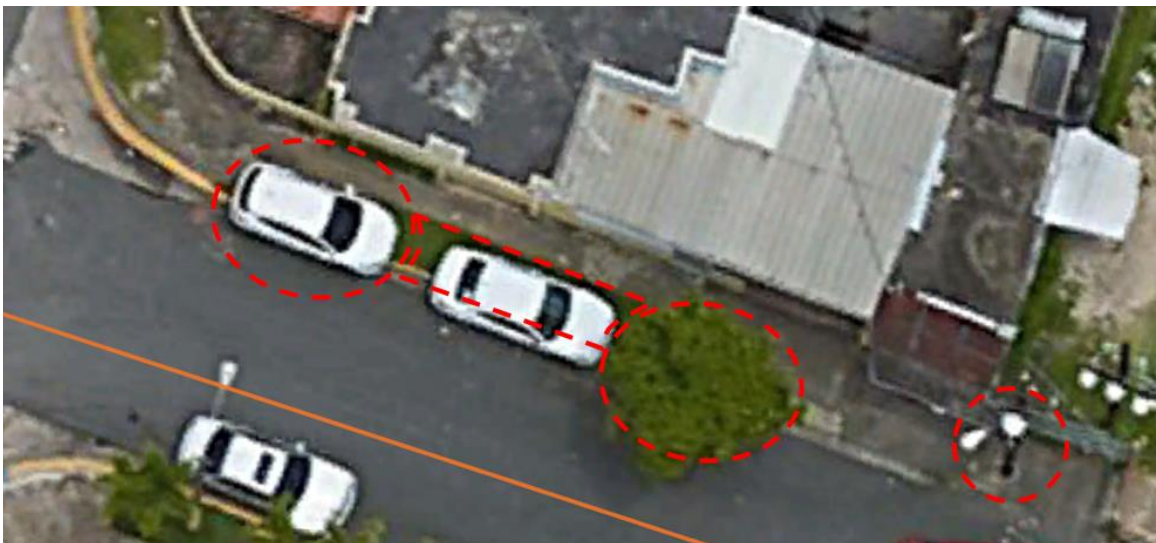
Figure 6-205 Sidewalk on Central Street from the Evacuation Route of Francisco Oller School in Plan View (Google Earth – 2016)

Another obstacle that stands in the way is the condition of the sidewalks through which the evicted school population travels. The sidewalks along Central Street (Figure 6-205) have a variant width ranging from 32 inches to 44 inches. This is due to the obstructions of posts, cars and green areas that limit the pedestrian crossing.

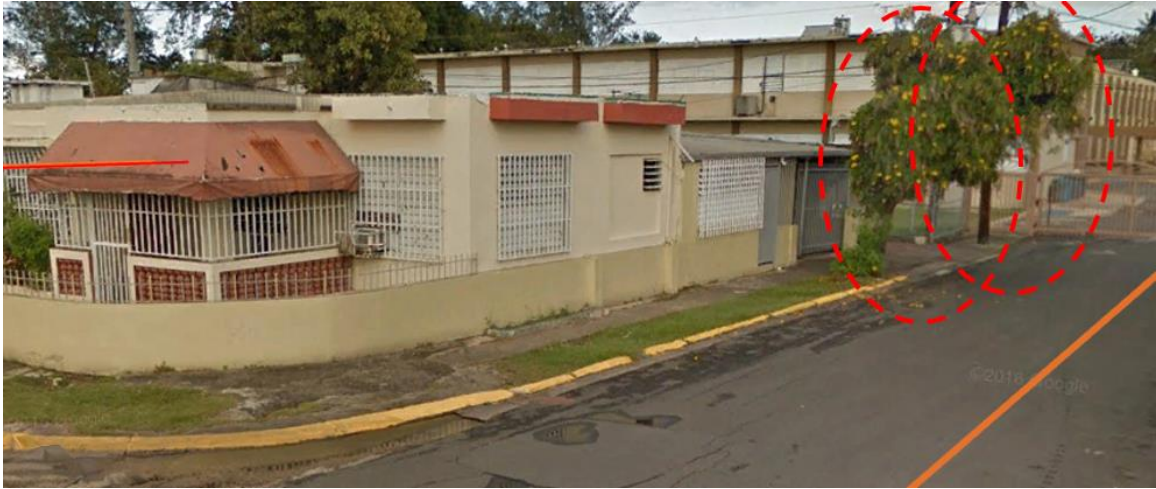
Figure 6-206 Sidewalk on Central Street from the Evacuation Route of Francisco Oller School in Street View (Google Earth – 2016)

Therefore, certain areas of this sidewalk do not meet the minimum clear width of 36 inches required by the ADA (Americans with Disabilities Act). The figure shows this same sidewalk, but in Street View where the trees, posts and green areas can be seen. The green area on this sidewalk is 50 inches wide.

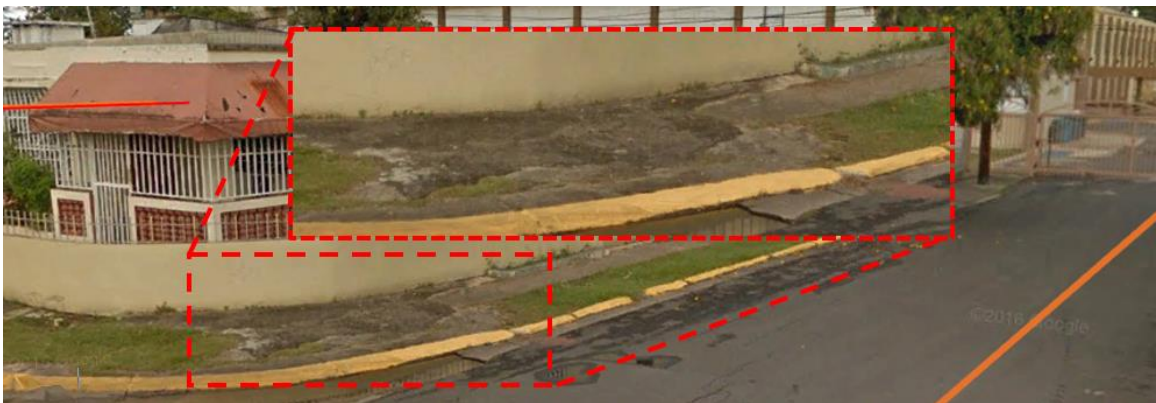
Figure 6-207 Damage of Sidewalk on Central Street from the Evacuation Route of Francisco Oller (Google Earth – 2016)

According to images taken in 2016 from Google Earth, the sidewalk of this street has deterioration and cracked segments as shown in Figure 6-207. Which would not make it suitable for people with disabilities. However, today this type of damage can be worse or better if it has been fixed.

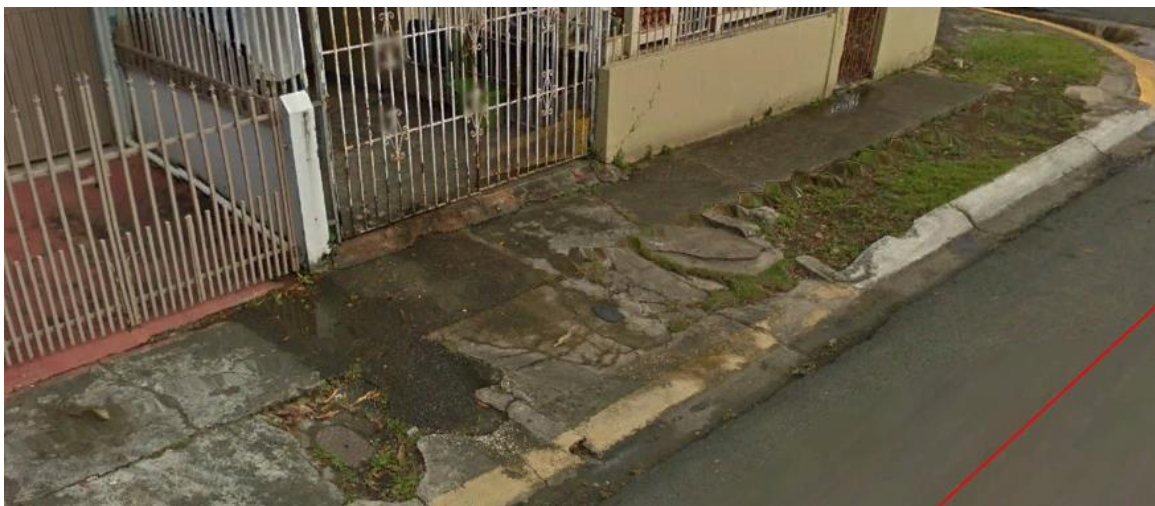
Figure 6-209 Sidewalk on East Street from the Evacuation Route of Francisco Oller School in Street View (Google Earth – 2016)

Figure 6-209 shows sidewalk damage with green areas and cracks interrupting the road. After this, Figure 6-211 shows the "zoom in" of both areas.

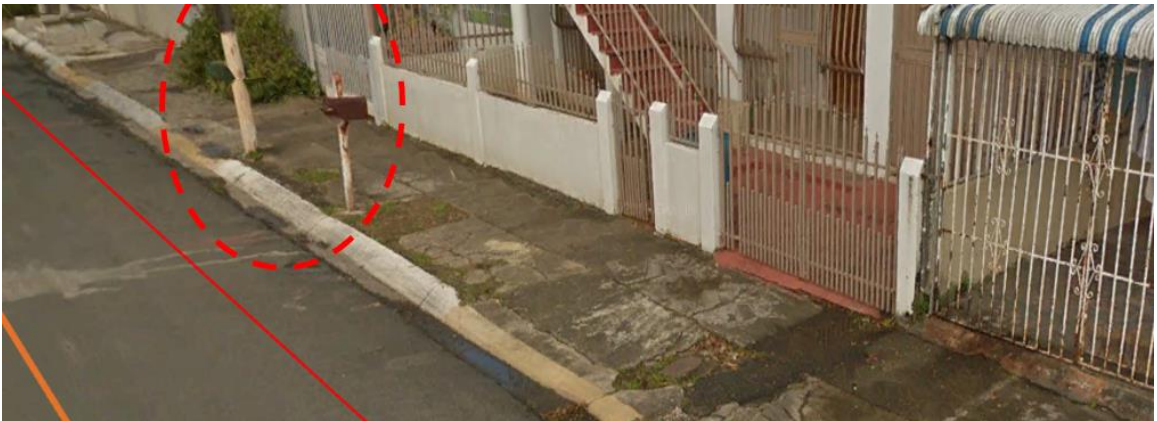
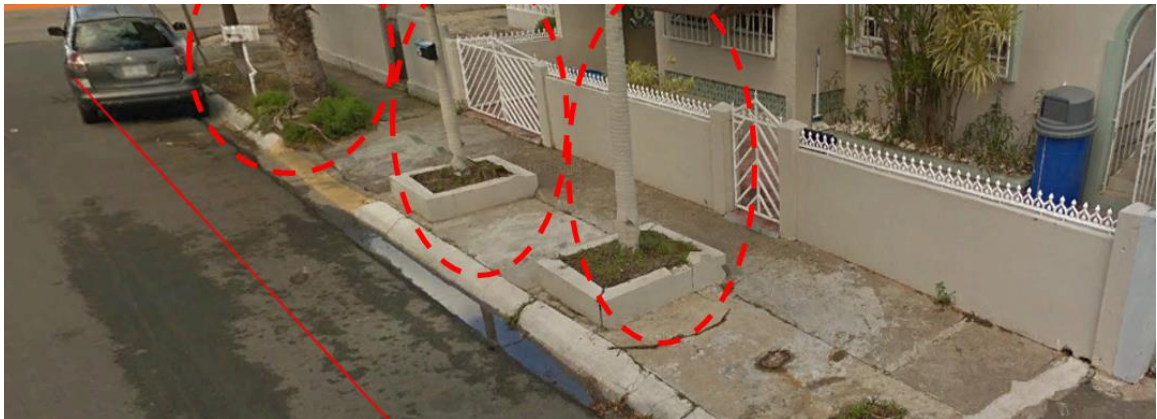
Figure 6-210 and Figure 6-212 present the interruption of the sidewalk with more vegetation, trees, palms, posts, and mailboxes. Despite the obstructions on this sidewalk, it has an effective width that varies from 38 inches to 90 inches. This means that this sidewalk is adapted for people with disabilities, although it does not have optimal conditions due to its advanced deterioration.

Figure 6-210 Urban Furniture of Sidewalk on East Street from the Evacuation Route of Francisco Oller (Google Earth – 2016)

Figure 6-212 Urban Furniture of Sidewalk on East Street from the Evacuation Route of Francisco Oller (Google Earth – 2016)

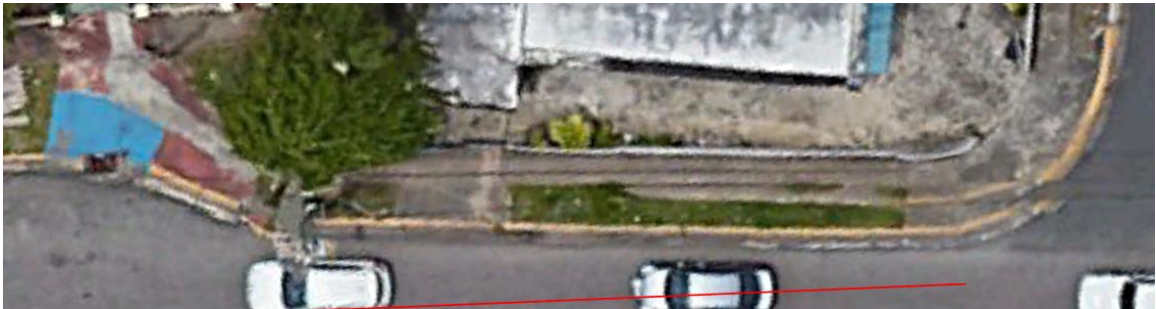
Figure 6-214 First Section of Sidewalk on Las Nereidas Avenue from the Evacuation Route of Francisco Oller School in Plan View (Google Earth – 2016)

The first section of this sidewalk has an effective width of 45 inches parallel to the green areas and 90 inches where the green areas are not (Figure 6-214). This width is not affected even though in this segment of the sidewalk there are posts and signs (Figure 6-215) that can serve as an obstruction for a large population that moves to a safe area in a hurry.

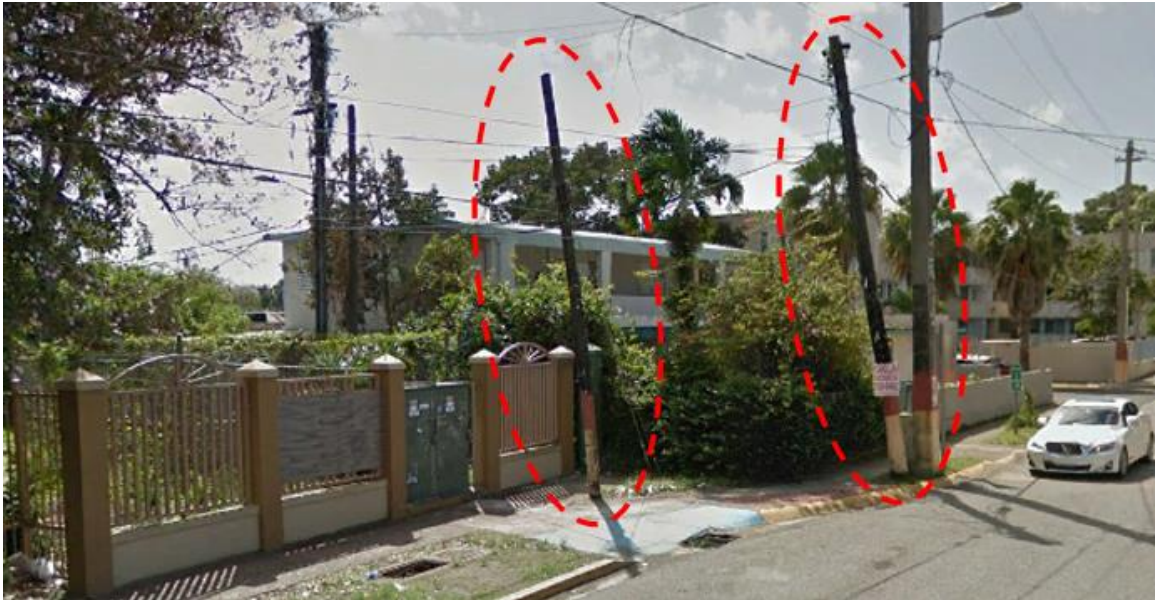
Figure 6-216 Poles with Power Lines in First Section of Sidewalk on Las Nereidas Avenue from the Evacuation Route of Francisco Oller School in Street View (Google Earth - 2016)

Where this section ends there are some inclined poles of power lines that are inclined as shown in Figure 6-216. This poses a threat to the safety of people at the school during the evacuation process. However, the condition of this section of sidewalk is optimal. It does not have cracks or any other type of damage or deterioration, which makes it suitable for people with disabilities.

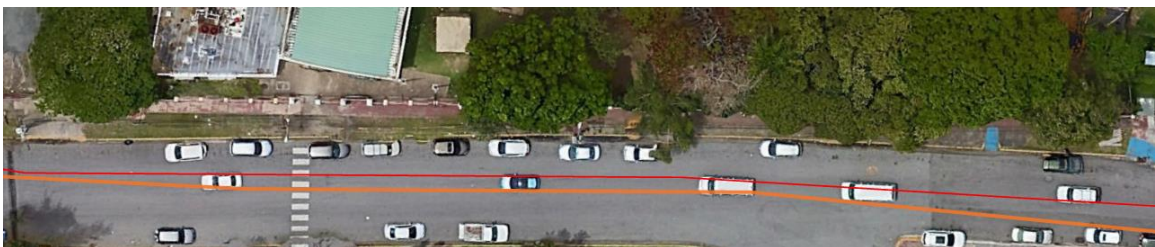
Figure 6-217 Second Section of Sidewalk on Las Nereidas Avenue from the Evacuation Route of Francisco Oller School in Plan View (Google Earth - 2016)

The second segment of this sidewalk is shown in Figure 6-217. It also has poles and signs, but they do not affect its effective width (Figure 6-218). In addition, it has acceptable conditions as it does not present any deterioration and instability. On the other hand, it has 76-inch continuous green areas and an equally continuous 54-inch effective curb width.

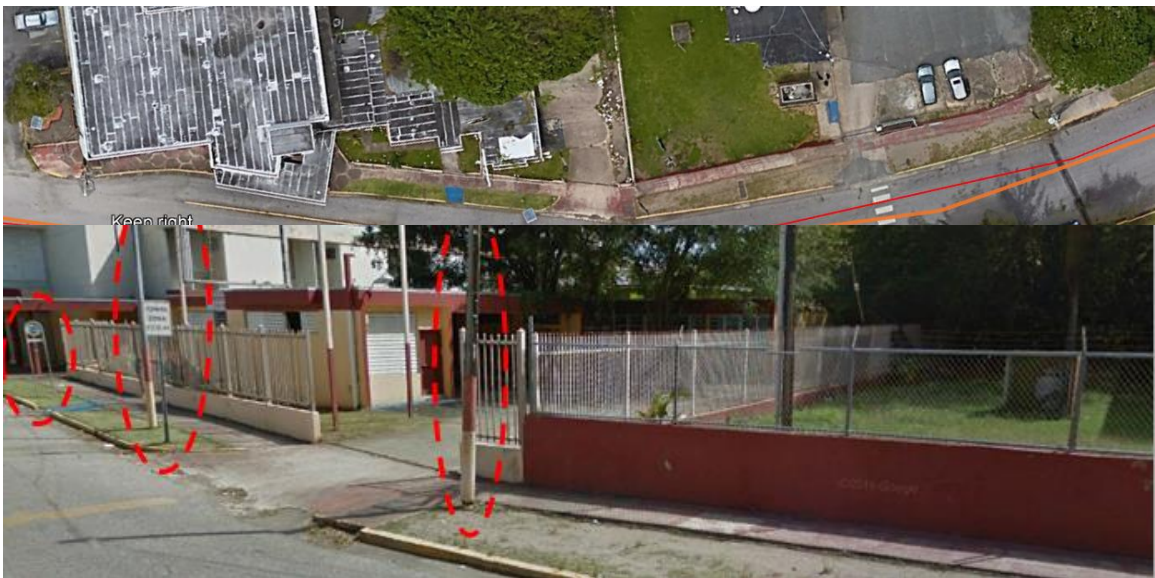
Figure 6-220 Third Section of Sidewalk on Las Nereidas Avenue from the Evacuation Route of Francisco Oller School in Street View (Google Earth – 2016)

The third section of the Las Nereidas Avenue sidewalk is shown in Figure 6-220. Like the curb segment above, this section has posts and signs that do not get in the way of the effective width of the curb (Figure 6-221) but could do so if population builds up during the evacuation process.

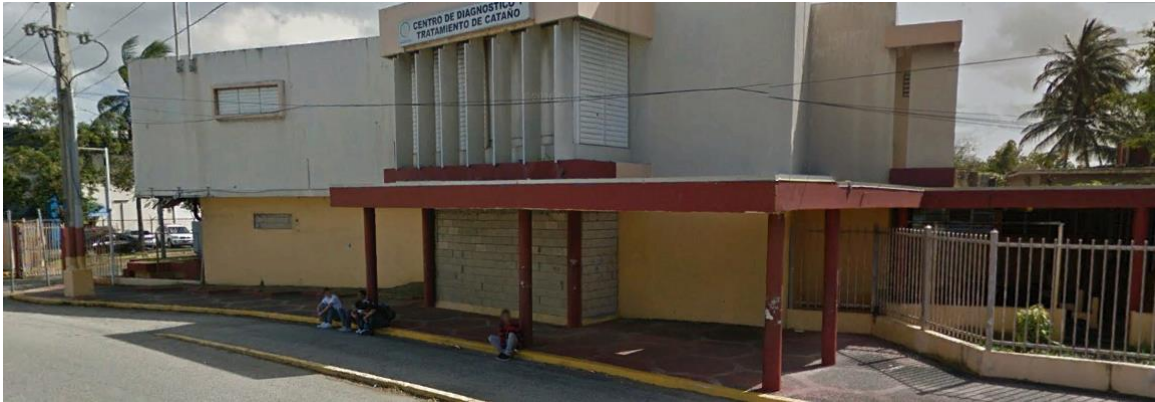
Figure 6-221 Portico on Third Section of Sidewalk on Las Nereidas Avenue from the Evacuation Route of Francisco Oller School in Street View (Google Earth - 2016)

This curb segment has a constant effective width of 54 inches with a green zone width of 64 inches. However, the green area ends because the sidewalk passes through a portico of the building of the “Centro de Diagnóstico y Tratamiento de Cataño” as shown in Figure

6-221. In this way, if this building were to fail during the pre-tsunami seismic event, the evacuation route could be obstructed.

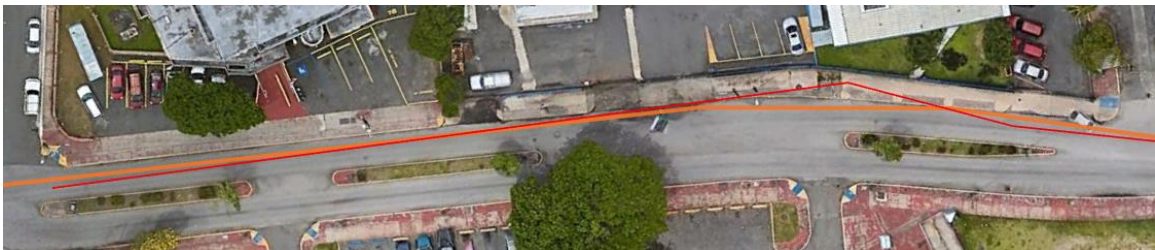
Figure 6-222 Fourth Section of Sidewalk on Las Nereidas Avenue from the Evacuation Route of Francisco Oller School in Plan View (Google Earth – 2016)

The fourth and last segment of this sidewalk (Figure 6-222) has an effective width that varies from 65 inches to 80 inches. This sidewalk does not have green areas like the previous sidewalk segments.

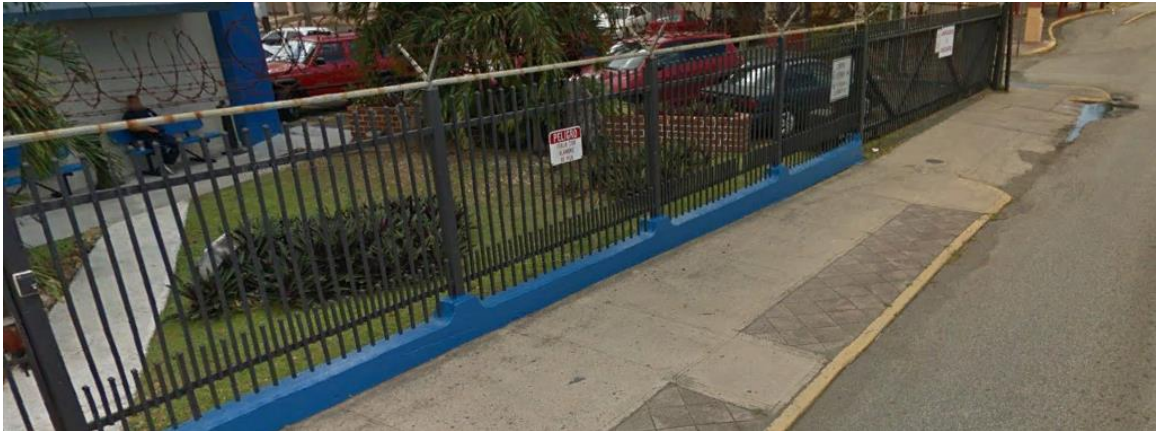
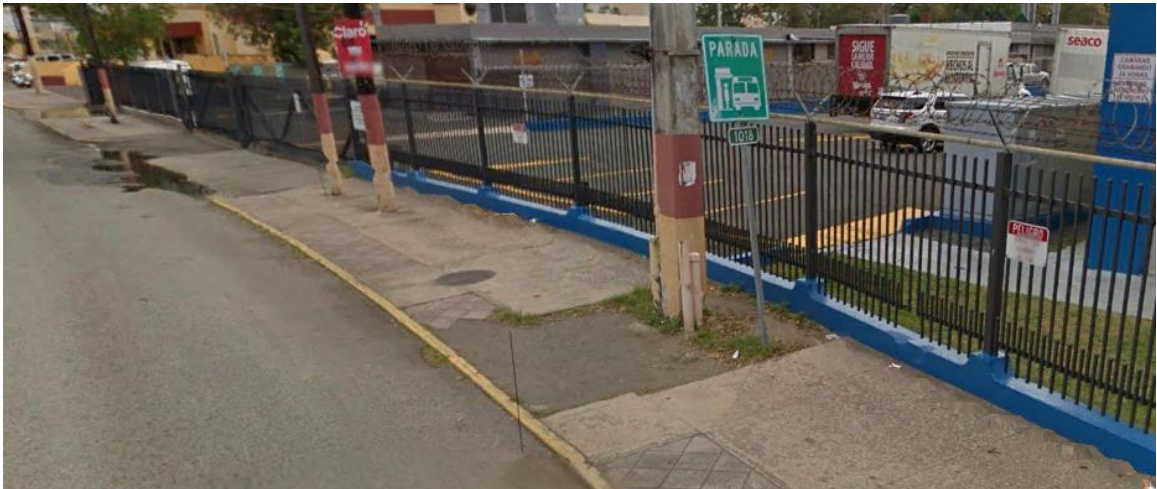
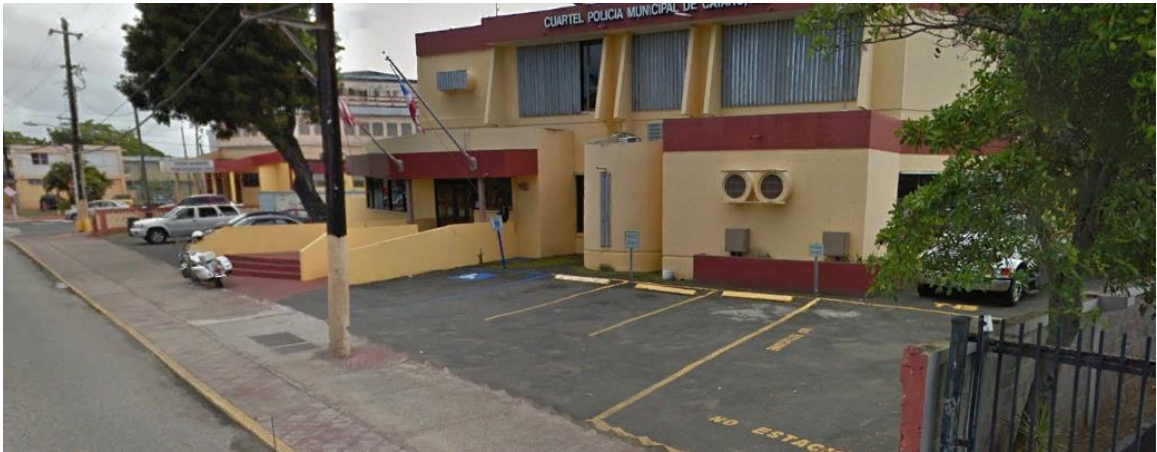
This sidewalk can affect the pedestrian crossing as cars pass through it due to the surrounding establishments as shown in Figure 6-223, Figure 6-224, Figure 6-225 and Figure 6-226. Although this segment of sidewalk does not have any type of damage, it has poles and signs that obstruct the route. These are in the center of the width of the sidewalk along the entire segment (Figure 6-224 and Figure 6-225).

Figure 6-223 Building Exit in Fourth Section of Sidewalk on Las Nereidas Avenue from the Evacuation Route of Francisco Oller School in Street View (Google Earth – 2016)

Figure 6-224 Poles in Fourth Section of Sidewalk on Las Nereidas Avenue from the Evacuation Route of Francisco Oller School in Street View (Google Earth – 2016)

Figure 6-225 Other Building Exit in Fourth Section of Sidewalk on Las Nereidas Avenue from the Evacuation Route of Francisco Oller School in Street View (Google Earth – 2016)

Figure 6-226 Building Exit and Poles in Fourth Section of Sidewalk on Las Nereidas Avenue from the Evacuation Route of Francisco Oller School in Street View (Google Earth – 2016)

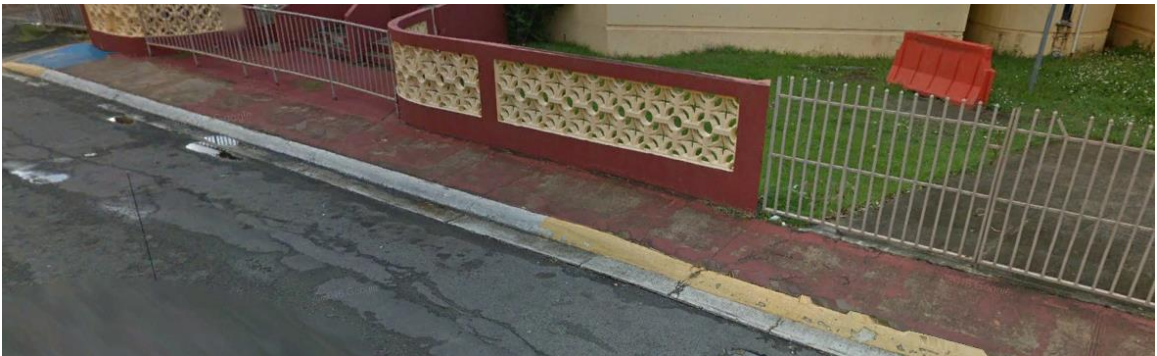
Figure 6-228 Sidewalk on Olivo Street from the Evacuation Route of Francisco Oller School in Street View (Google Earth – 2016)

The sidewalk along Olivo Street is shown in Figure 6-227. This sidewalk that has no vegetation (Figure 6-228), varies from 43 inches to 53 inches.

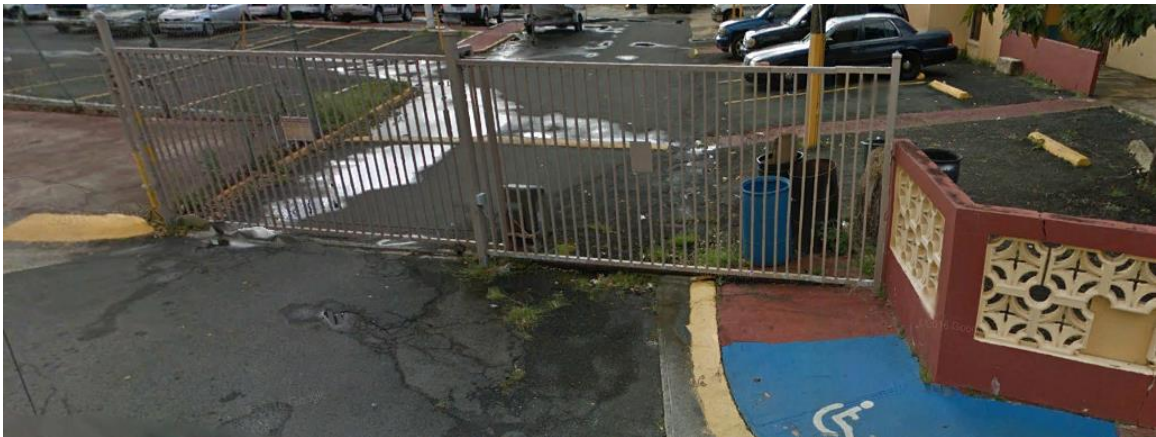
Figure 6-229 Sidewalk Division on Olivo Street from the Evacuation Route of Francisco Oller School in Street View (Google Earth – 2016)

This sidewalk splits (Figure 6-229), exposing it to traffic flow. This represents a danger to the school population during the evacuation process as vehicles can obstruct the pedestrian flow.

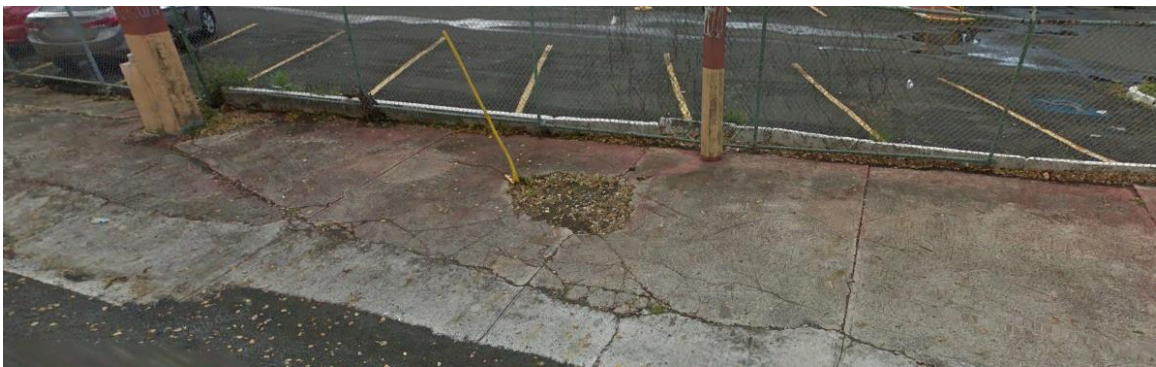
Figure 6-230 Sidewalk Damage on Olivo Street from the Evacuation Route of Francisco Oller School in Street View (Google Earth – 2016)

On the continuation of this sidewalk there is deterioration, damage and cracks as shown in Figure 6-230. This unfavorable condition represents an obstacle for the school population since their condition may worsen due to the seismic event, which could prevent the passage through this evacuation route.

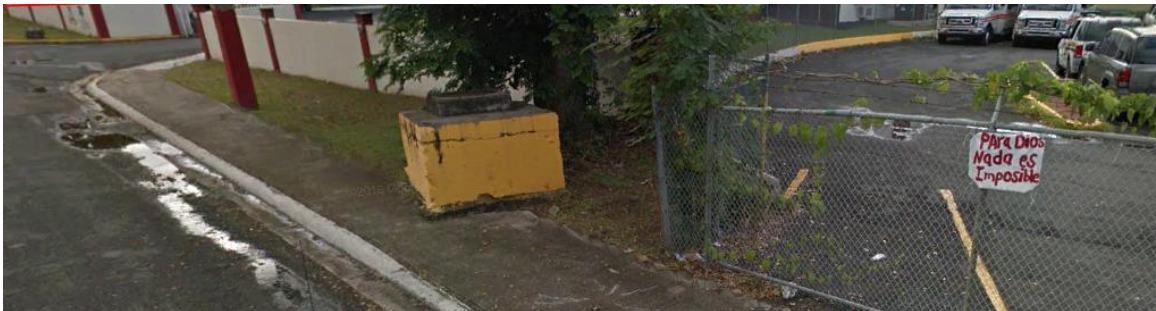
Figure 6-231 Manhole in Sidewalk on Olivo Street from the Evacuation Route of Francisco Oller School in Street View (Google Earth – 2016)

Figure 6-231 shows posts and a manhole that interrupts the effective width of the sidewalk. Due to this obstacle the width of the sidewalk is reduced to 28 inches. This means that the sidewalk does not meet 36 inches according to the ADA (Americans with Disabilities Act) requirement for people with disabilities. In this way, the school population could be forced to cross the street and continue the evacuation route on the other sidewalk that is close to the street. This other sidewalk is in optimal condition (Figure 6-232 and Figure 6-233).

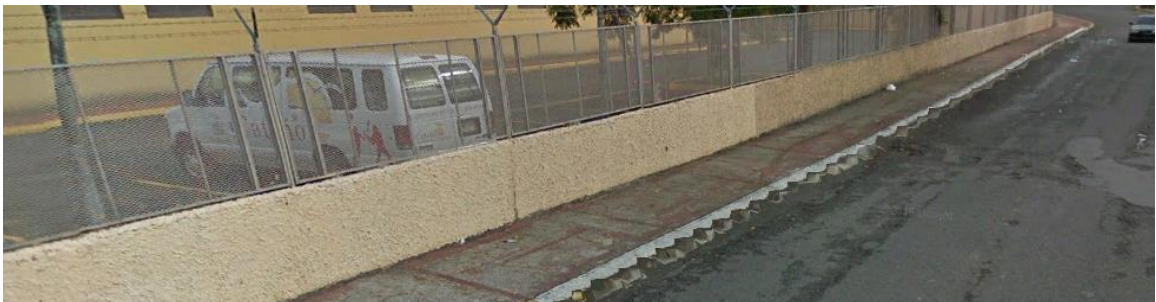
Figure 6-233 Other Sidewalk on Olivo Street from the Evacuation Route of Francisco Oller School in Street View (Google Earth – 2016)

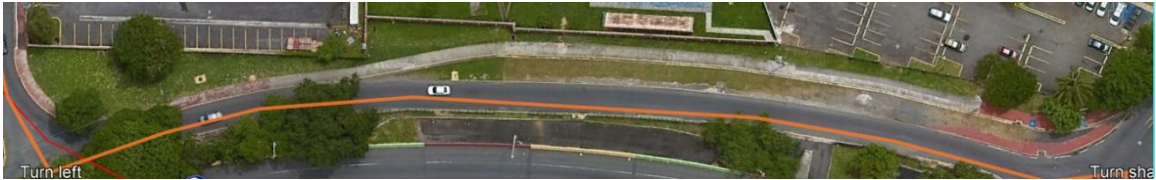
The most convenient sidewalk for the evacuation process that is located along El Caño Avenue is the one to the North as shown in Figure 6-234. It has a constant width of 100 inches, almost triple what is required for people with disabilities. This sidewalk has trees and posts (Figure 6-235 and Figure 6-236), but they do not affect its effective width

Figure 6-234 Sidewalk on El Caño Avenue from the Evacuation Route of Francisco Oller School in Plan View (Google Earth – 2016)

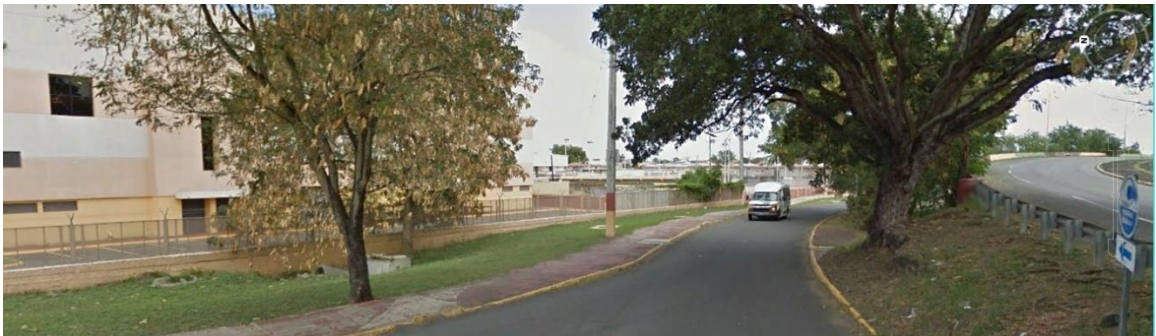
Figure 6-235 Sidewalk on El Caño Avenue from the Evacuation Route of Francisco Oller School in Street View (Google Earth – 2016)

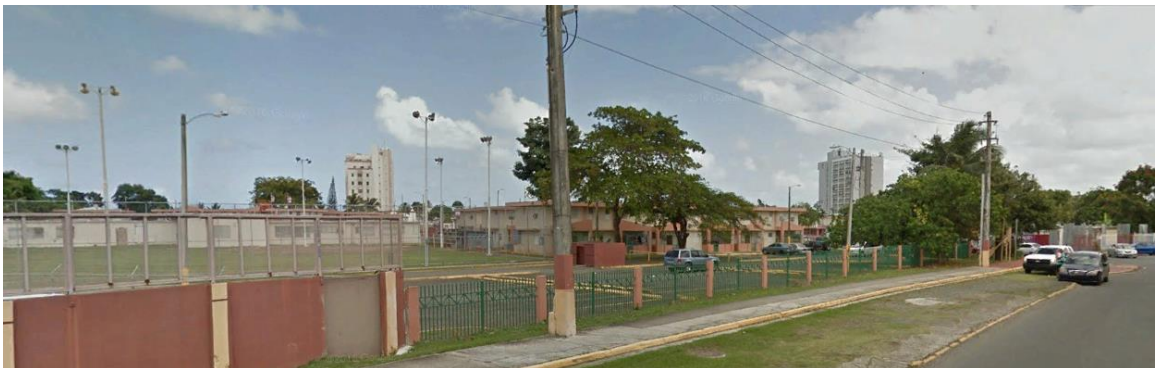
Figure 6-236 Poles in Sidewalk on El Caño Avenue from the Evacuation Route of Francisco Oller School in Street View (Google Earth – 2016)

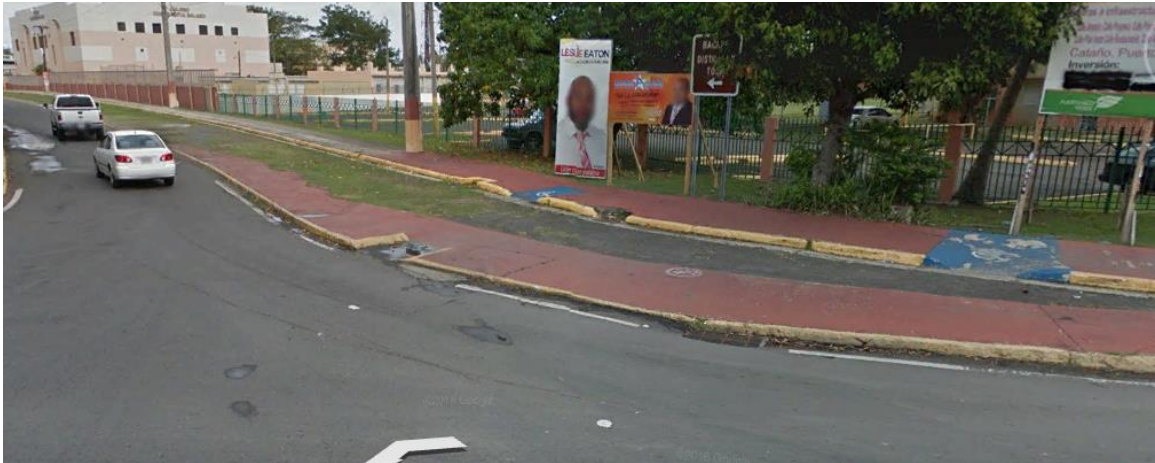
On this route along El Caño Avenue, the sidewalk divides into two according to Figure 6-237. One of the parts that make up the sidewalk has green areas that invade the ideal space to pass through this route. Despite having easy access ramps for people with

disabilities, the double sidewalk could represent a risk for this population during the evacuation process due to the drastic and unexpected change in level.

Figure 6-237 Double Sidewalk on El Caño Avenue from the Evacuation Route of Francisco Oller School in Street View (Google Earth – 2016)

The sidewalk that is to the south of this avenue (Figure 6-237) requires making a crossing on the road, which is not ideal for pedestrian flow due to the danger it represents. In addition, it is incomplete since it does not have a sidewalk in the entire route of the avenue, only in a segment of it as shown in Figure 6-238. For this reason, the most suitable route for this avenue is the North as mentioned above.

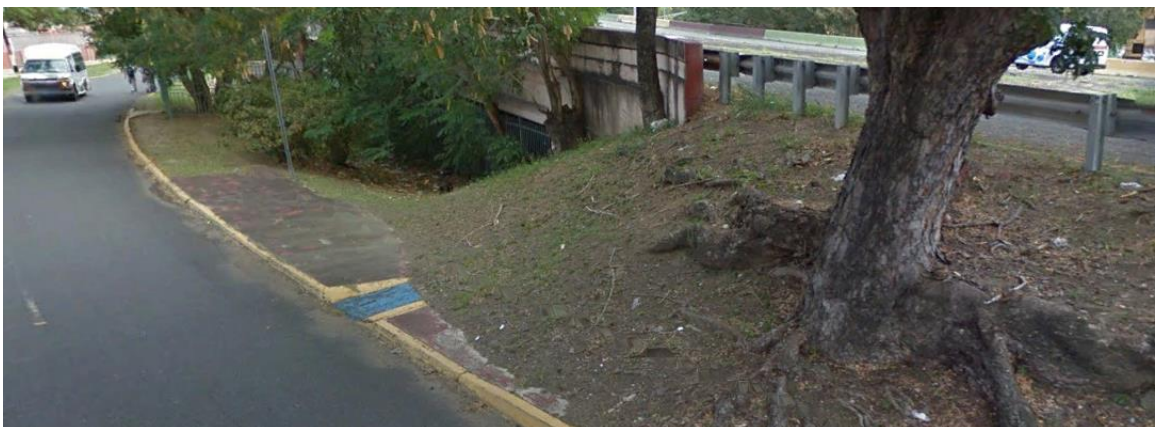
Figure 6-238 Incomplete Sidewalk on El Caño Avenue from the Evacuation Route of Francisco Oller School in Plan View (Google Earth – 2016)

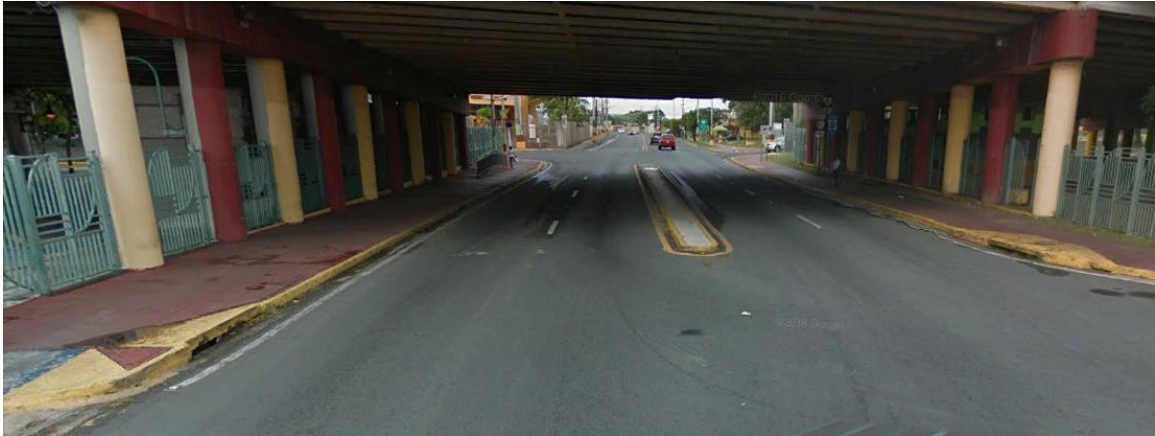
The evacuation route along José Celso Barbosa Avenue has two possible sidewalks to reach the safe area as shown in Street View in Figure 6-239. Both are in good condition with an effective width of 114 inches. But the sidewalk on the left splits at a certain point when a ramp begins (Figure 6-240). This ramp is adapted for people with disabilities, including the necessary railings for it. The curb width of the ramp is 60 inches while the width of the flat curb is 54 inches. The effective width for both sidewalks is not affected despite having posts and signs on the road (Figure 6-240). However, the sidewalks are under a bridge, posing a real hazard to the pedestrian flow evacuating the school during the evacuation process as mentioned above.

Figure 6-239 Sidewalks on José Celso Barbosa Avenue from the Evacuation Route of Francisco Oller School in Street View (Google Earth – 2016)

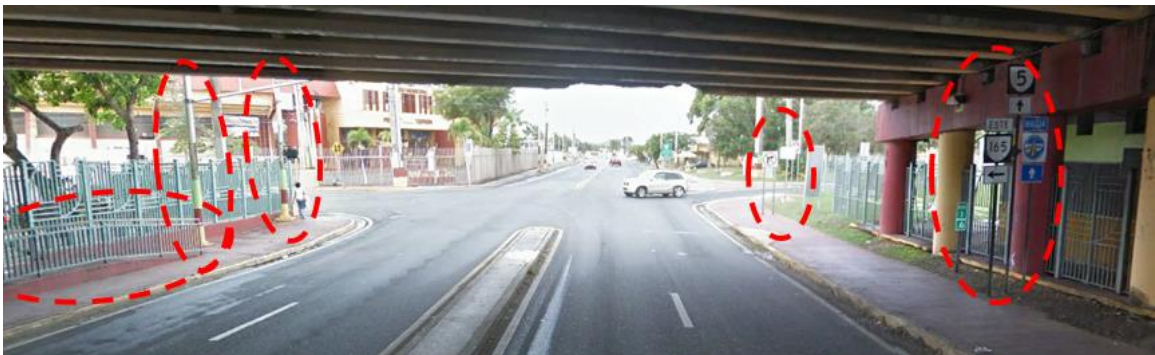
Figure 6-240 Urban Furniture in Sidewalks on José Celso Barbosa Avenue from the Evacuation Route of Francisco Oller School in Street View (Google Earth – 2016)

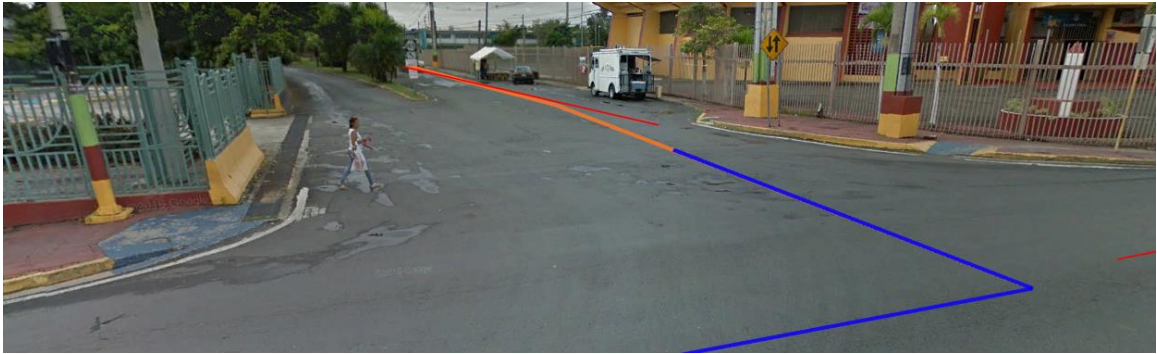
Right where the tsunami hazard zone ends (shown in the blue line in Figure 6-242) is the sidewalk heading to the assembly site.

Figure 6-242 Sidewalk on Street Next to the Assembly Place from the Evacuation Route of Francisco Oller School in Street View (Google Earth – 2016)

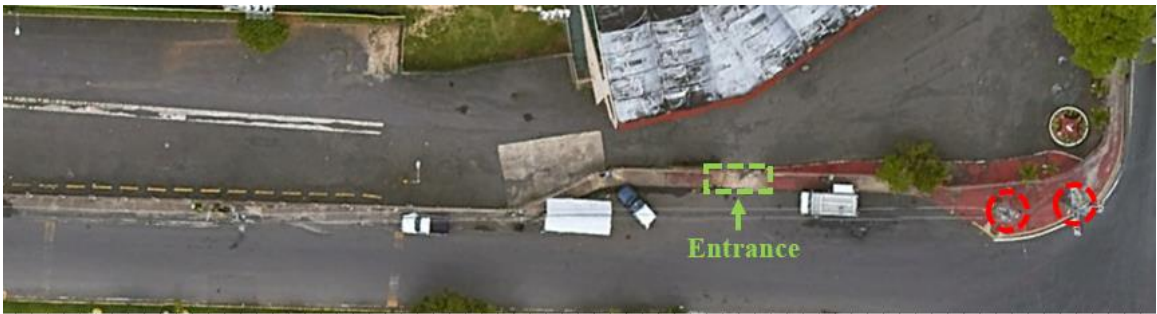
The sidewalk to get to the assembly site is incomplete and is only at the end of it as shown in Figure 6-243 and Figure 6-244. This sidewalk is obstructed by posts and signs that affect its effective width, varying from 160 inches to 32 inches in width.

Figure 6-243 Sidewalk on Street Next to the Assembly Place from the Evacuation Route of Francisco Oller School in Plan View (Google Earth – 2016)

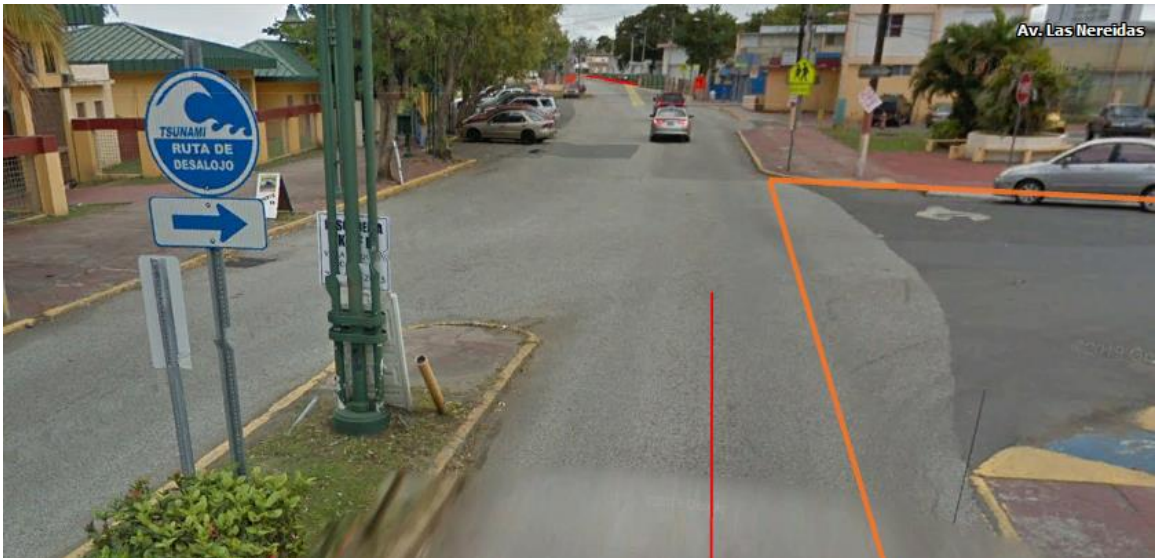
The rest of the evacuation route signs can be found at: (c) by Las Nereidas Avenue (PR-888) towards Olivo Street (Figure 6-248), (d) by Olivo Street (Hernández Street) towards the marginal of El Caño Avenue (Figure 6-249), (e) El Caño Avenue (PR-165) (Figure 6-250), and (f) by José Celso Barbosa Avenue (PR-5) (Figure 6-251). This evacuation route sign (f) is located along the same avenue as the entering and leaving hazard zone signs in Figure 6-186.

Figure 6-248 Evacuation Route Sign through Las Nereidas Avenue Near to Francisco Oller School (Google Earth – 2016)

Although there are a variety of evacuation route signs close to the Francisco Oller school perimeter, only two of them are located along the shortest evacuation route shown in orange for this school. These two signs are the (c) (Figure 6-248) and (d) (Figure 6-249) as shown in Figure 6-245.

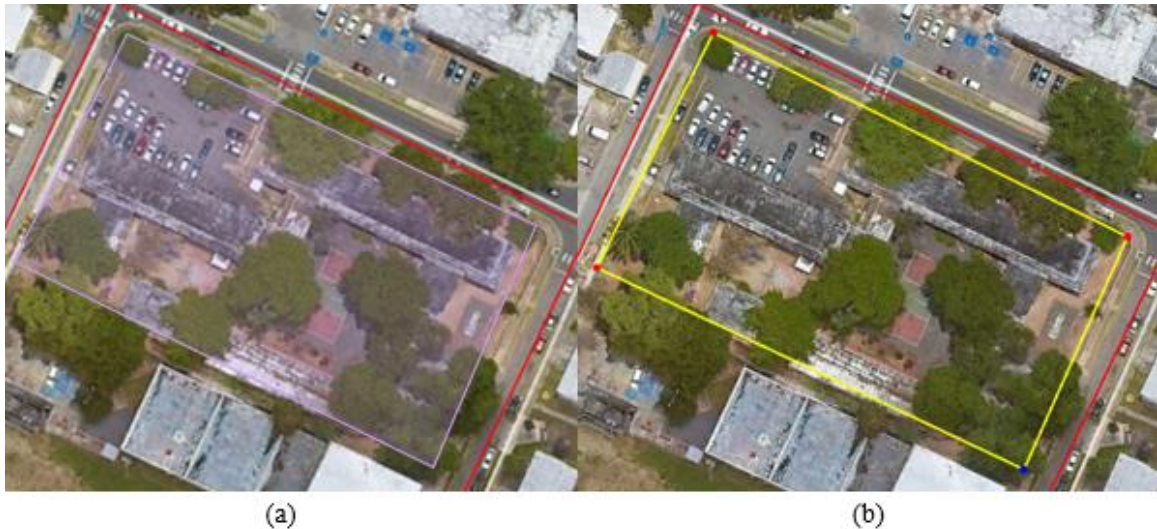
Luis Llorens Tores school occupies an approximate space of 5900 square meters of land according to measurements estimated in Google Earth. The delimited area of this terrain is shown in Figure 6-254 through a polygon with (a) shaded fill and (b) marked edge.

Figure 6-254 Estimated Total Floor Area for Luis Llorens Torres School (Google Earth – 2016)

This school has a parking lot, court, and separate structures that can serve as administrative offices, classrooms, and cafeteria. This assumption is based solely on the observation of a flat map in Google Earth (Figure 6-254).
