VULNERABILITY OF SCHOOLS IN PUERTO RICO TO TSUNAMI EVENTS

RESEARCH FINAL REPORT

POLYTECHNIC UNIVERSITY OF PUERTO RICO

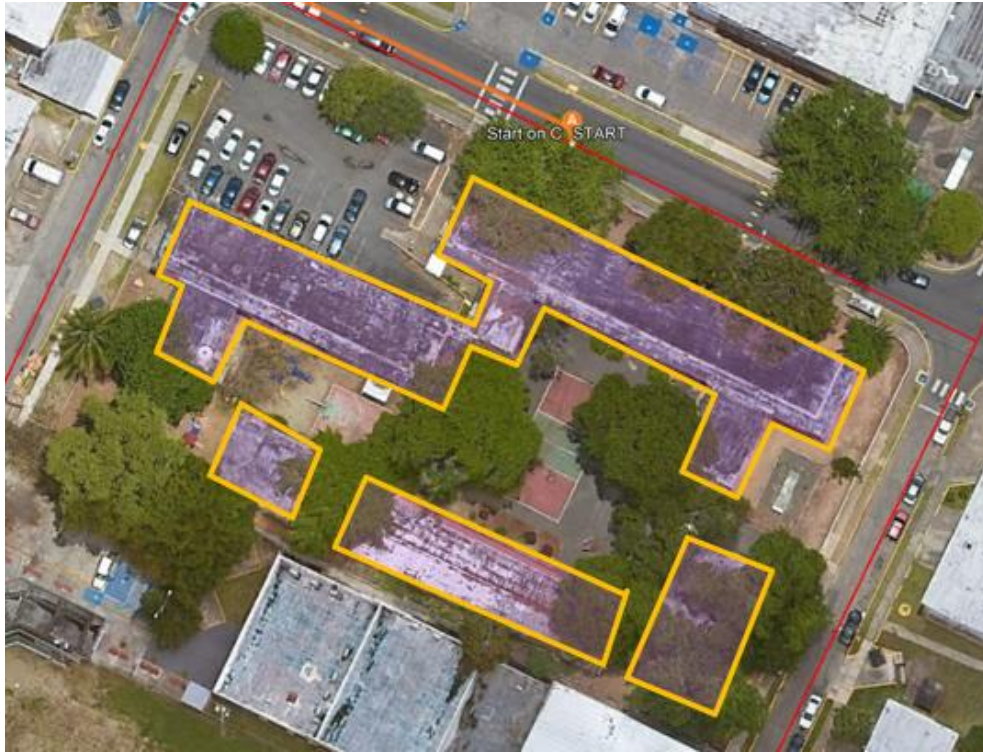
Luis Llorens Torres school is also made up of more than one independent structural framing system divided by joints. In this way it has an irregularity in plan that is shown in Figure 6-255. It has a complex geometric shape and two independent structures with a rectangular geometric shape. Therefore, irregular geometric shapes can be dangerous for the building and its population when the seismic event occurs.

Figure 6-255 Structure Geometry in Plan of Luis Llorens Torres School

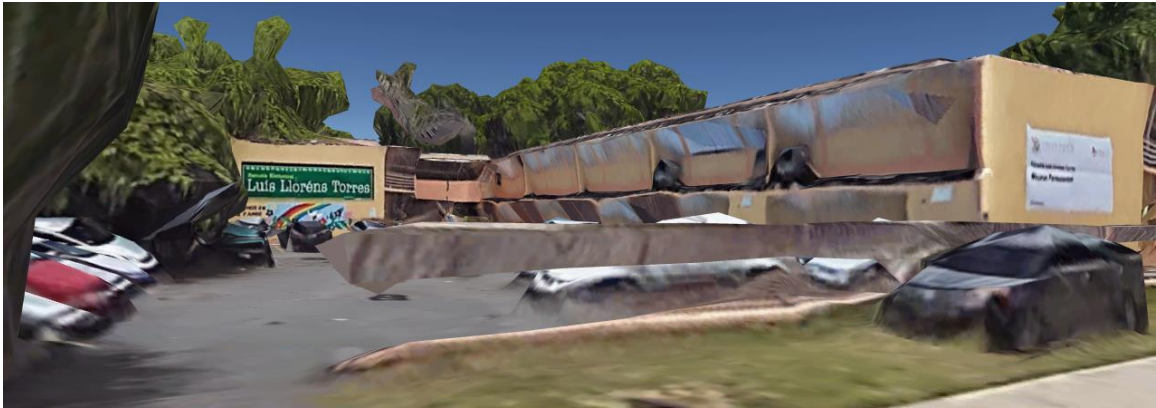
Considering this aspect, Luis Llorens Torres school does not have elevation irregularity since it has a simple elevation as shown in Figure 6-256. Furthermore, according to this Figure, this school also has two levels. Unlike the irregular geometric shape of the school structure, its simple elevation does not pose a threat to the school population.

Figure 6-256 Luis Llorens Torres School in 3D Building (Google Earth – 2016)

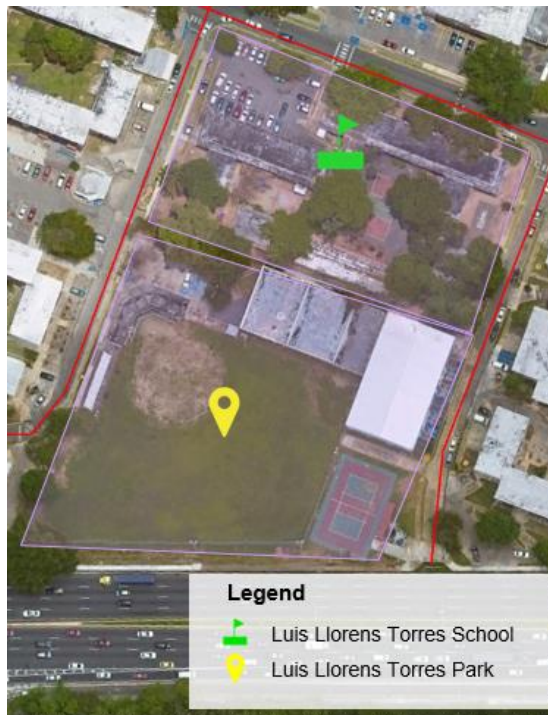
Luis Llorens Torres school is located on the corner in the urban block. Its position is not a danger to the structure of the school, however, as it is in a residential area, it could be surrounded by critical neighboring buildings. This school is located next to “Parque Luis Llorens Torres” in the urban block as shown in Figure 6-257.

Figure 6-257 Position of Luis Llorens Torres School in Urban Block

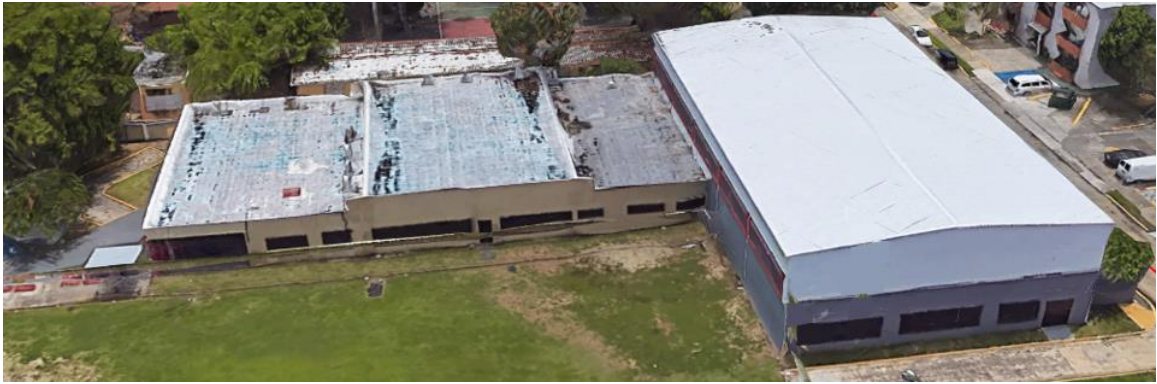
“Cancha Res Llorens Torres” at Luis Llorens Torres Park has one floor (Figure 6-259). On the other hand, it has an irregularity in plan and elevation due to its “L” type geometric shape and its change in elevation. While Complejo Deportivo Monserrate (Kike) Ríos also

Figure 6-259 Cancha Res Llorens Torres as Adjacent Building to Luis Llorens Torres School (Google Earth – 2016)

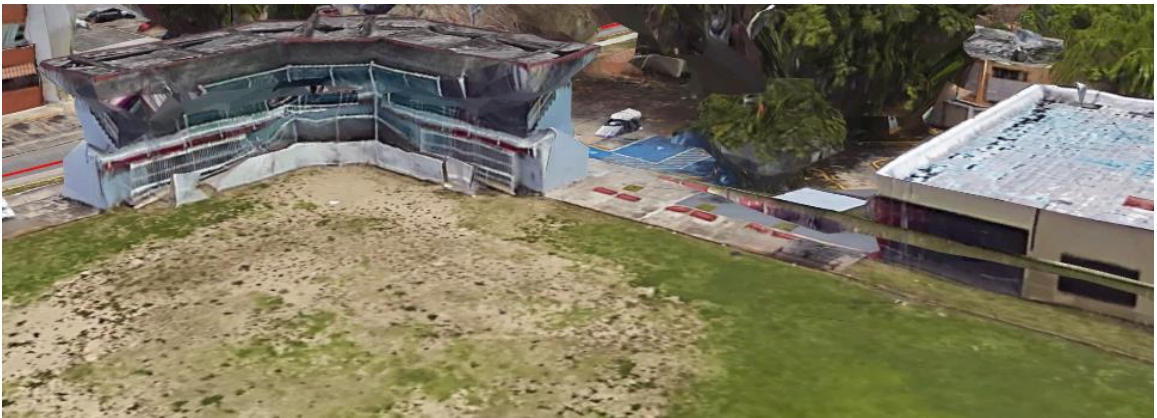
from Luis Llorens Torres Park has two floors as presented in Figure 6-260. Although it does not have irregularity in elevation, it does have it in plan due to its complex geometric shape. In this way, the structures found in this neighboring park to the study school are considered critical for the vulnerability of Luis Llorens Torres school.

Figure 6-260 Cancha (Llorens) Monserrate Kike Ríos as Adjacent Building to Luis Llorens Torres School (Google Earth – 2016)

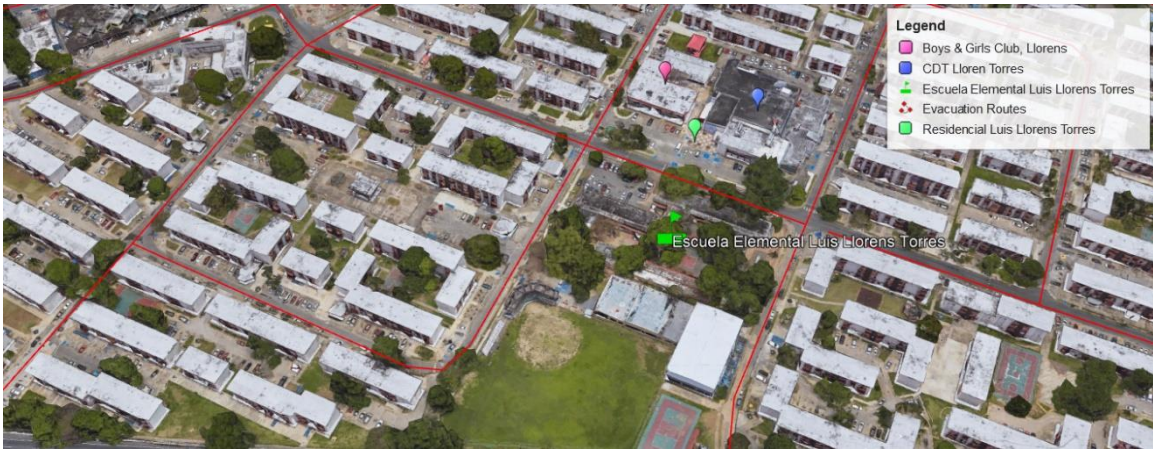
Luis Llorens Torres school is located around other buildings that are not in its urban block but that can also significantly influence its vulnerability. These are located at a distance greater than 0.01 miles from the physical location of the Luis Llorens Torres school structure. As shown in Figure 6-261, the existing structures near this school are the Boys & Girls Club building, the CDT Llorens Torres, and the residences of the “Residencial Luis Llorens Torres”.

Figure 6-261 Other Adjacent Buildings to Luis Llorens Torres School (Google Earth – 2016)

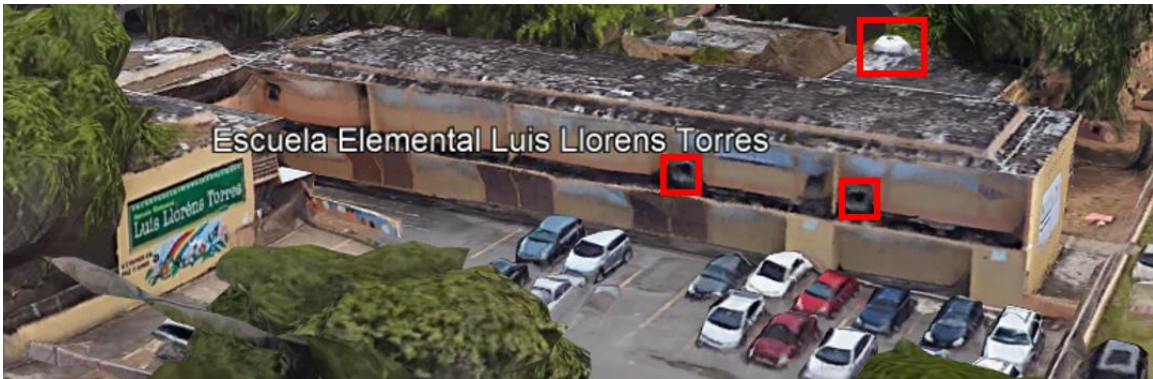
This school has nonstructural falling hazards as shown in Figure 6-262. Although the images do not have good resolution, the tall and heavy roof equipment and components can be seen in different parts of the school building. In this way, these falling hazards increase the vulnerability of the school because they threaten the life of the school population during the seismic event.

Figure 6-262 Nonstructural Falling Hazards at Luis Llorens Torres School (Google Earth – 2016)

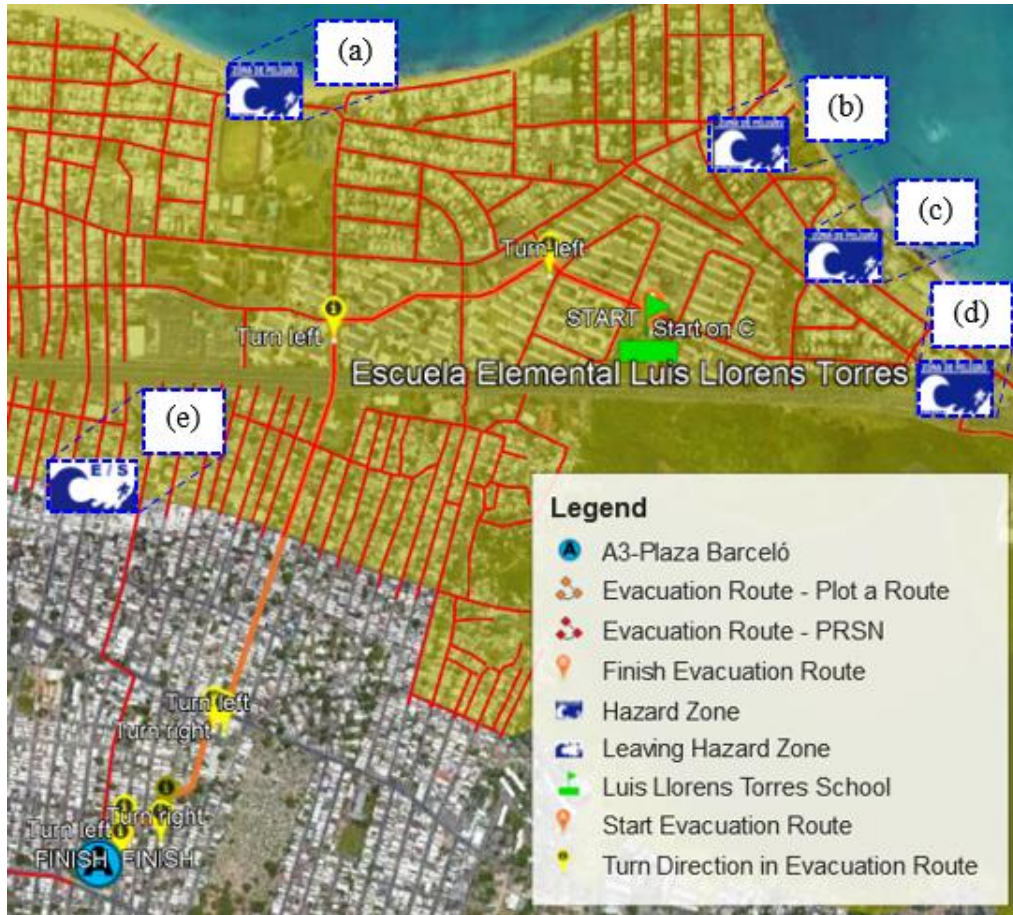
Figure 6-264 Hazard Zone Signs Near the Perimeter of Luis Llorens Torres School (Goole Earth – 2016)

Tsunami evacuation zones, also tsunami danger zones are represented in yellow and are marked near the perimeter of Luis Llorens Torres school and its evacuation route. The location of the signs is arbitrarily around the entire coastline between 0.20 miles and 0.80 miles from the location of the school. Of these, four represent the tsunami danger zones and one indicates the exit from said zone, as shown in Figure 6-264.

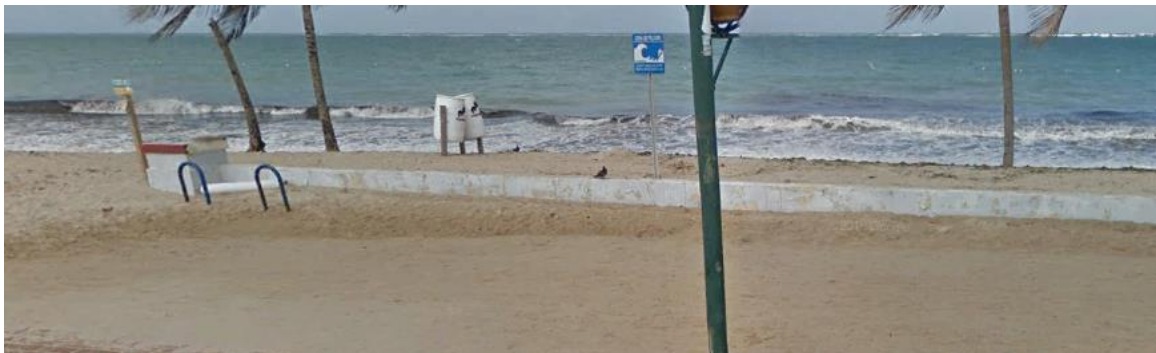
Figure 6-265 Hazard Zone Sign through General Patton Street Near the Perimeter of Luis Llorens Torres School (Google Earth – 2016)

As a continuation of Figure 6-264, Figure 6-265 shows the hazard zone sign (a) located on General Patton Street.

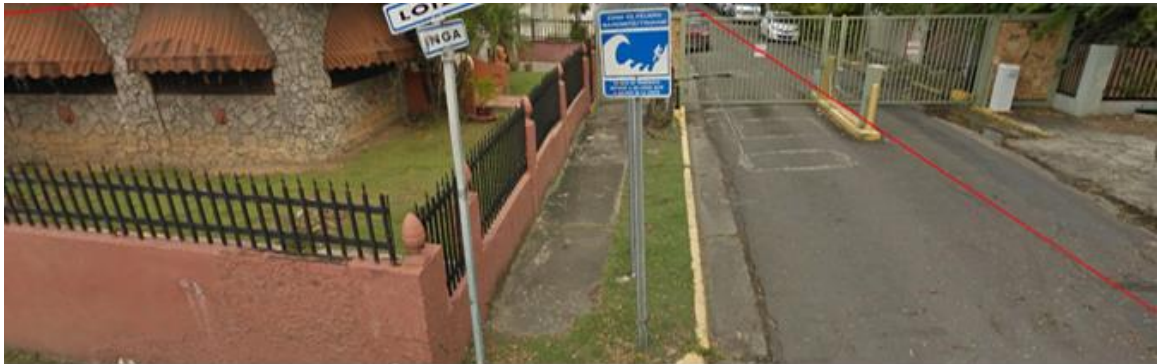
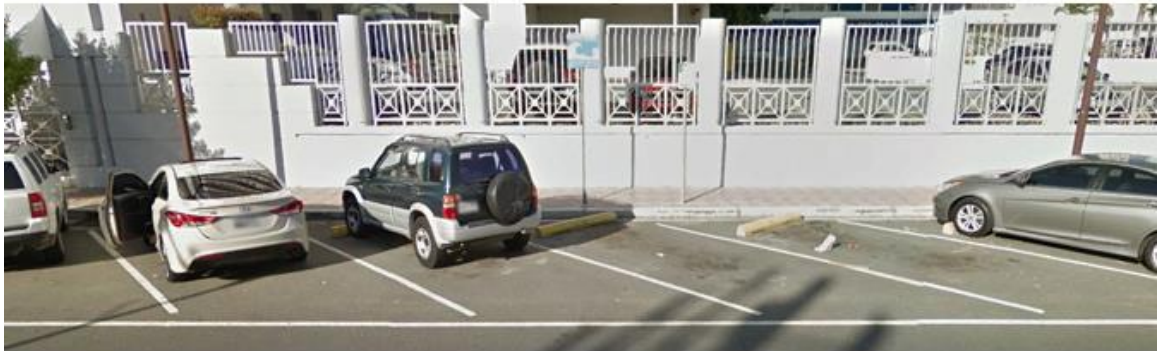
Figure 6-266 Hazard Zone Signs through Loíza Street Near the Perimeter of Luis Llorens Torres School (Google Earth – 2016)

In Loíza Street there are two signs through the PR-37. These are sign (b) in Figure 6-266 and sign (c) in Figure 6-266.

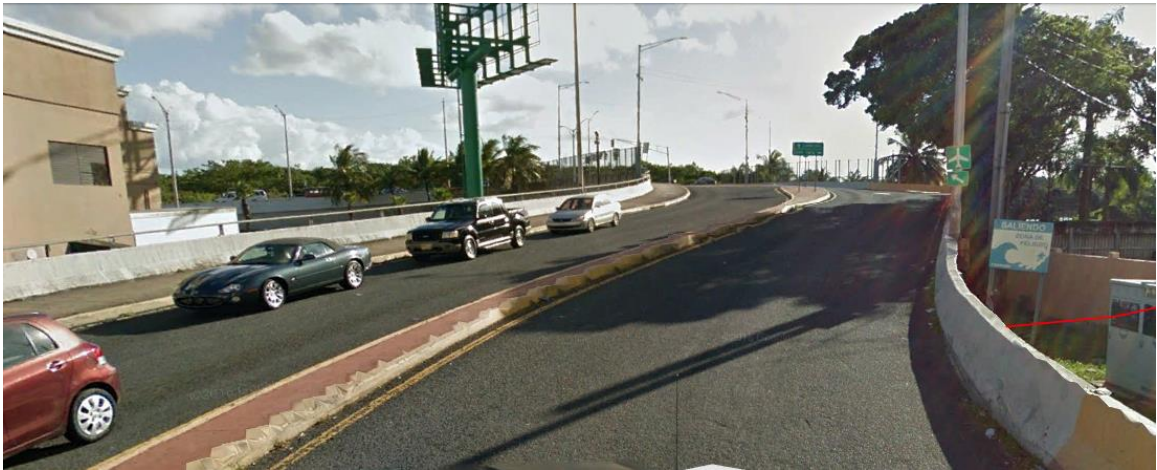
Figure 6-267 Hazard Zone Sign through Isla Verde Avenue Near the Perimeter of Luis Llorens Torres School (Google Earth – 2016)

Figure 6-267 shows the hazard zone sign (d) located on Isla Verde Avenue (PR-37) in the direction of PR-26. On the other hand, near this school the exit of the tsunami hazard zone is also signaled. This is located on Degetau Street as shown in Figure 6-268. This sign is upside down according to Google Earth images in 2016. This represents a danger for the population that evacuates during the eviction process if they do not know the signs of the area correctly. Said signage must be properly installed, so that the entire population can go to the safe area quickly. However, today this sign may be in optimal condition and correctly indicating the area. Contrary to the area near the Cataño school above, the area around Luis Llorens Torres school does not have signs indicating the entrance to the hazard zone.

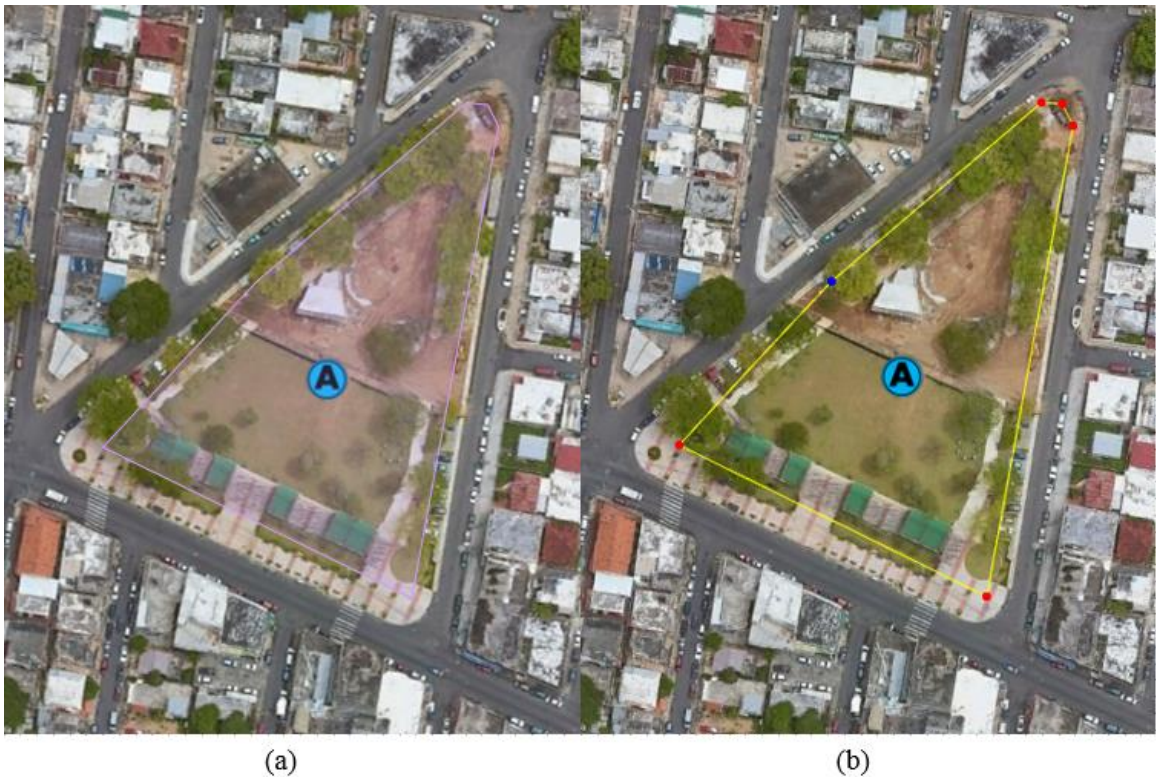
Figure 6-269 Estimated Total Floor Area for “Plaza Barceló” (Google Earth - 2016)

For Luis Llorens Torres school, the place of assembly also corresponds to the safe areas. This school leaves its physical facilities to "Plaza Antonio R. Barceló", also "Plaza Barceló", as the same assembly place evaluated for evacuation routes. Its facilities have a land area of around 7400 square meters according to measurements made in Google Earth. Figure 6-269 represents by means of a polygonal figure the area of said terrain in (a) shaded fill and (b) marked edge.

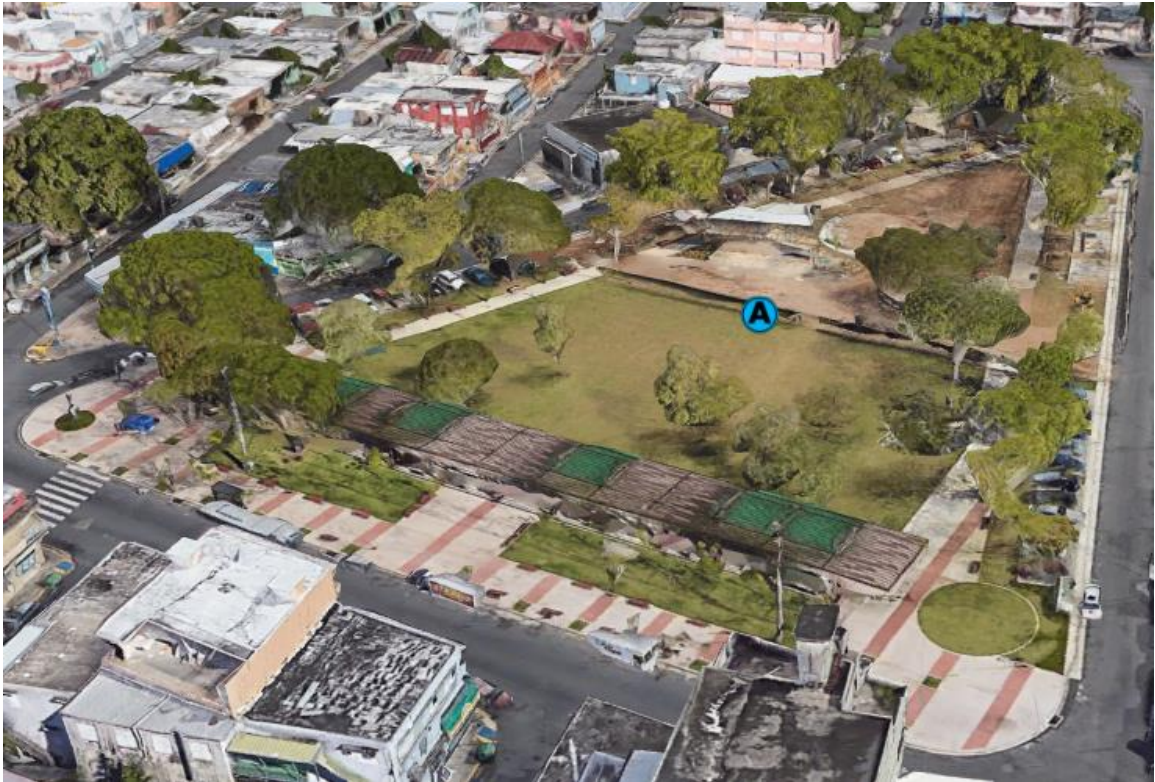
Figure 6-270 “Plaza Barceló” (Google Earth - 2016)

The facilities of this assembly place are shown in Figure 6-270 and Figure 6-271. By 2016 "Plaza Barceló" was undergoing renovation. This represents a threat to the school population that comes to this safe area as a meeting place despite the fact that it is in a zone out of tsunami danger. But considering this is the only nearby assembly place in the area, the entire surrounding population could resort to the same assembly point and accumulate. And if the amount of square feet of land is not enough to house that many people, then it becomes a truly pervasive hazard. And if in the worst case, this assembly place continues with construction and remodeling processes, the land capacity would be limited and would further threaten the population. These are assumptions based on the location of this plaza, its function and importance, as well as the lack of information on the population's capacity for that location.

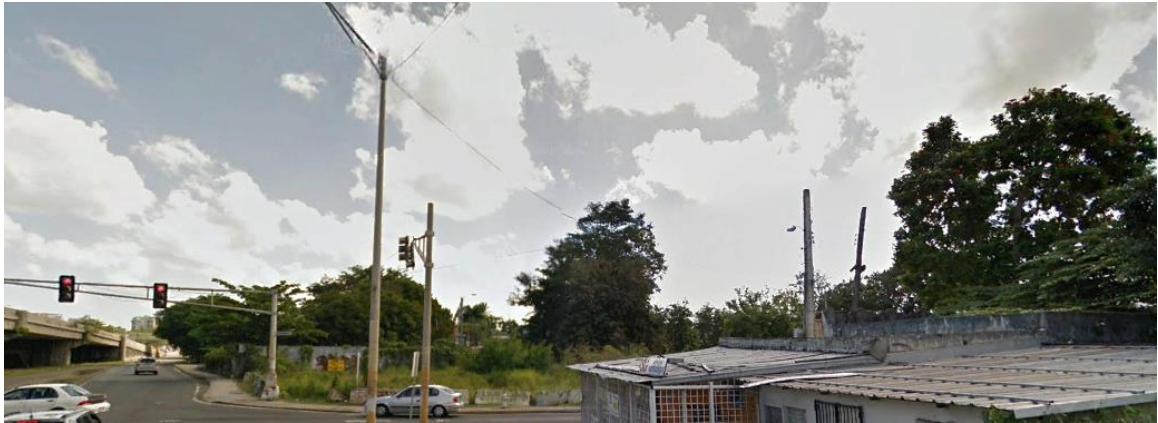
Figure 6-276 Power Lines on the Evacuation Route of Luis Llorens Torres School through Pellín Rodríguez Street [Beginning of the Street] (Google Earth – 2016)

Figure 6-276 shows the power lines (a) as a continuation of the previous Figure 6-275 that pass through Pellín Rodríguez Street. Also, it shows the traffic lights at the beginning of this street. If these are not fixed in the correct way, they represent a danger during the

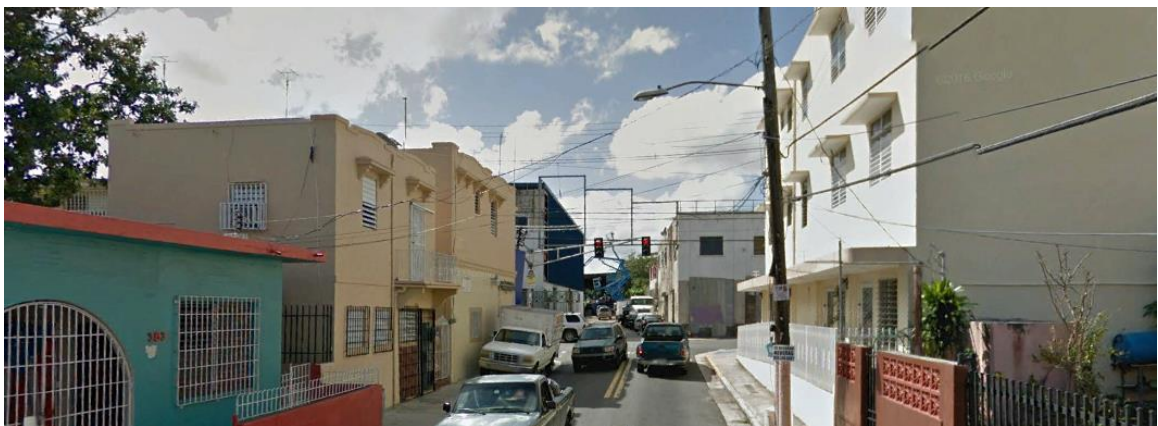
Figure 6-277 Power Lines on the Evacuation Route of Luis Llorens Torres School through Pellín Rodríguez Street [End of the Street] (Google Earth – 2016)

emergency event. While Figure 6-277 shows the power lines (b) that pass at the end of this same street.

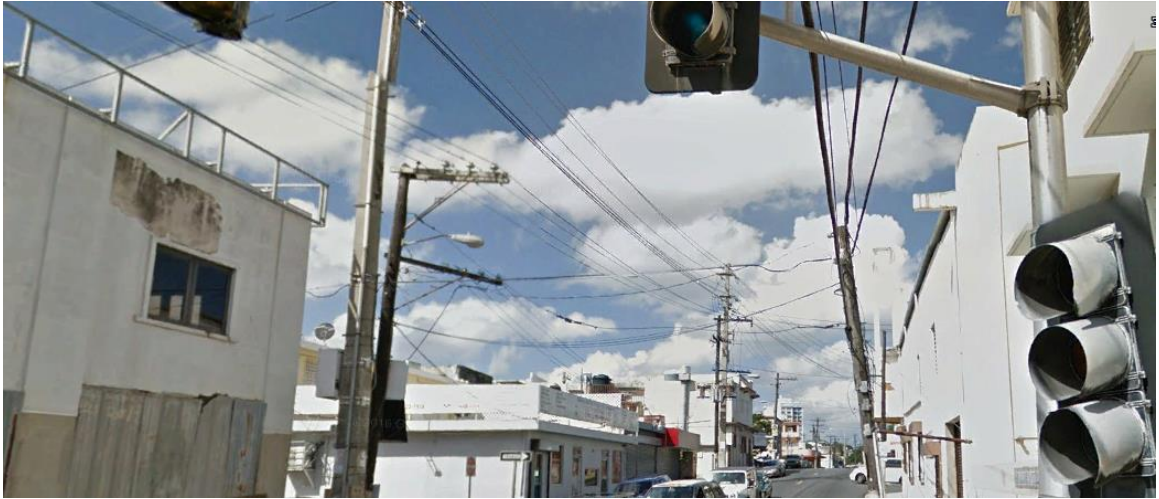
Figure 6-279 Power Lines on the Evacuation Route of Luis Llorens Torres School through Eduardo Conde Avenue (Google Earth – 2016)

The power lines (c) that pass-through Eduardo Conde Avenue are shown in Figure 6-279. On the other hand, through the same evacuation route are the power lines (d) that pass-through Los Santos Street (Figure 6-278) and the power lines (e) that pass through Lippit Street (Figure 6-280). In addition, the power lines (f) that go through the beginning of Tite Curet Alonso Avenue and the power lines (g) that go through the same avenue are shown in Figure 6-281 and Figure 6-282.

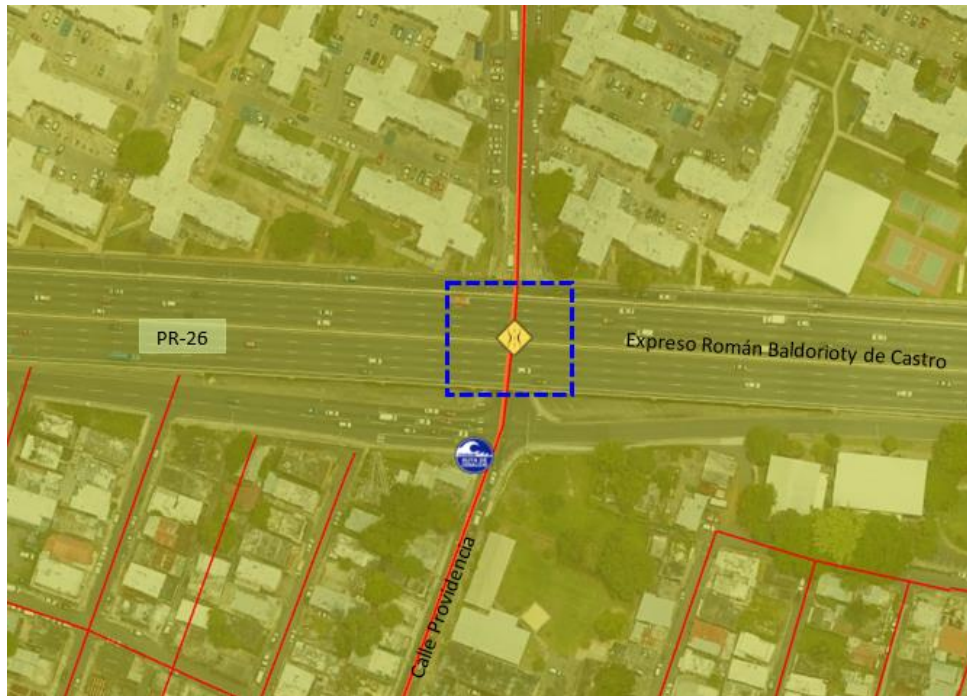
Figure 6-283 Location of the Bridge on the Evacuation Route of Luis Llorens Torres School (Google Earth – 2016)

Like the Cataño school (Francisco Oller school), Luis Llorens Torres school also goes under a bridge on its fastest evacuation route. This bridge is located on Pellín Rodríguez (Providencia Street). This is precisely the bridge of the "Expreso Román Baldorioty de Castro" through the PR-26 as presented in Figure 6-283. Also, Figure 6-284 shows the bridge in Street View.

In this way, Luis Llorens Torres school has a vulnerable evacuation route due to the bridge through which the school population that evacuates during the eviction process is exposed. This is another reason that the third criterion is not met regarding evacuation routes for this school. Knowing that, if the bridge collapses during the pre-tsunami seismic event, the pedestrian flow would not have a faster route to reach the safe zone.

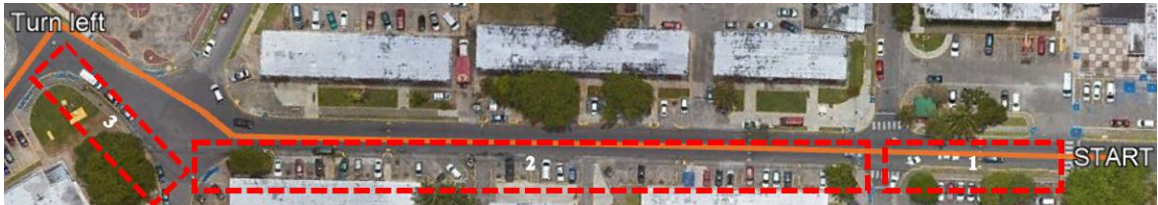
Figure 6-285 Sidewalk on María Isabel Street from the Evacuation Route of Luis Llorens Torres School in Plan View (Google Earth – 2016)

The sidewalk at the beginning of the route that is located by María Isabel Street is divided into different segments to facilitate its visualization, as presented in Figure 6-285.

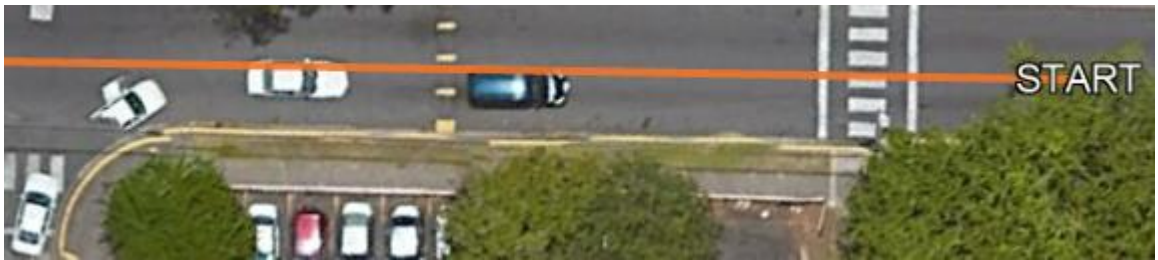
Figure 6-286 First Section of Sidewalk on María Isabel Street from the Evacuation Route of Luis Llorens Torres School in Plan View (Google Earth – 2016)

The first segment of this sidewalk has a constant effective width of 50 inches (Figure 6-286). This width is not affected by any urban furniture or green areas with a width of 36 inches. In this way, this section of sidewalk is adapted and is ideal for people with disabilities in the event of an emergency event.

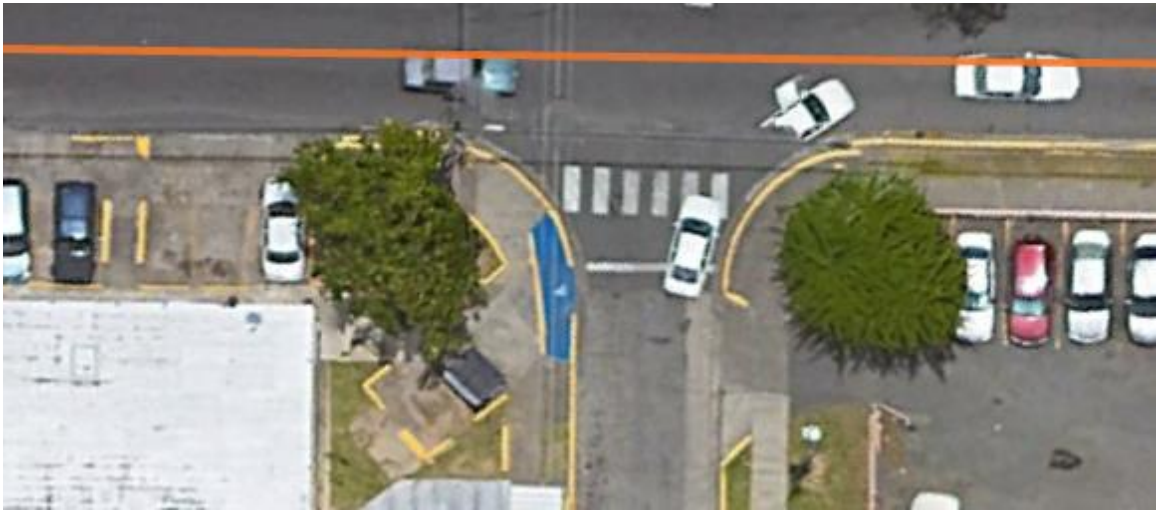
Figure 6-287 Crossing between First and Second Section of Sidewalk on María Isabel Street from the Evacuation Route of Luis Llorens Torres School in Plan View (Google Earth – 2016)

Between the end of the first segment and the beginning of the second sidewalk segment, the evacuation route crosses Cundeamor Street (Figure 6-287). This represents a threat to the population that flows through this area due to the danger that the vehicular flow represents for the passage of pedestrians. This, even though both sidewalks have accessible ramps adapted for people with disabilities as can be seen in the Google Earth images.

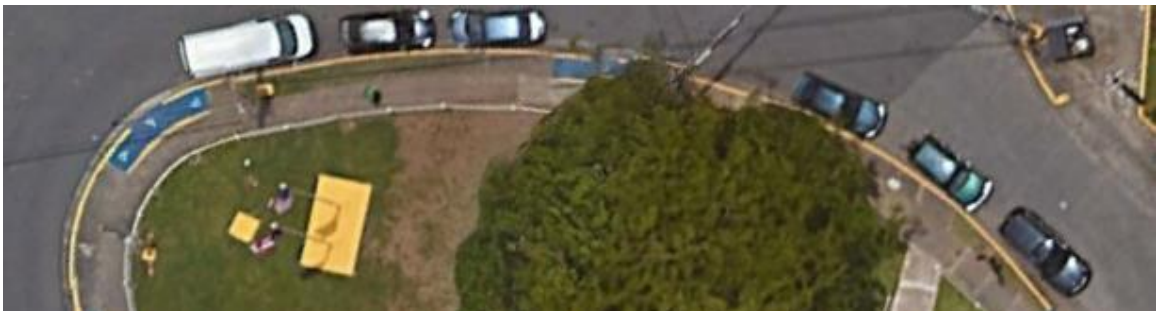
Figure 6-290 Thrid Section of Sidewalk on María Isabel Street from the Evacuation Route of Luis Llorens Torres School in Plan View (Google Earth – 2016)

The third section of sidewalk on María Isabel Street is curved (Figure 6-290). Despite its shape, it has a curb width that varies from 36 to 80 inches. In addition, it has green areas that do not interrupt the width of the sidewalk.

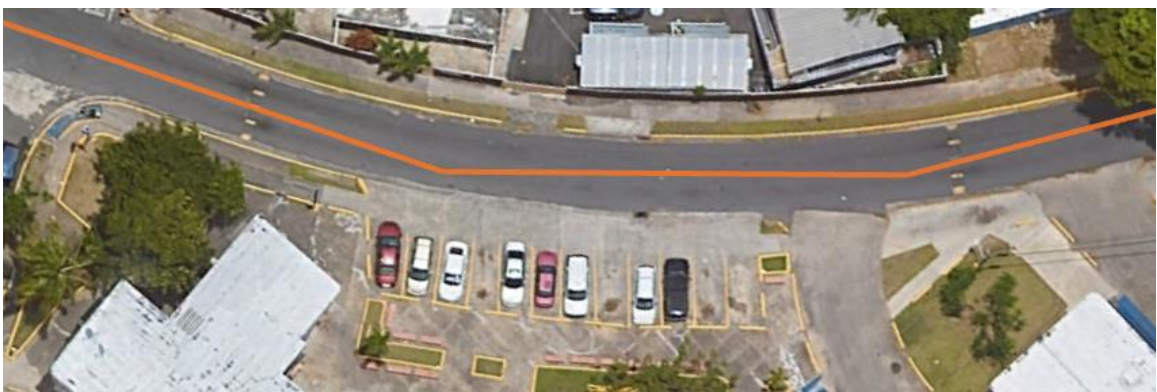
Figure 6-293 Second Section of Sidewalk on Marina Street from the Evacuation Route of Luis Llorens Torres School in Plan View (Google Earth – 2016)

The second section of this sidewalk is 36 inches to 45 inches wide (Figure 6-293). However, this segment of sidewalk also has vehicular flow that poses a hazard to pedestrian flow during the tsunami evacuation process.

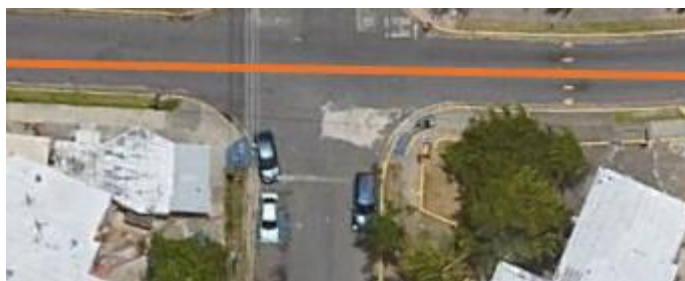
Figure 6-294 Crossing between Second and Third Section of Sidewalk on Marina Street from the Evacuation Route of Luis Llorens Torres School in Plan View (Google Earth – 2016)

Between the second and third segment of the sidewalk, the evacuation route crosses Barcarola Street. Figure 6-294 presents this junction indicating a threat to the route.

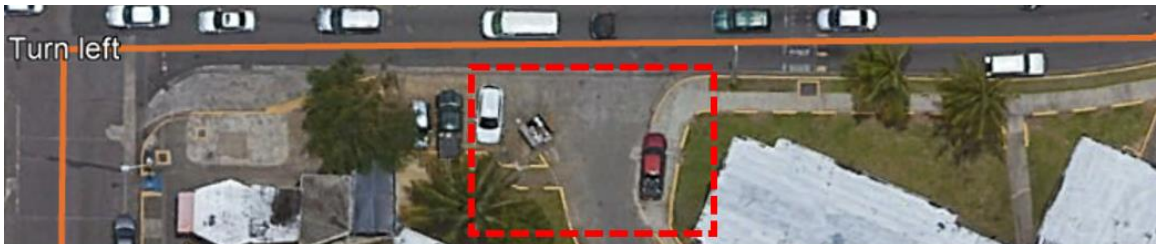
Figure 6-297 Fifth Section of Sidewalk on Marina Street from the Evacuation Route of Luis Llorens Torres School in Plan View (Google Earth – 2016)

The fifth section of this sidewalk also has a small intersection interrupted by vehicles entering and leaving the “Residencial Luis Llorens Torres” (Figure 6-297). The beginning of this segment of sidewalk (considering the continuation of the route in the direction from right to left) is 50 inches wide. This is interrupted by the intersection with the vehicular flow. Subsequently, the end of this sidewalk is obstructed by parked vehicles that affect its ideal effective width.

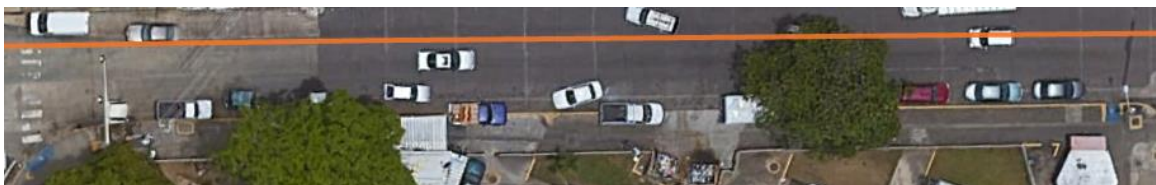
Figure 6-299 First Section of Sidewalk on Pellín Rodríguez Street from the Evacuation Route of Luis Llorens Torres School in Plan View (Google Earth – 2016)

The first section of this sidewalk (Figure 6-299) is 115 inches wide. But this width is affected by cars parked on the same curb, reducing it to 70 inches. Although the reduction in width is sufficient for disabled pedestrian crossing, interaction with cars during the evacuation process is dangerous.

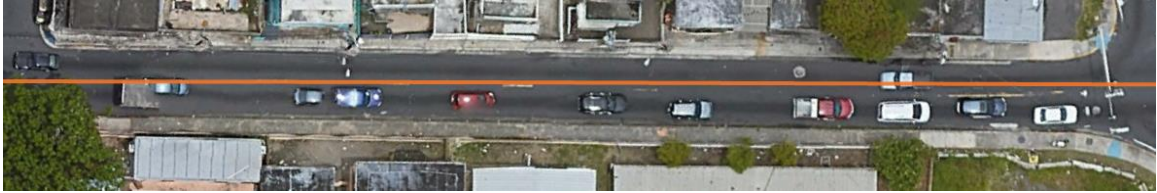
Figure 6-302 Second Section of Sidewalk on Pellín Rodríguez Street from the Evacuation Route of Luis Llorens Torres School in Plan View (Google Earth – 2016)

The route is through a junction that is dangerous due to interaction with vehicles. For the second section there are two sidewalks on the North (Plan View) or right (Street View) and South (Plan View) or left (Street View) as shown in Figure 6-302 and Figure 6-303. Regardless of which of the two sidewalks are suitable for the route, for it is necessary to cross the street in order to access them. The North sidewalk has an effective width of 60 inches and is reduced to less than 12 inches. This width is affected by posts that are in the

center of the sidewalk. While the South sidewalk is also 60 inches wide. But its width is affected to 20 inches due to street furniture that also obstructs the sidewalk.

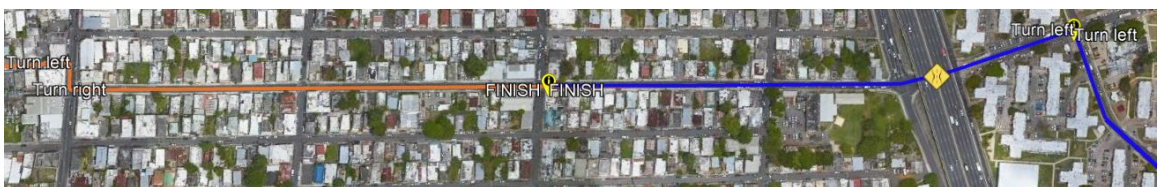
Figure 6-306 Tsunami Hazard Zone Ends on Pellín Rodríguez Street from the Evacuation Route of Luis Llorens Torres School in Plan View (Google Earth – 2016)

Between the third and fourth section of the sidewalk there is a crossroads. But just where the third curb segment ends for this street, the tsunami hazard zone for this evacuation route also ends. As shown in Figure 6-306 and Figure 6-307, just where the route marked in blue ends, the tsunami evacuation zone ends. Consequently, the rest of the sidewalks (from the fourth section of the sidewalk of Pellín Rodríguez Street onwards) and their conditions are in a safe zone on the route identified in orange. In this way, in case any of the sidewalks are not in optimal conditions for pedestrian flow, the school population of Luis Llorens Torres school could consider other accessible and safe ways to reach the assembly place as soon as possible. As mentioned for the Cataño school, it is important that the school population reaches the meeting place or safe meeting point as quickly as possible during the emergency event, even if it is in a safe area.

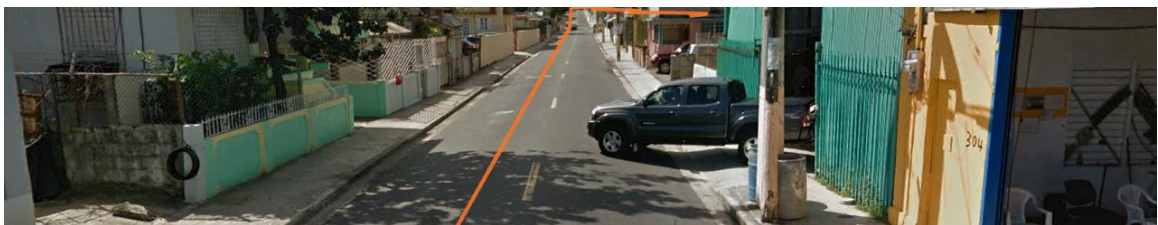
Figure 6-309 Fourth Section of Sidewalk on Pellín Rodríguez Street from the Evacuation Route of Luis Llorens Torres School in Street View (Google Earth – 2016)

The fourth section of this sidewalk is presented in Figure 6-308 and Figure 6-309. This section also has interaction of the vehicular flow that leaves and enters the businesses that are located on this highway. The North sidewalk (right) is 60 inches wide. But this is interrupted by posts that decrease their width to 32 inches. While the south sidewalk (left) has width variations from 40 inches to 60 inches. Both sidewalks are not in poor condition. The South sidewalk (left) is better adapted for the evacuation process. This sidewalk does not have as many obstacles as the opposite sidewalk presents.

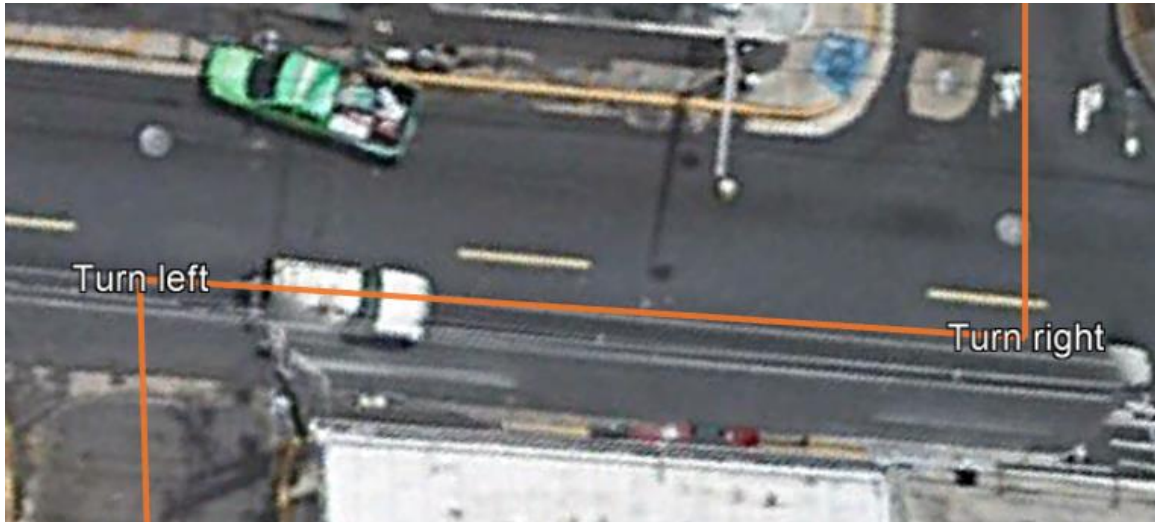
Figure 6-312 Sidewalk on Eduardo Conde Avenue from the Evacuation Route of Luis Llorens Torres School in Plan View (Google Earth – 2016)

Along Eduardo Conde Avenue there are also two sidewalks available (Figure 6-312) but depending on which one is chosen for evacuation, the route would have to cross. Both sidewalks have an effective width of 60 inches but due to obstructions by posts and traffic lights the width is reduced from 20 inches to 30 inches (Figure 6-313). The sidewalks do

not have green areas or grays that hinder their conditions. However, it does not meet the adaptive requirements for the handicapped for sidewalks.

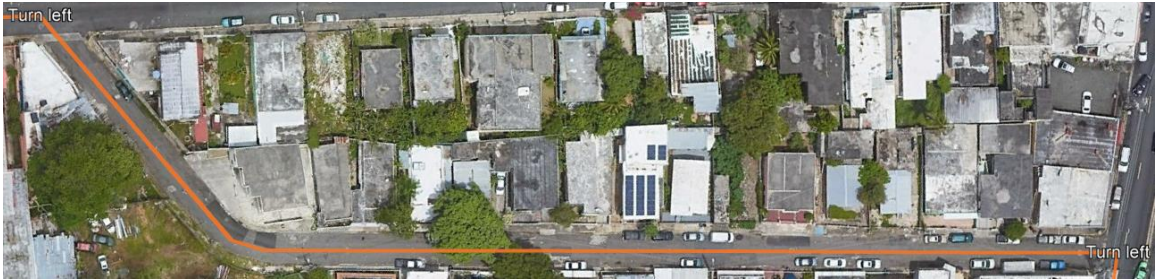
Figure 6-314 Sidewalk on Los Santos Street from the Evacuation Route of Luis Llorens Torres School in Plan View (Google Earth – 2016)

Figure 6-314 presents the accessible sidewalks on Los Santos Street. Like the previous ones, this street has two possible sidewalks to walk on during the evacuation route. Both sidewalks have an available width of 60 inches that is reduced to 20 inches or less because of different obstacles along the route. Sidewalks have posts that meet at their center (Figure 6-314 and Figure 6-316), and cars around them and parked (**Error! Reference source not found.**).

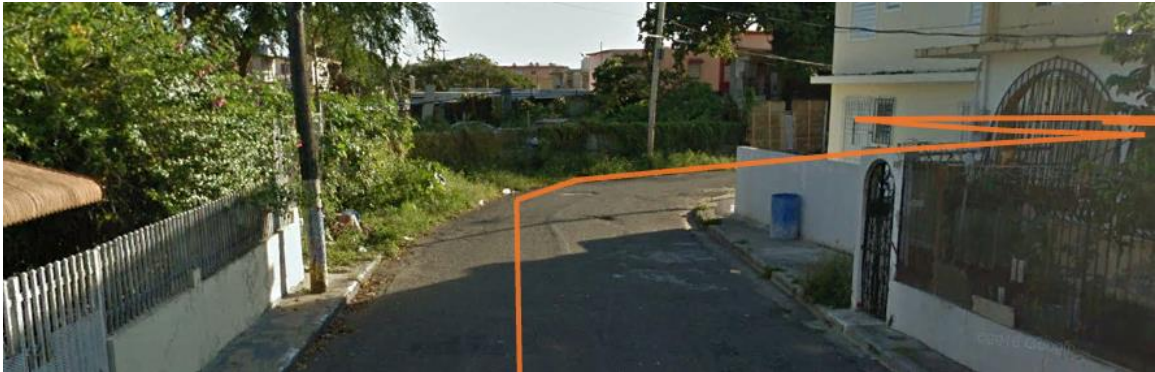
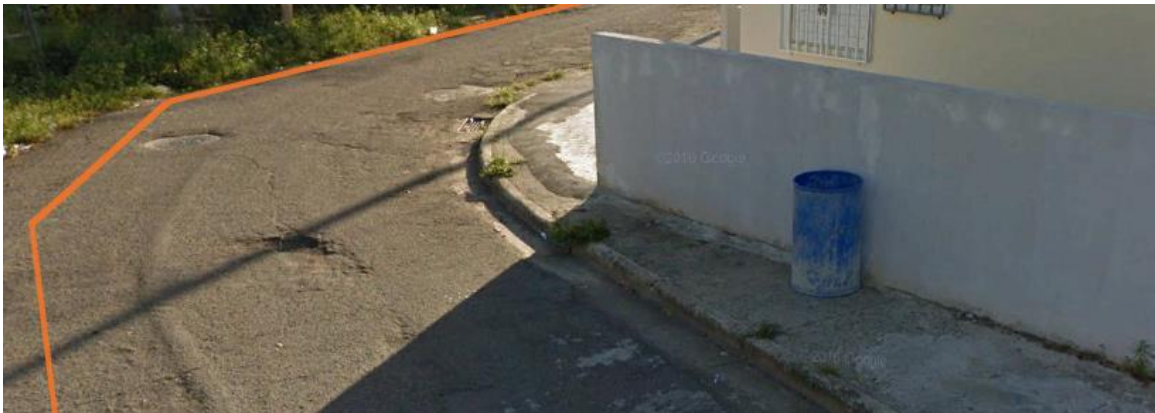
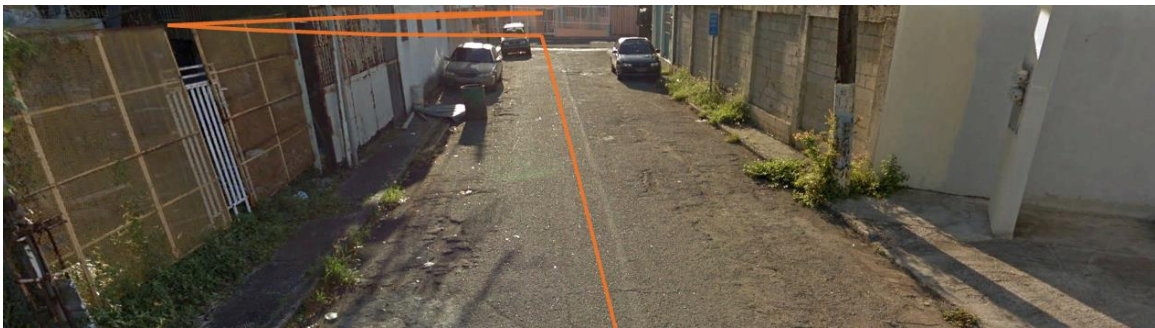
At the curve of this street, the sidewalk on the left (South) ends and the sidewalk on the right (North) is reduced. After the curve, in the continuation of this street the sidewalks are interrupted by posts, vegetation and parked cars (Figure 6-317, Figure 6-318 and Figure 6-319).

Figure 6-317 Other Poles in Sidewalk on Los Santos Street from the Evacuation Route of Luis Llorens Torres School in Street View (Google Earth – 2016)

Figure 6-318 Sidewalk Reduction on Los Santos Street from the Evacuation Route of Luis Llorens Torres School in Street View (Google Earth – 2016)

Figure 6-319 Other Sidewalk Obstruction on Los Santos Street from the Evacuation Route of Luis Llorens Torres School in Street View (Google Earth – 2016)

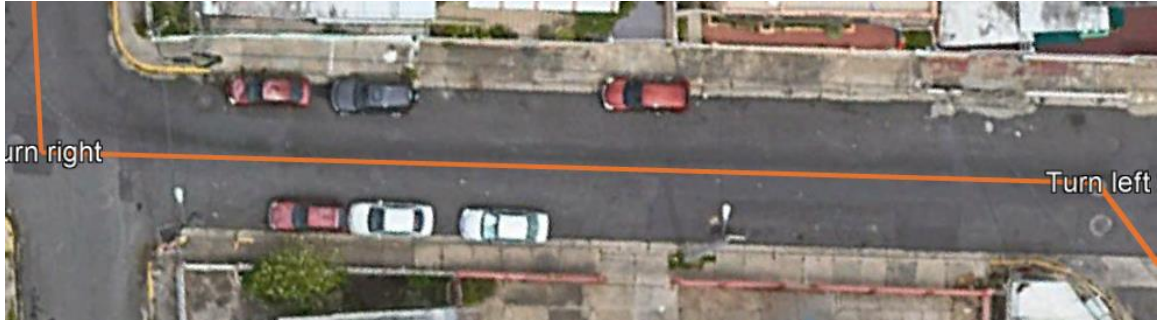
Figure 6-320 Sidewalk on Lippit Street from the Evacuation Route of Luis Llorens Torres School in Plan View (Google Earth – 2016)

Lippit Street also has two sidewalks available (Figure 6-320). Both have an effective width of 64 inches, but they do for positions that get in the way (Figure 6-321). They are reduced to a width of less than 36 inches, which is what is required for people with disabilities.

Their condition is quite acceptable, but regardless due to their reduced width they are not suitable for the eviction process.

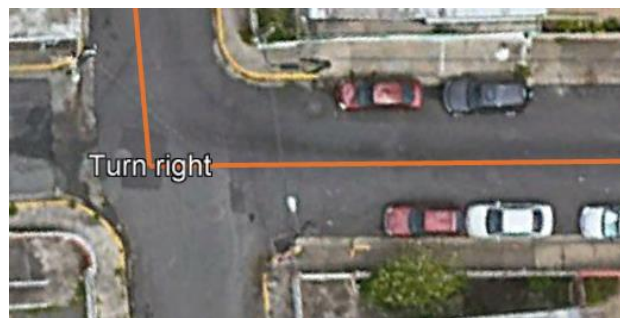
Figure 6-322 Crossing between Lippit Street and Tite Curet Alonso Avenue of Sidewalk from the Evacuation Route of Luis Llorens Torres School in Plan View (Google Earth – 2016)

Between Lippit Street and Catalino “Tite” Curet Alonso Avenue is a junction, as shown in Figure 6-322.

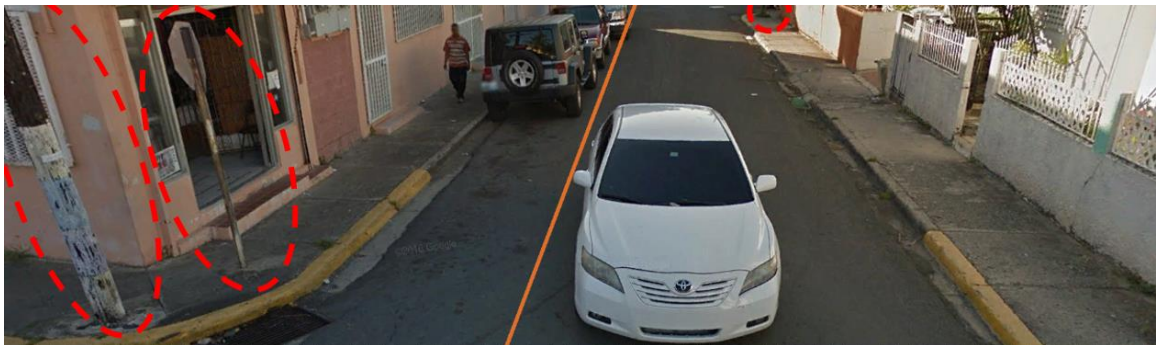
Figure 6-324 First Section of Sidewalk on Catalino “Tite” Curet Alonso Avenue from the Evacuation Route of Luis Llorens Torres School in Street View (Google Earth – 2016)

Catalino “Tite” Curet Alonso Avenue sidewalks are shown in Figure 6-323. This route is interposed by a junction that crosses José Gautier Benítez Street. The sidewalks of both segments of this avenue have a continuous width of 60 inches. However, for the first section of sidewalk on this avenue there is a reduction in the width of the sidewalk to less than 20 inches due to power lines and signs that get in the way (Figure 6-324). For the second segment of the avenue, the sidewalks and their width are interrupted by cars parked along the road (Figure 6-325).

The sidewalks of this avenue are shown in perfect condition, but they do not meet the width necessary for the eviction process.

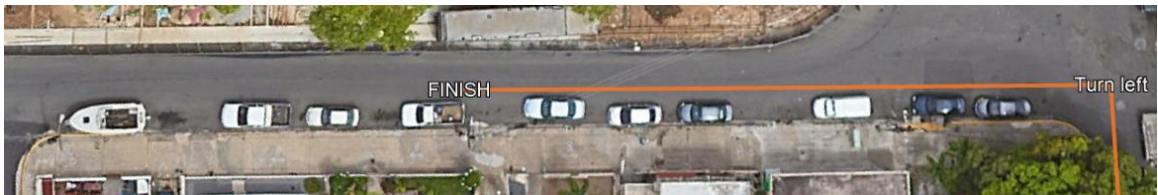
Figure 6-326 Sidewalk on Felipe R. Goyco Street from the Evacuation Route of Luis Llorens Torres School in Plan View (Google Earth – 2016)

The last sidewalk of the route is on Felipe R. Goyco Street, right where the predetermined assembly place is located (“Plaza Antonio R. Barceló”) (Figure 6-326). The sidewalk has a constant width of 150 inches. In addition, this sidewalk is not obstructed by power lines or signs. Its only obstacle lies in a power plant that reduces its width to 68 inches on the road (Figure 6-327).
