VULNERABILITY OF SCHOOLS IN PUERTO RICO TO TSUNAMI EVENTS

RESEARCH FINAL REPORT

POLYTECHNIC UNIVERSITY OF PUERTO RICO

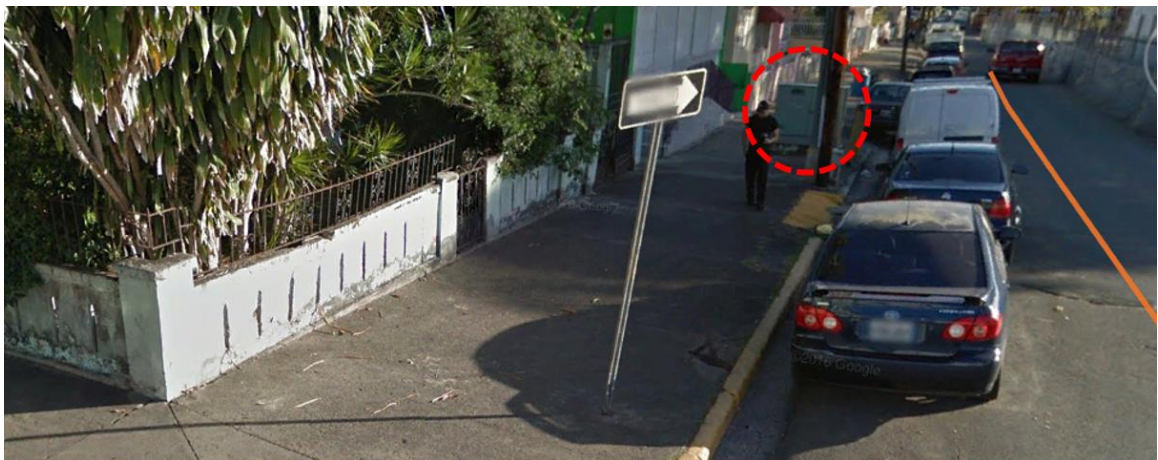
Figure 6-327 Sidewalk on Felipe R. Goyco Street from the Evacuation Route of Luis Llorens Torres School in Street View (Google Earth – 2016)

The last sidewalk of the route is on Felipe R. Goyco Street, right where the predetermined assembly place is located (“Plaza Antonio R. Barceló”) (Figure 6-326). The sidewalk has a constant width of 150 inches. In addition, this sidewalk is not obstructed by power lines or signs. Its only obstacle lies in a power plant that reduces its width to 68 inches on the road (Figure 6-327).

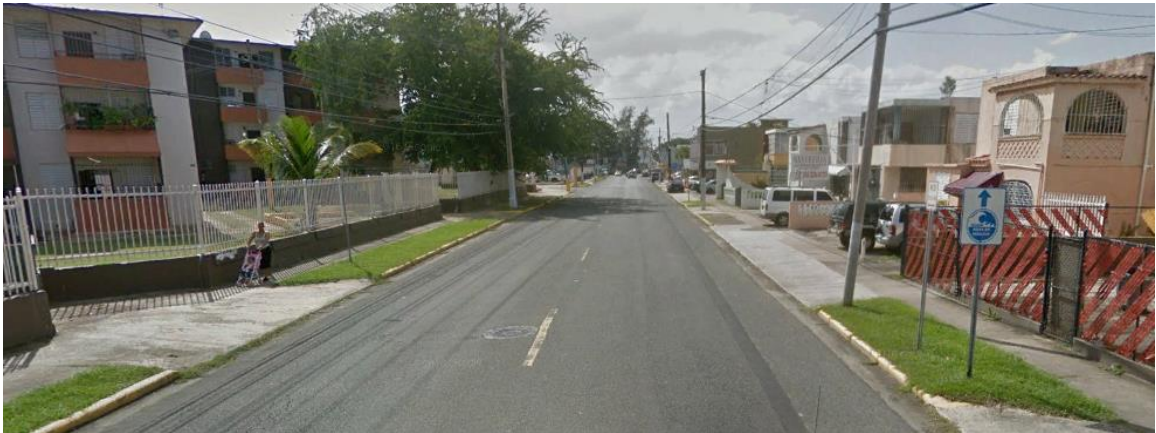
Figure 6-329 Evacuation Route Sign (a) through Loíza Street Near to Luis Llorens Torres School (Google Earth – 2016)

Por Four of the evacuation route signs are located on Loíza Street (PR-37). These are the evacuation route sign (a) (Figure 6-329), sign (b) (Figure 6-330), sign (c) (Figure 6-331), and sign (e) (Figure 6-332). Evacuation route signs (a), (b), and (c) are identified and seen on the highway heading east to west. While the sign (e) is recognized from West to East by the same road.

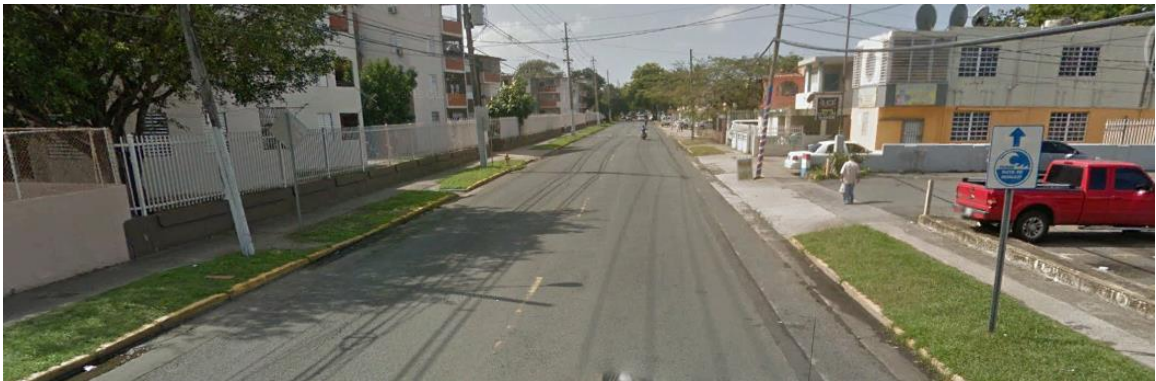
Figure 6-330 Evacuation Route Sign (b) through Loíza Street Near to Luis Llorens Torres School (Google Earth – 2016)

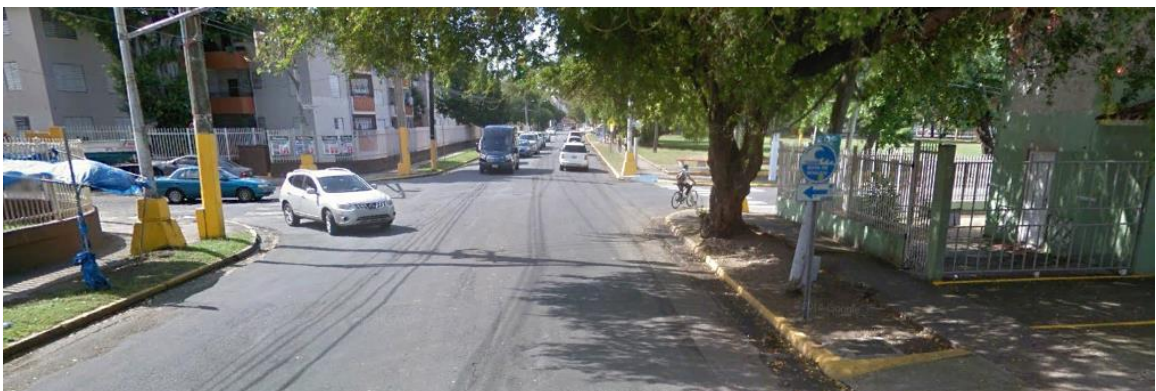
Figure 6-331 Evacuation Route Sign (c) through Loíza Street Near to Luis Llorens Torres School (Google Earth – 2016)

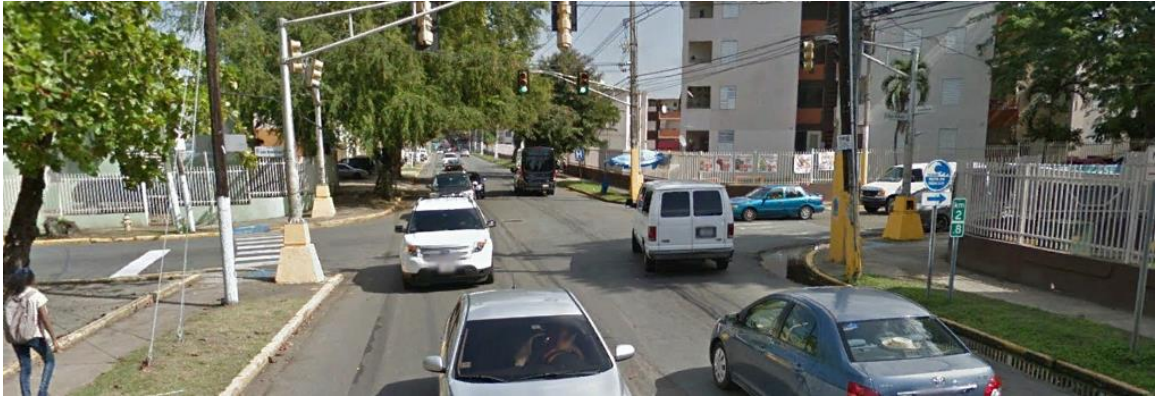
Figure 6-332 Evacuation Route Sign (e) through Loíza Street Near to Luis Llorens Torres School (Google Earth – 2016)

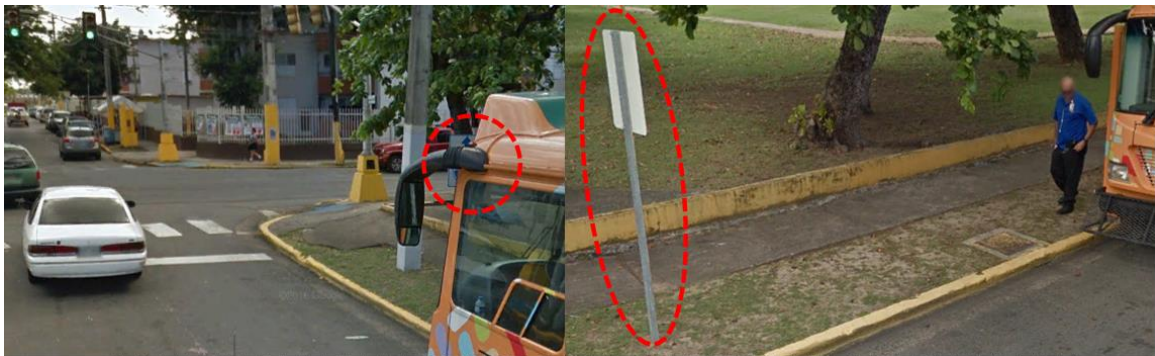
Figure 6-333 shows the evacuation route sign (d) located along Las Américas Avenue. This shows on the left the front of the sign that is obstructed by a car according to the Google Earth shot. And on the right, it presents the rear of the same sign without any obstruction.

Figure 6-333 Evacuation Route Sign (d) through Las Américas Avenue Near to Luis Llorens Torres School (Google Earth – 2016)

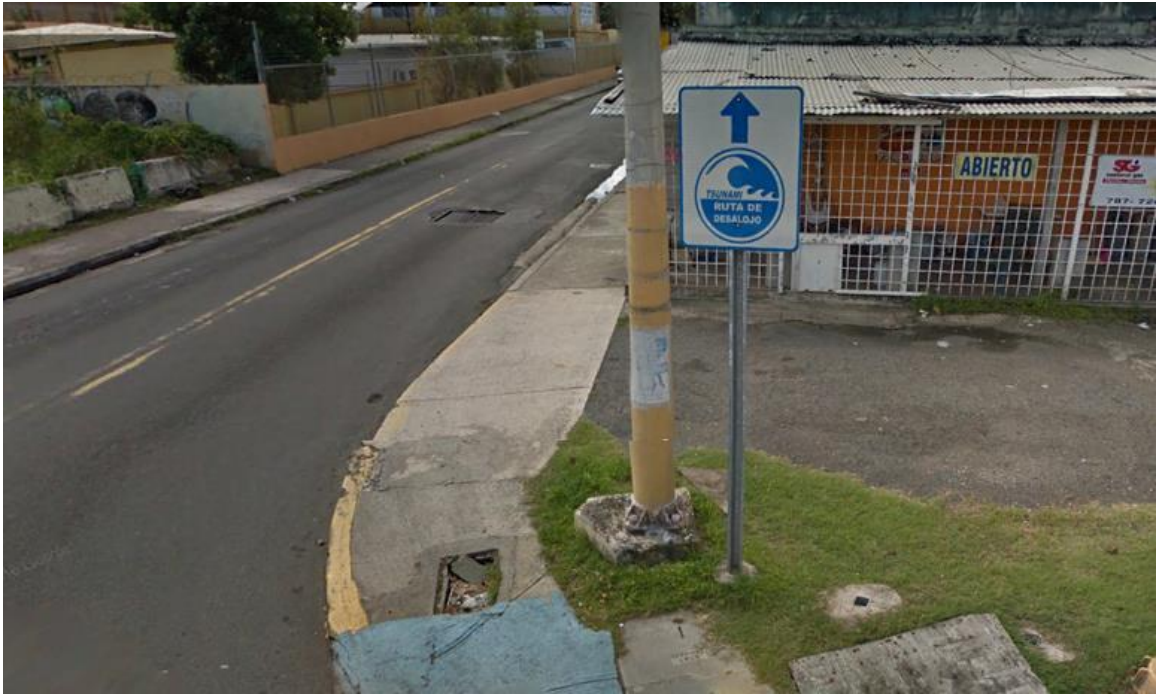
The evacuation route sign (f) is located on Román Baldorioty de Castro Avenue as shown in Figure 6-334. This is in a direction from East to West along the avenue. This is the only sign that is found and can be seen on the evacuation route of Luis Llorens Torres school through Pellín Rodríguez (Providencia Street) in a North to South direction.

Figure 6-334 Evacuation Route Sign (f) through Román Baldorioty de Castro Avenue Near to Luis Llorens Torres School (Google Earth – 2016)

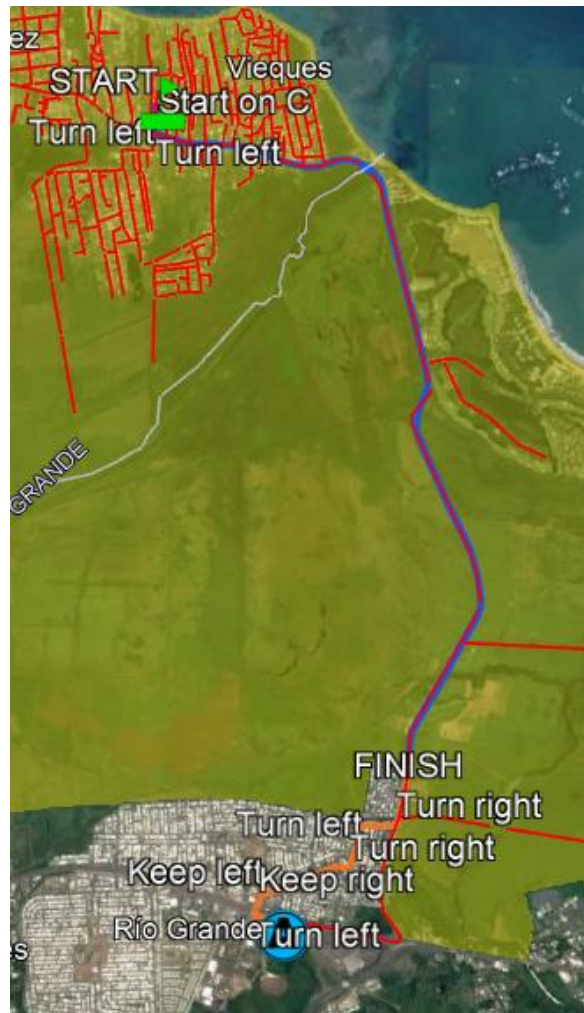
Figure 7-7 shows the evacuation route for this school up to the assembly site in orange and out of the tsunami hazard zone in blue.

Figure 7-7 Evacuation Route of Medianía Alta Elemental School at Loíza

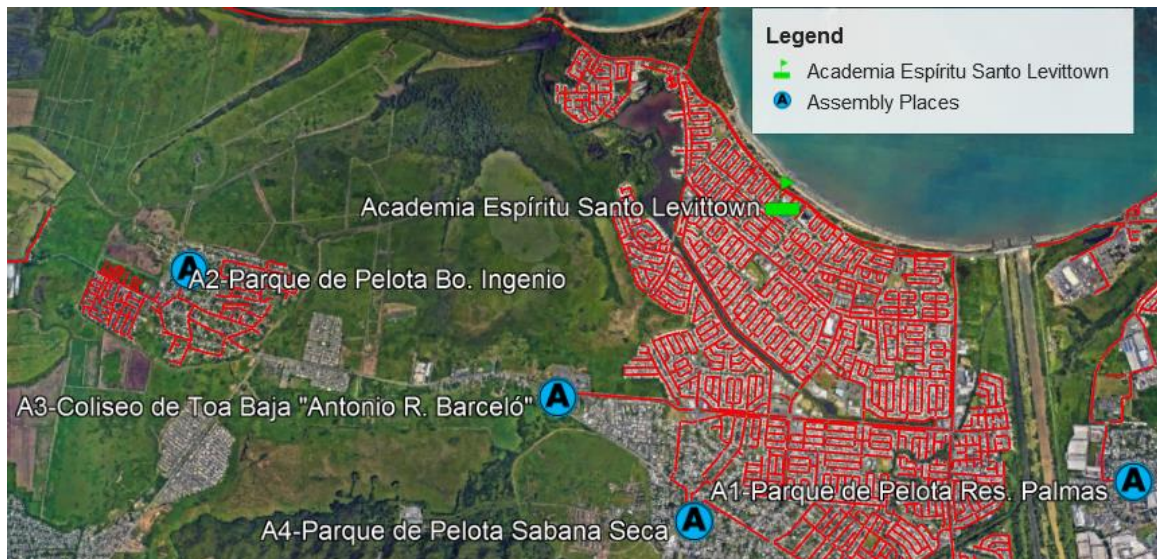
Figure 7-9 Location of Assembly Places with Respect to Academia Espiritu Santo Levittown

For Toa Baja there are five available assembly locations closest to the area. These are “Parque de Pelota de Campanillas”, “Parque de Pelota Bo. Ingenio”, “Coliseo de Toa Baja (Antonio R. Barceló)” and “Parque de Pelota Sabana Seca” located in Toa Baja, as well as the “Parque de Pelota Res. Palmas” in Cataño (Figure 7-9). The assembly place used for the evacuation route from this school is “Parque de Pelota Sabana Seca”.
