Carlos Soto  
 Advisor: Prof. Héctor J. Cruzado, PhD, PE  
 Graduate School

## Alternate Test Procedures

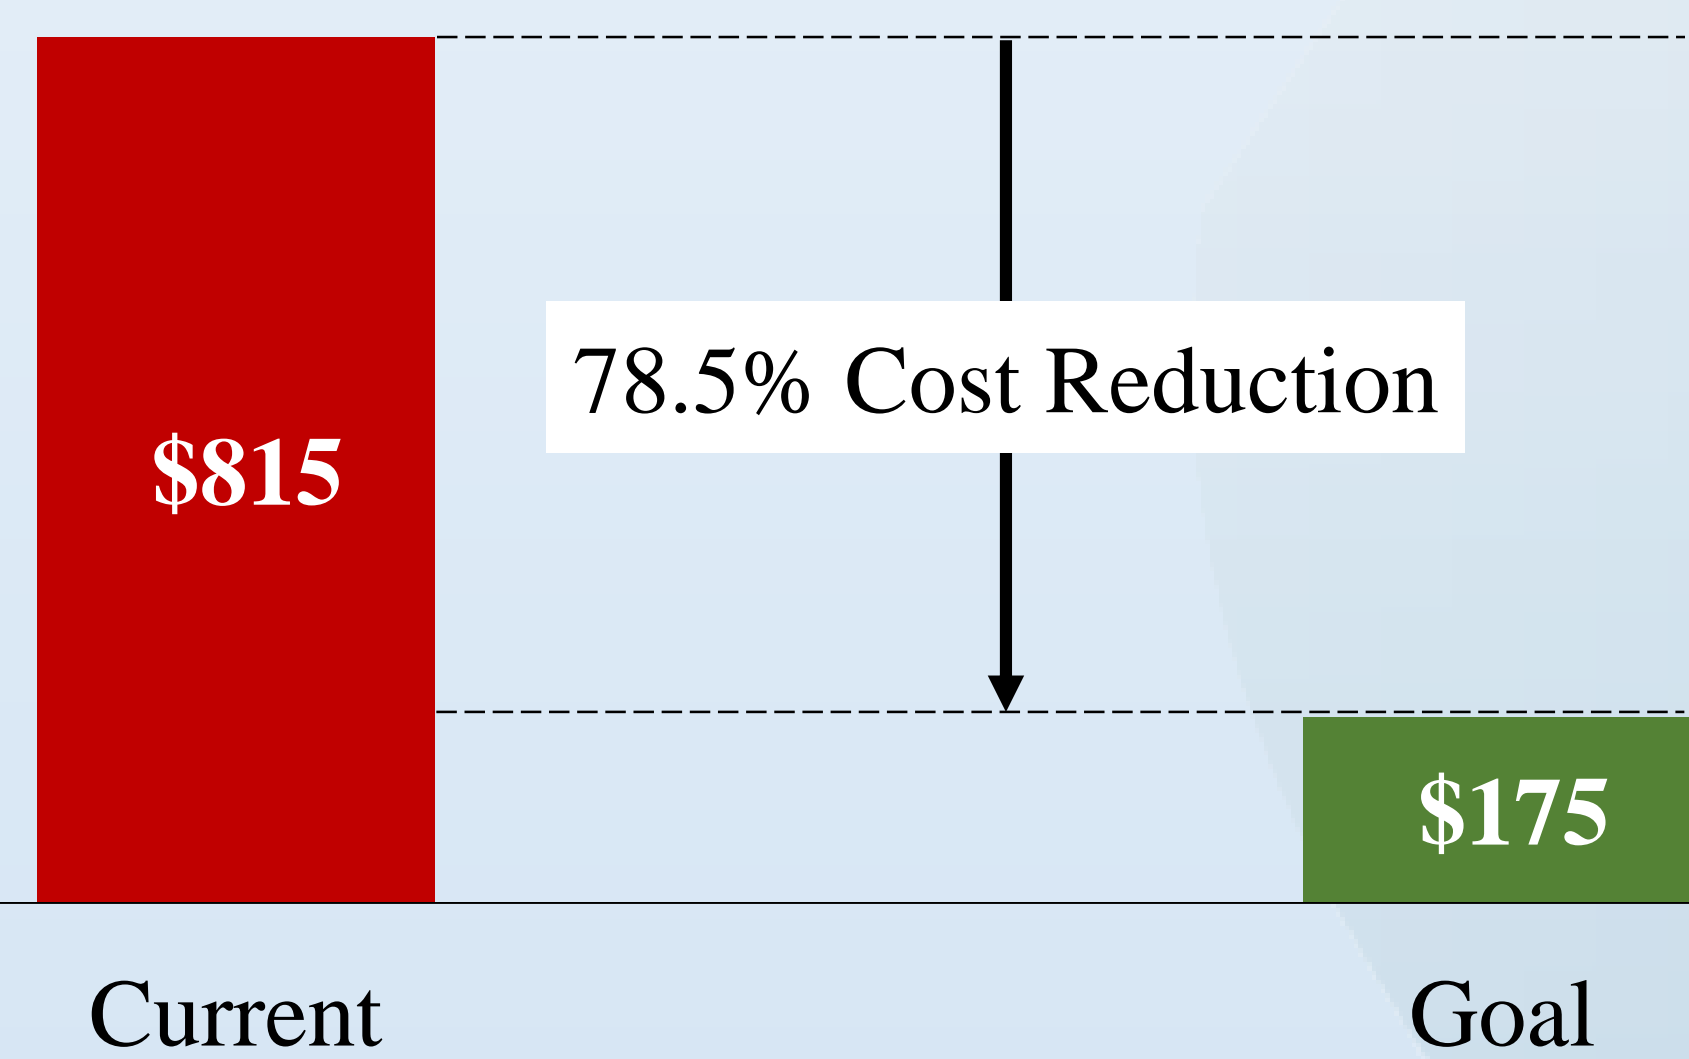
OUS Average Shipping Cost per Repair

Calculated OUS average cost of shipping from historical service cases.

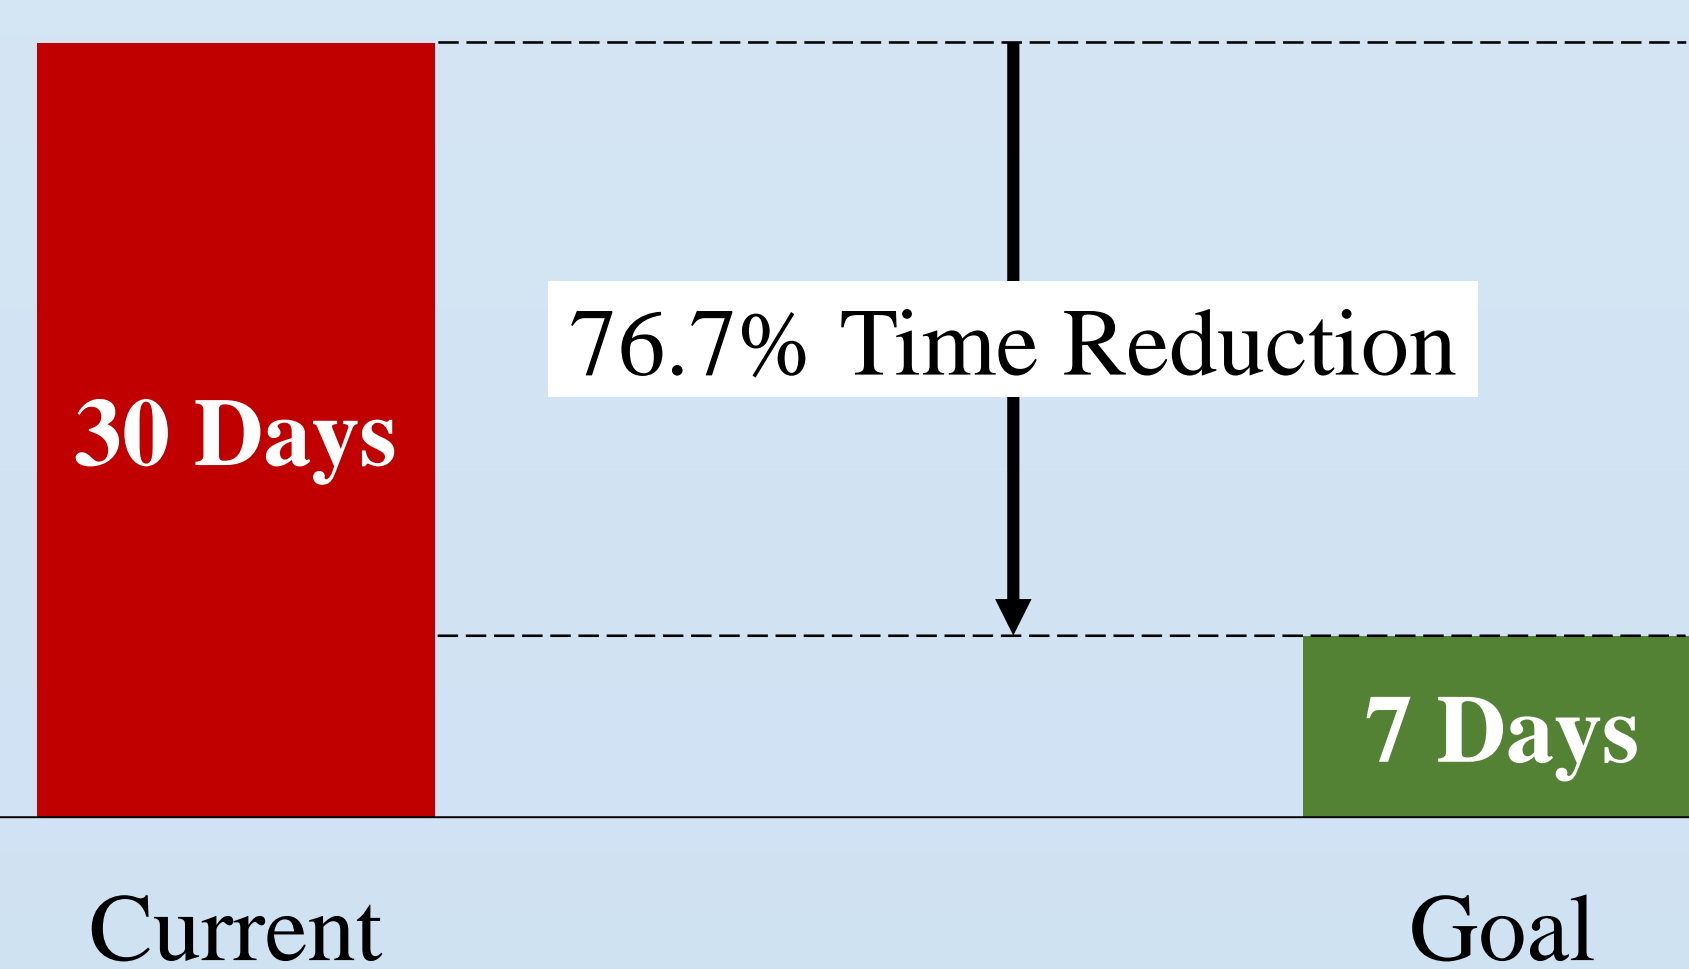
OUS Average Turnaround Time per Repair

Calculated OUS average repair turnaround time from historical service cases.

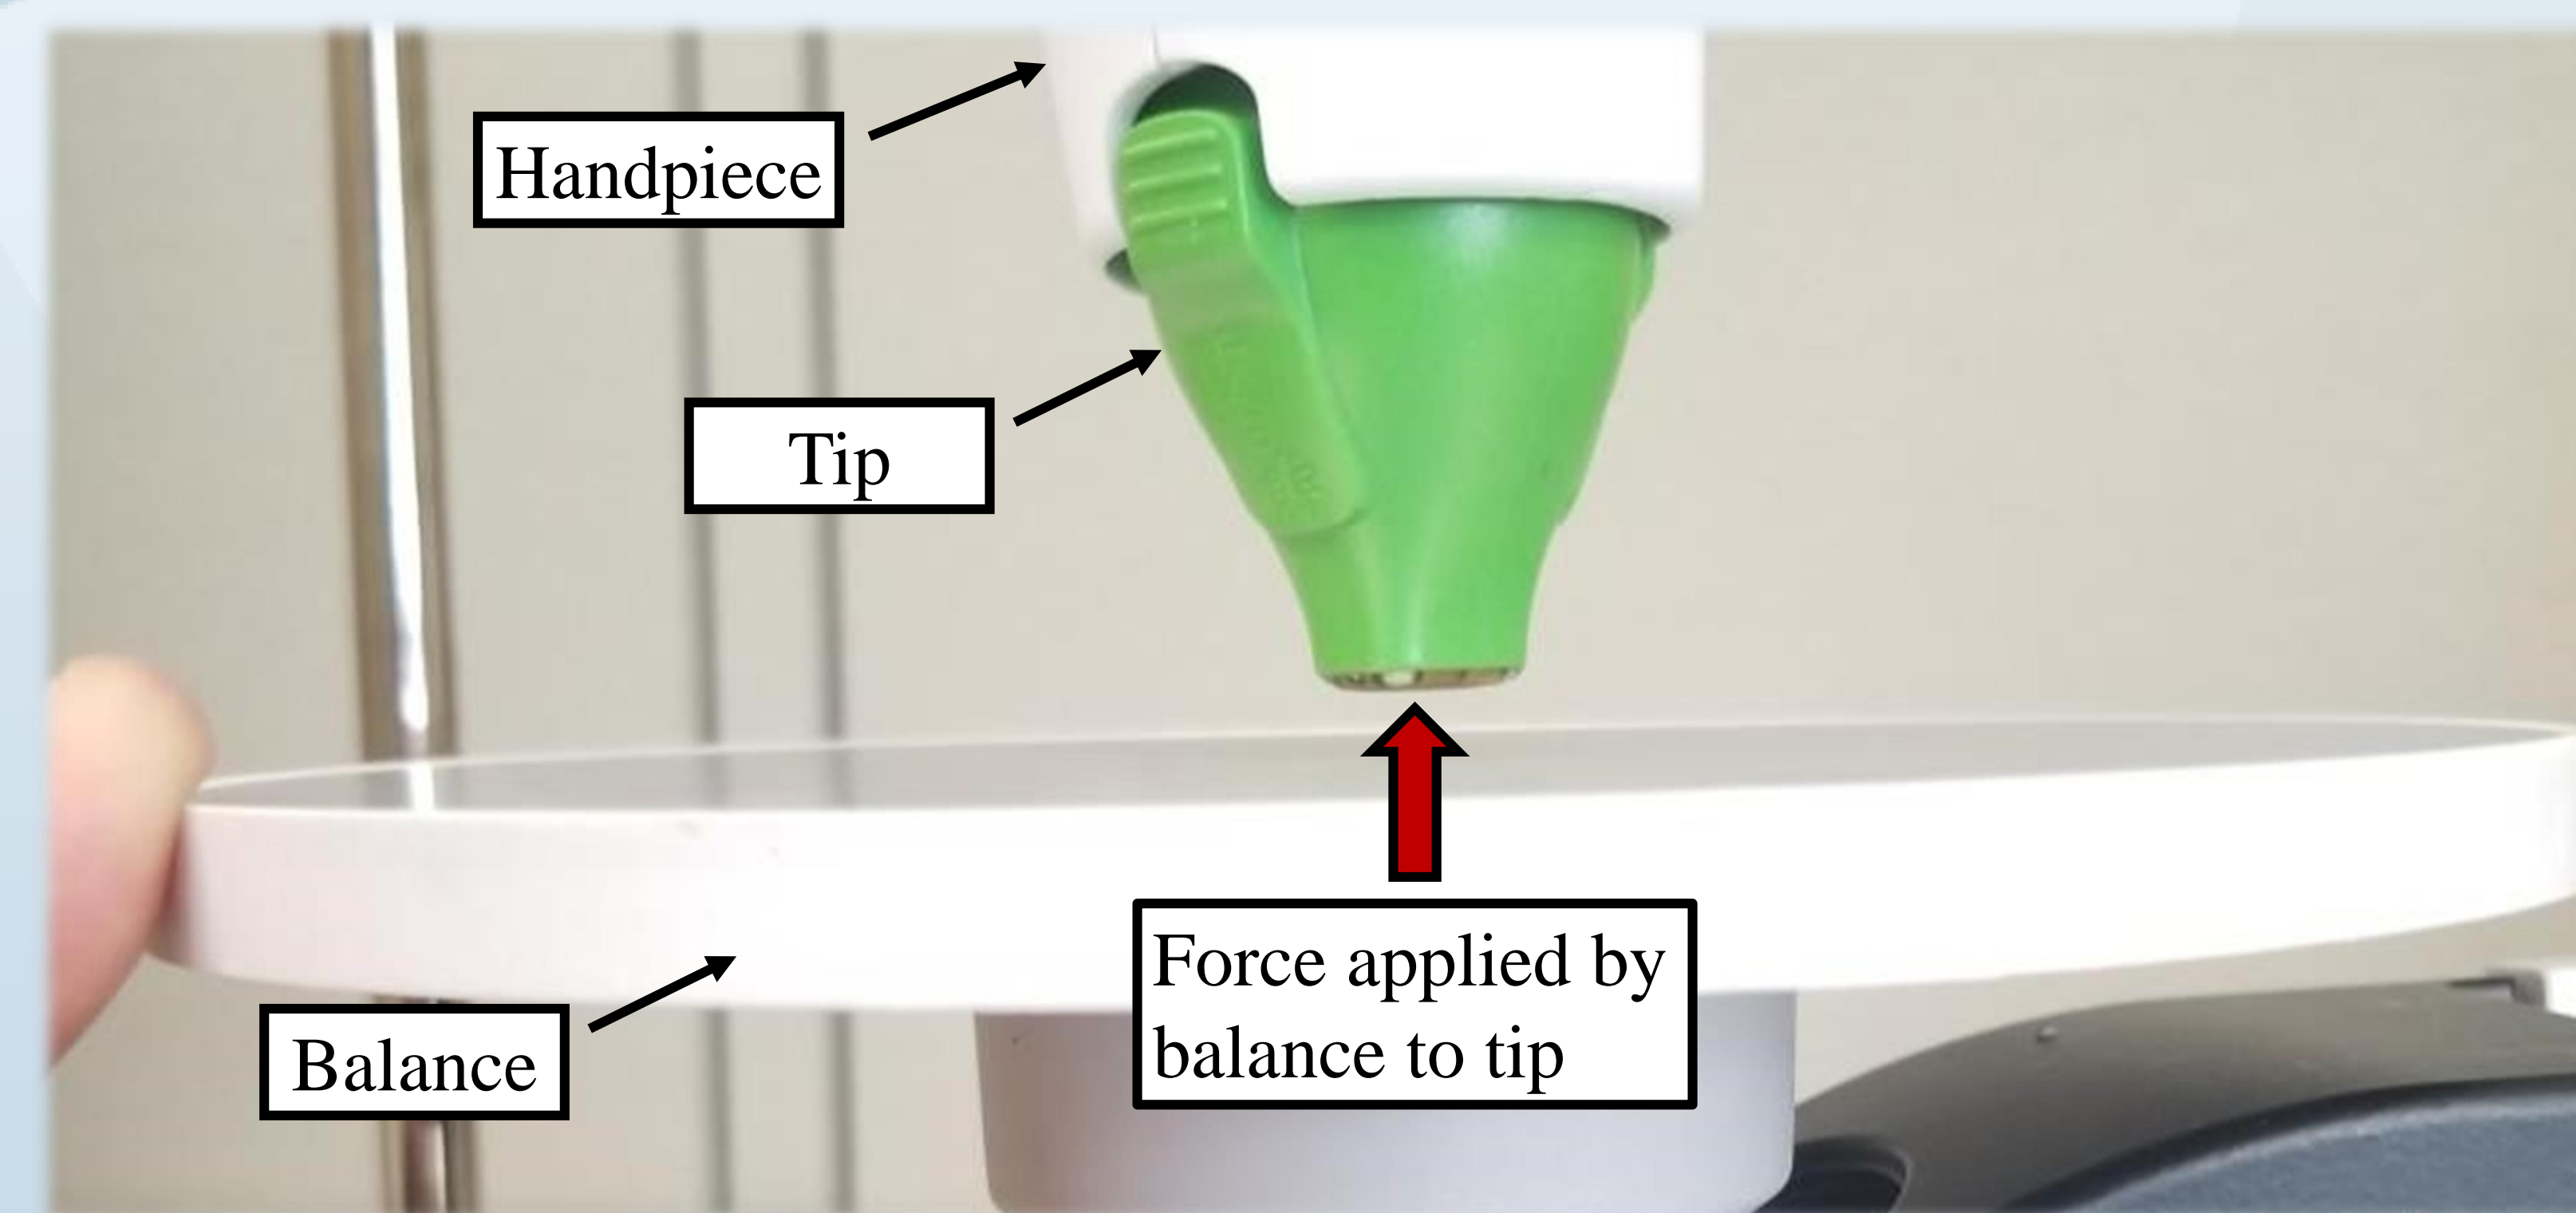
### Force sensor calibration check
