Hurricane Resistant Curtain Wall System

Master of Engineering in Civil Engineering

Polytechnic University of Puerto Rico

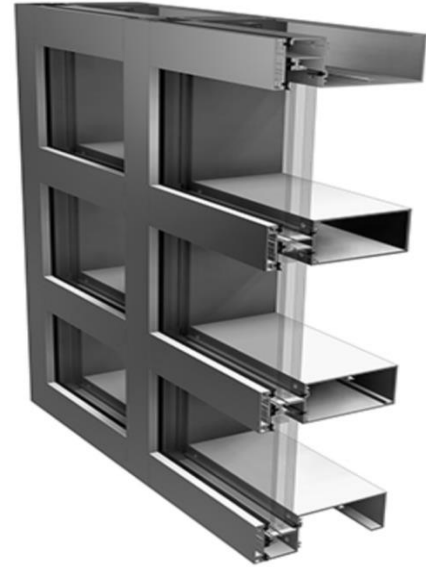
Figure 2
StormWallXL™ System Assembly

Hurricane-Resistant Curtain Wall is designed to meet the most demanding performance requirements for areas exposed to hurricane and other severe weather. CR Laurence – U.S. Aluminum, a leading manufacturer and supplier of architectural glazing system for 60 years, has introduced StormWallXL™ Hurricane-Resistant Curtain Wall. The curtain wall is engineered to provide steadfast protection against severe weather while meeting stringent building code requirements. It is NFRC-rated, has Florida Product Approval, Miami-Dade Certified (NOA), and is fully tested to ASTM and TAS Standards. This is an innovative system that meet unique regional requirements, presents a credentialed, impact-resistant glazing solution for coastal communities that completes a comprehensive product offering. The assemblage takes into consideration the site peculiarities, including but not limited to the expansion and contraction movements so there is no possibility of loosening, weakening, or fracturing connection between units and building structure or assembly between units themselves. It provides the best defense against high winds, airborne debris, and water infiltration. Designed and engineered for exceptional strength, reliability, and quality, it ensures that architects and glazing contractors receive the best high-performance curtain wall for their at-risk projects. The system integrates seamlessly with CRL-U.S. hurricane-resistant windows and doors to provide a

complete building envelope solution. The system offers shear block assembly with no exposed fasteners for improved aesthetics and installation flexibility [1].

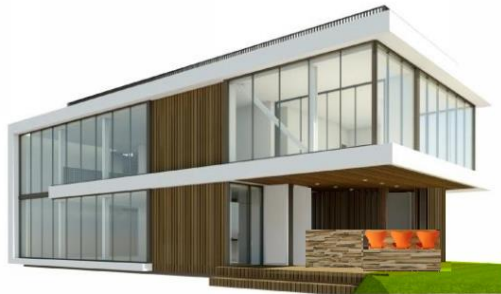
Figure 7

Curtain Wall Installed: South-East View
