Coronary Guide Wires

Author: Edwin Espinell Marquez
 Advisor: Carlos Pons, PhD.
 Manufacturing Engineering

Abstract

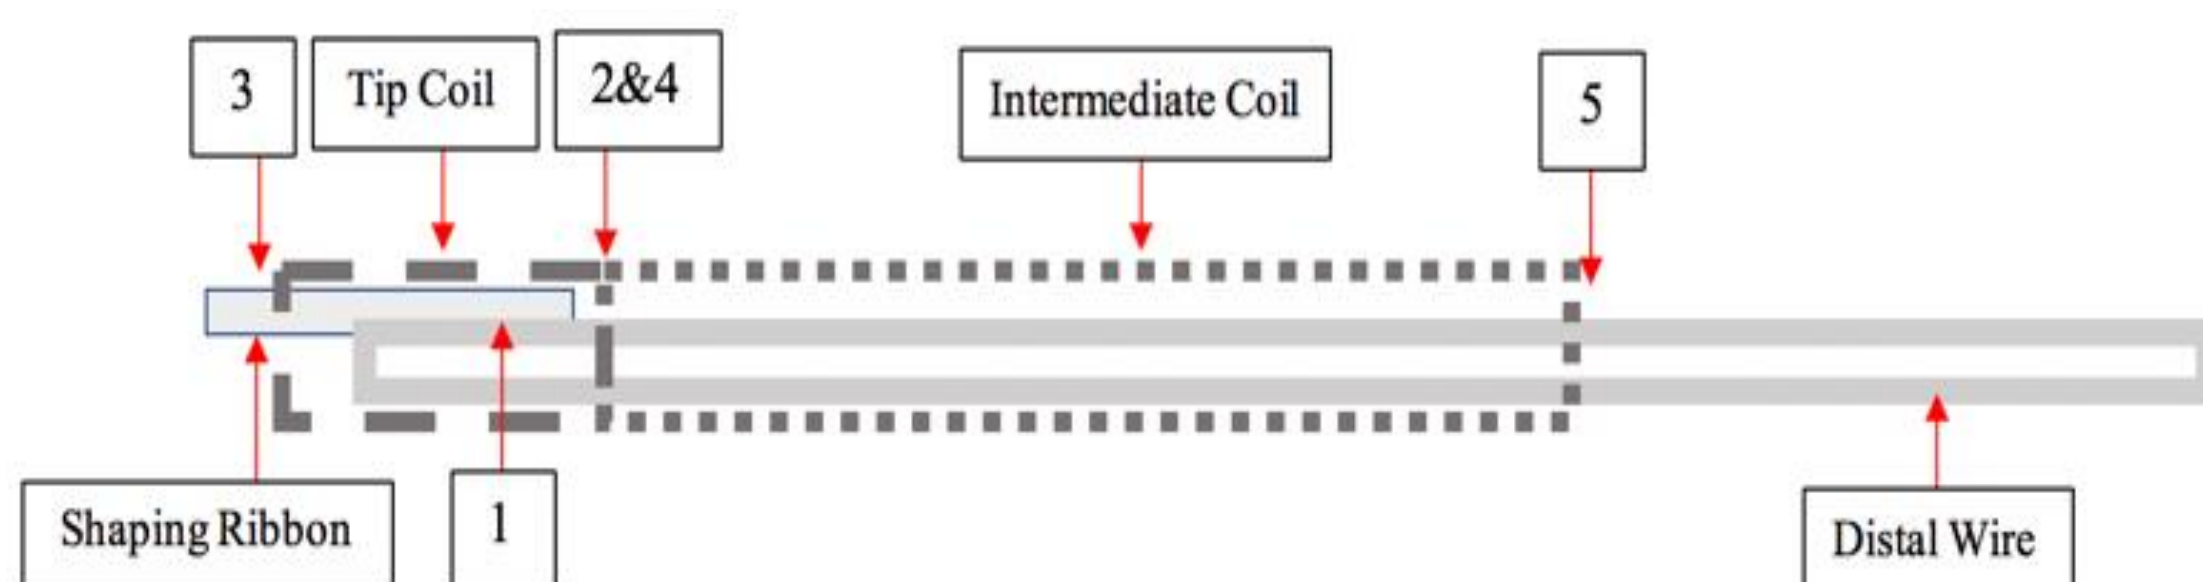
There is a variety of guide wire models manufactured within Abbot Vascular known as Balance, Whisper and Universal. Therefore, different manufacturing processes are required. Balance Manufacturing, which is the focus of the project, has three different zones utilized to assemble and deliver the whole wire, which are: Soldering Zone, Adhesive Zone and Packaging Zone in that order. Within Balance Soldering Zone, there are four lines with six manufacturing stations in a specific order where each one has a different task to complete: Tack Solder (1), Tip Attach (2), Tip Solder (3), Center Solder (4), Proximal Solder (5) and Wire Inspection, in that order. Balance Manufacturing yield has been lowered due to defects of coils identified at Soldering Zone Tip Attach station.

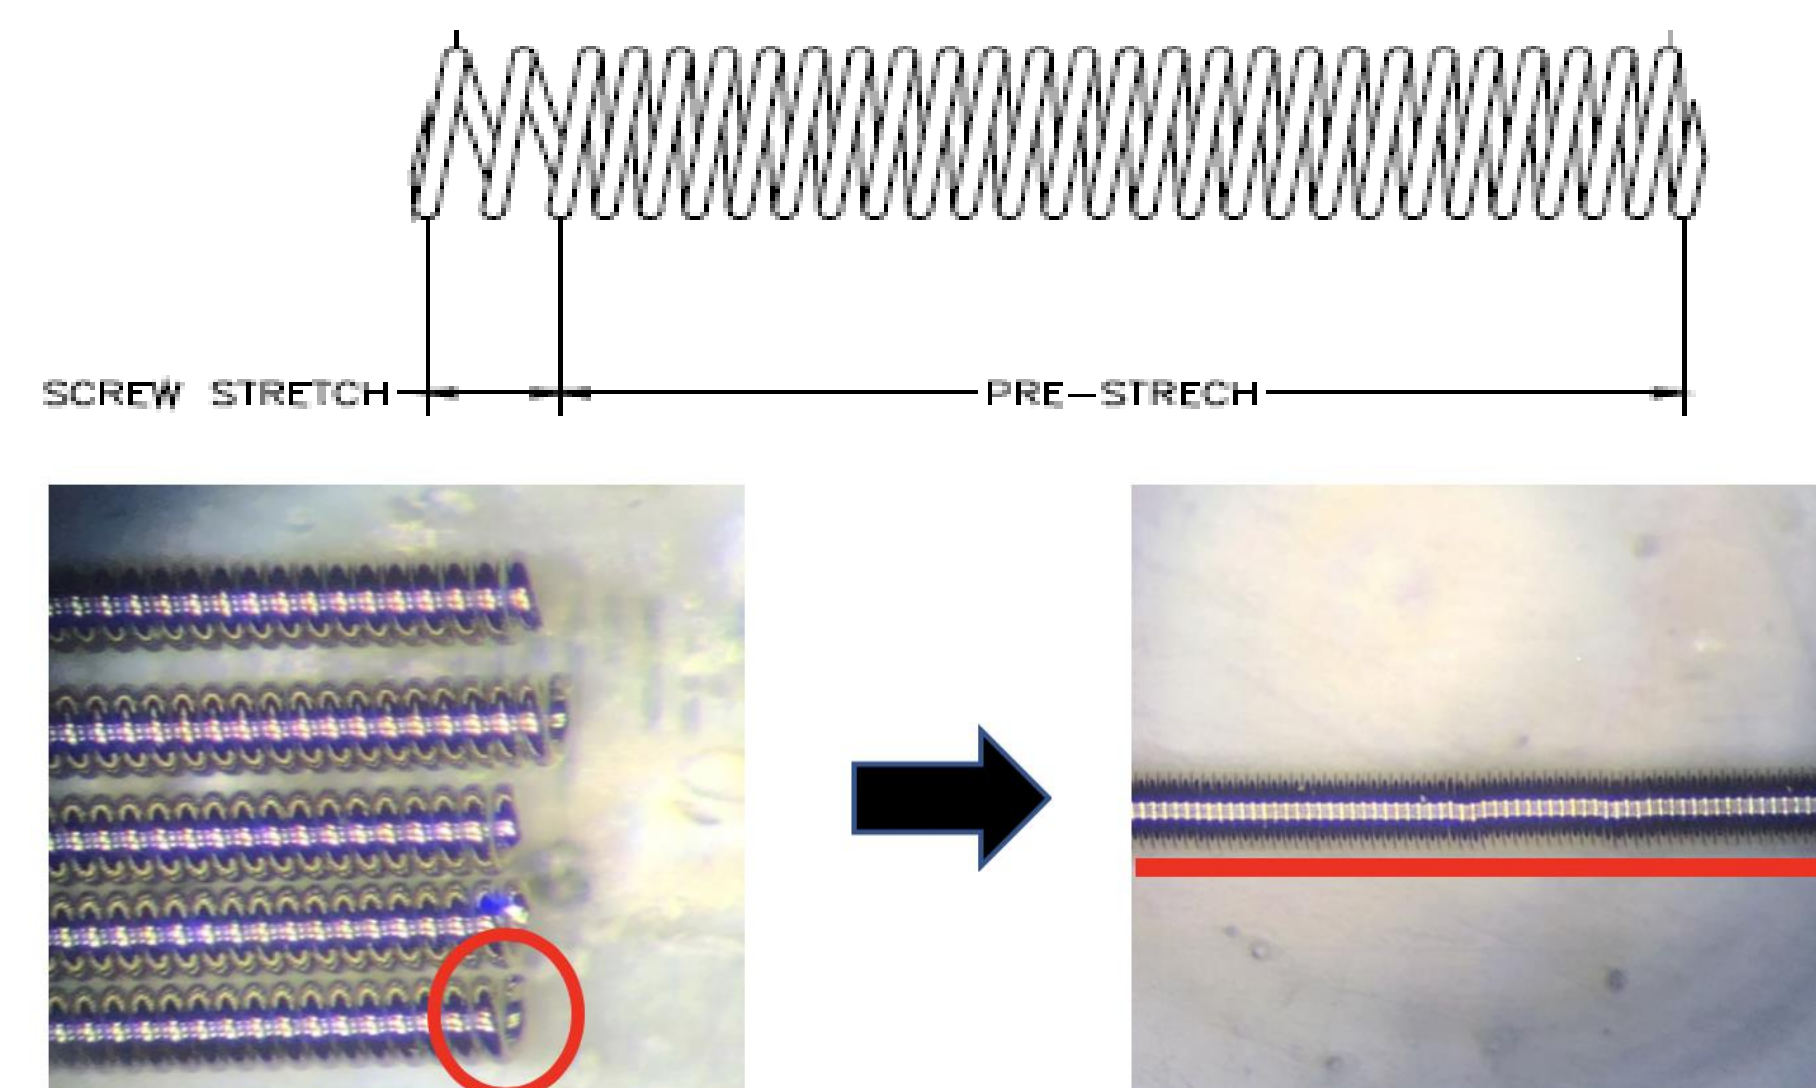
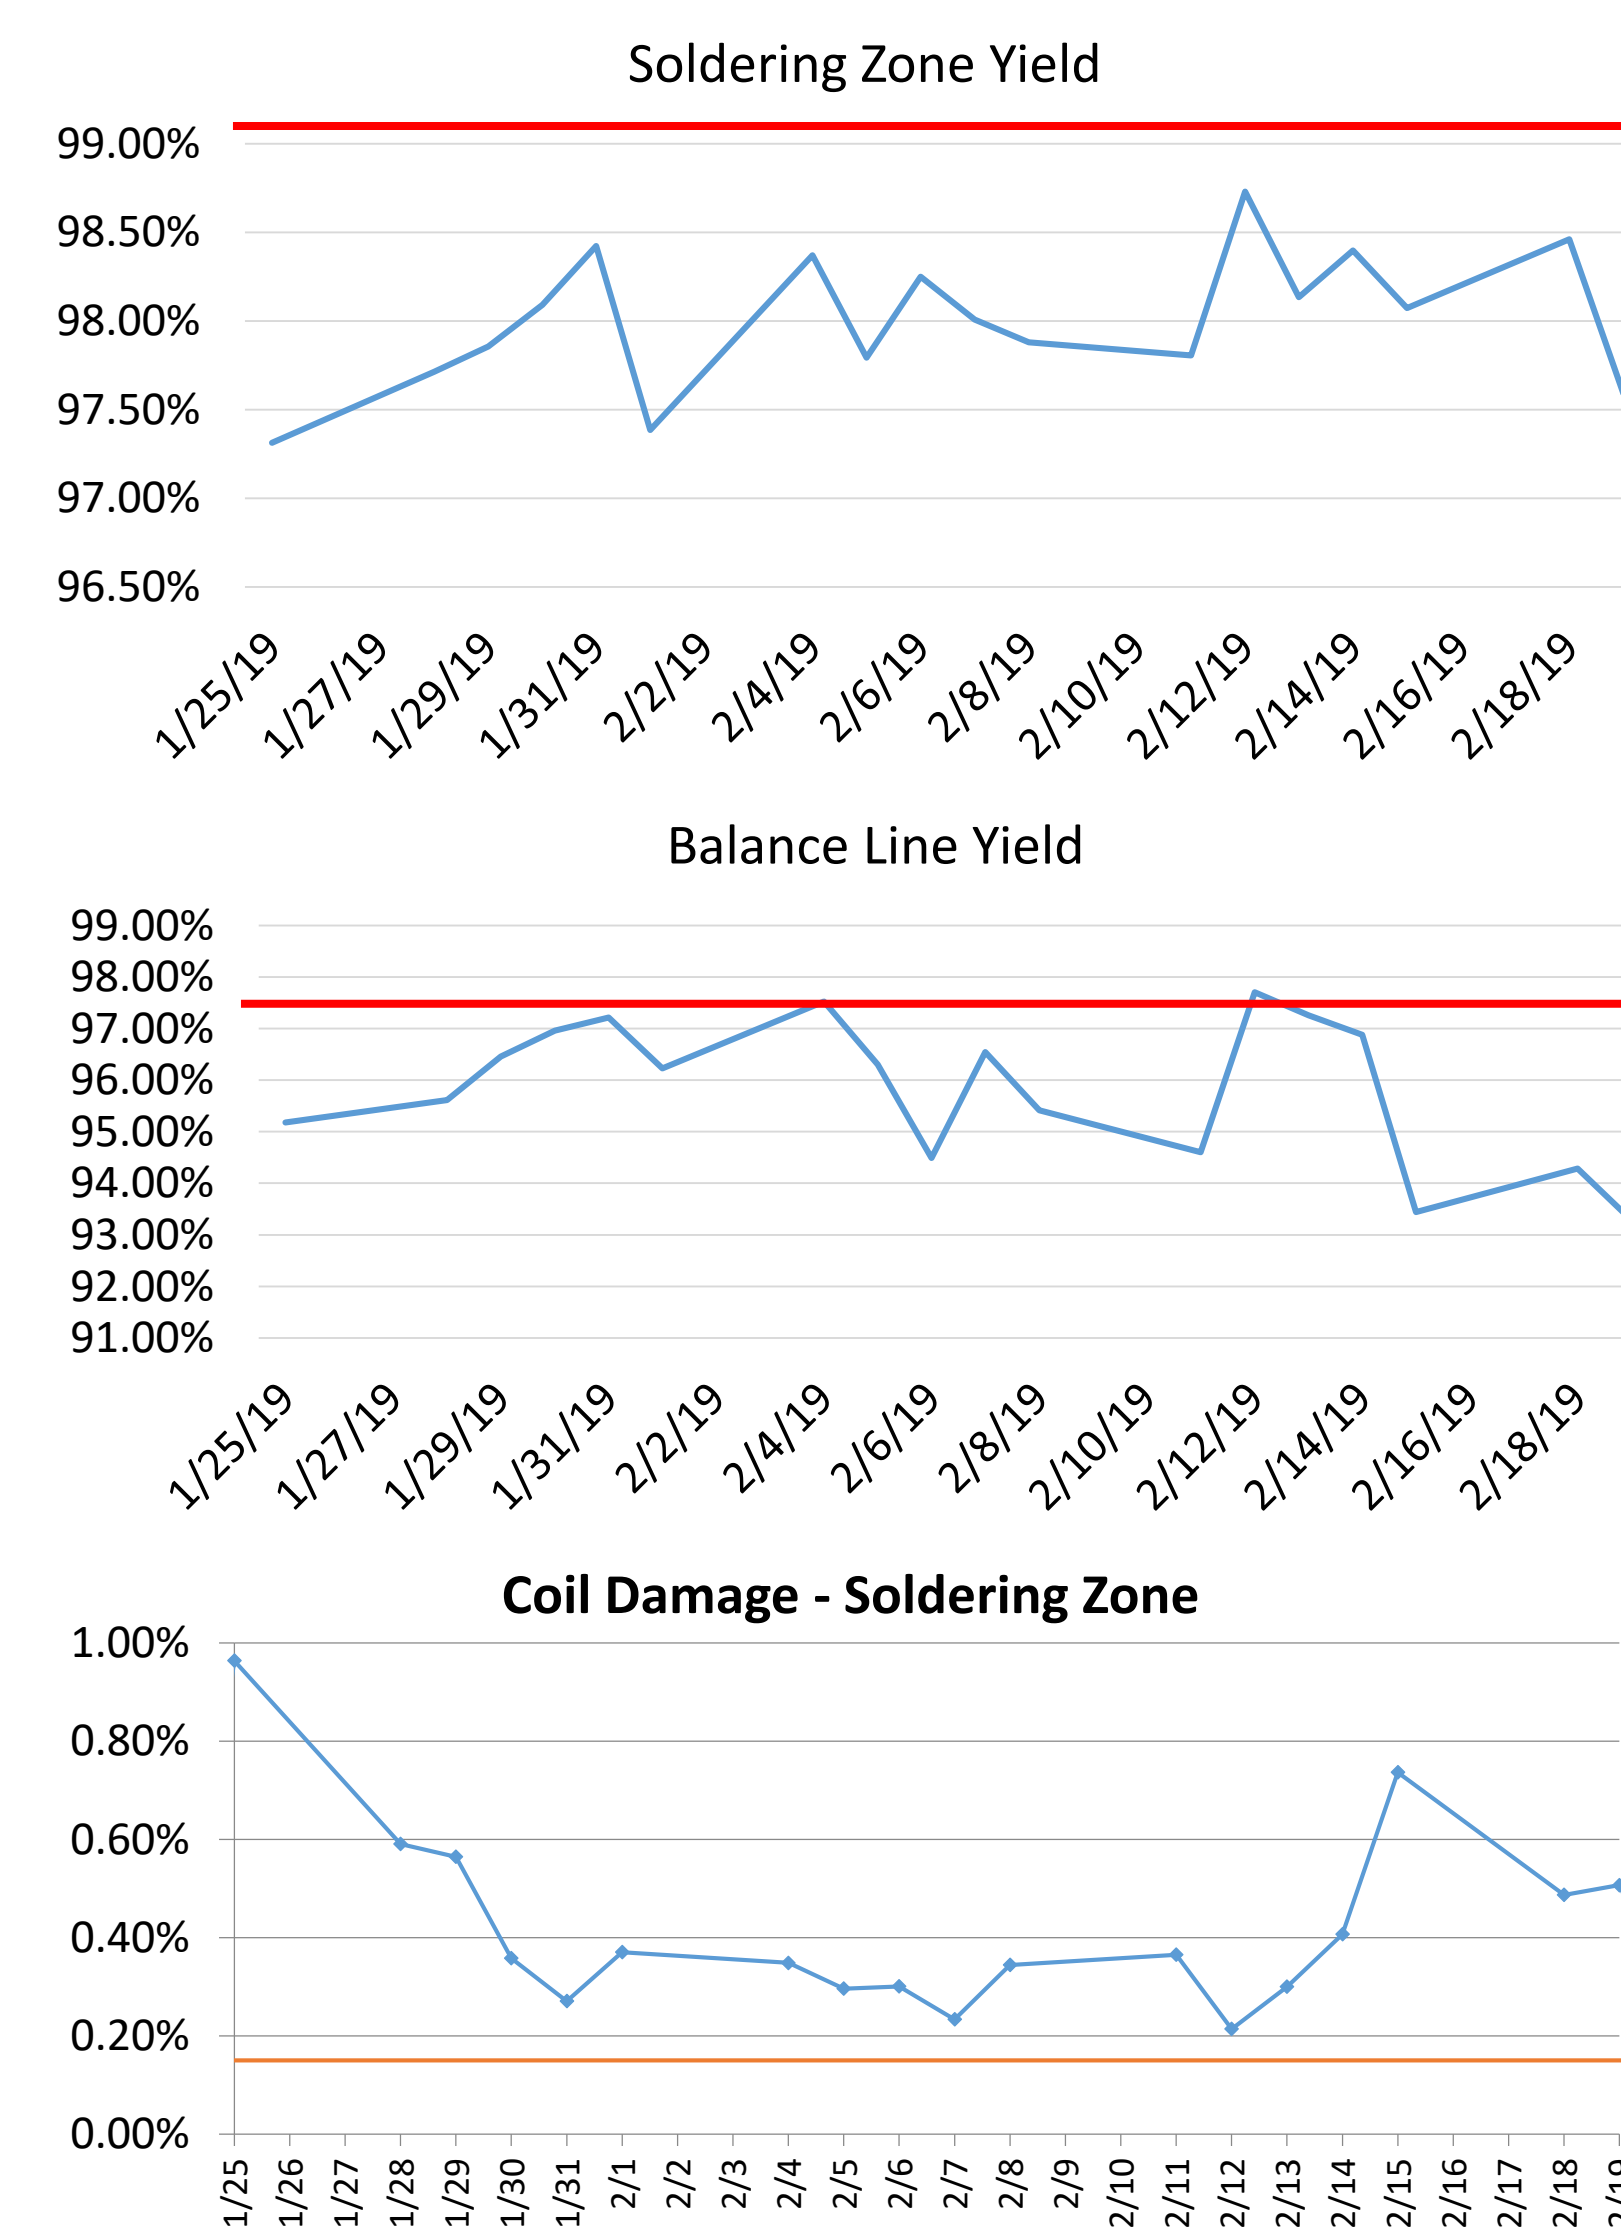
Operator's task will be dependent of the tip and intermediate coils variables. Each variable has its own specification already established in current Manufacturing Process Instructions. Soldering Zone Yield and Balance Line Yield were monitored as for a period of time. The Balance Line Yield only met its target of 97.5% twice having an average of 96.1% and Soldering Zone Yield never met its target of 99.1% having an average of 98.0%. As for coil damage percentage, during this period, it never met its target of 0.2%.

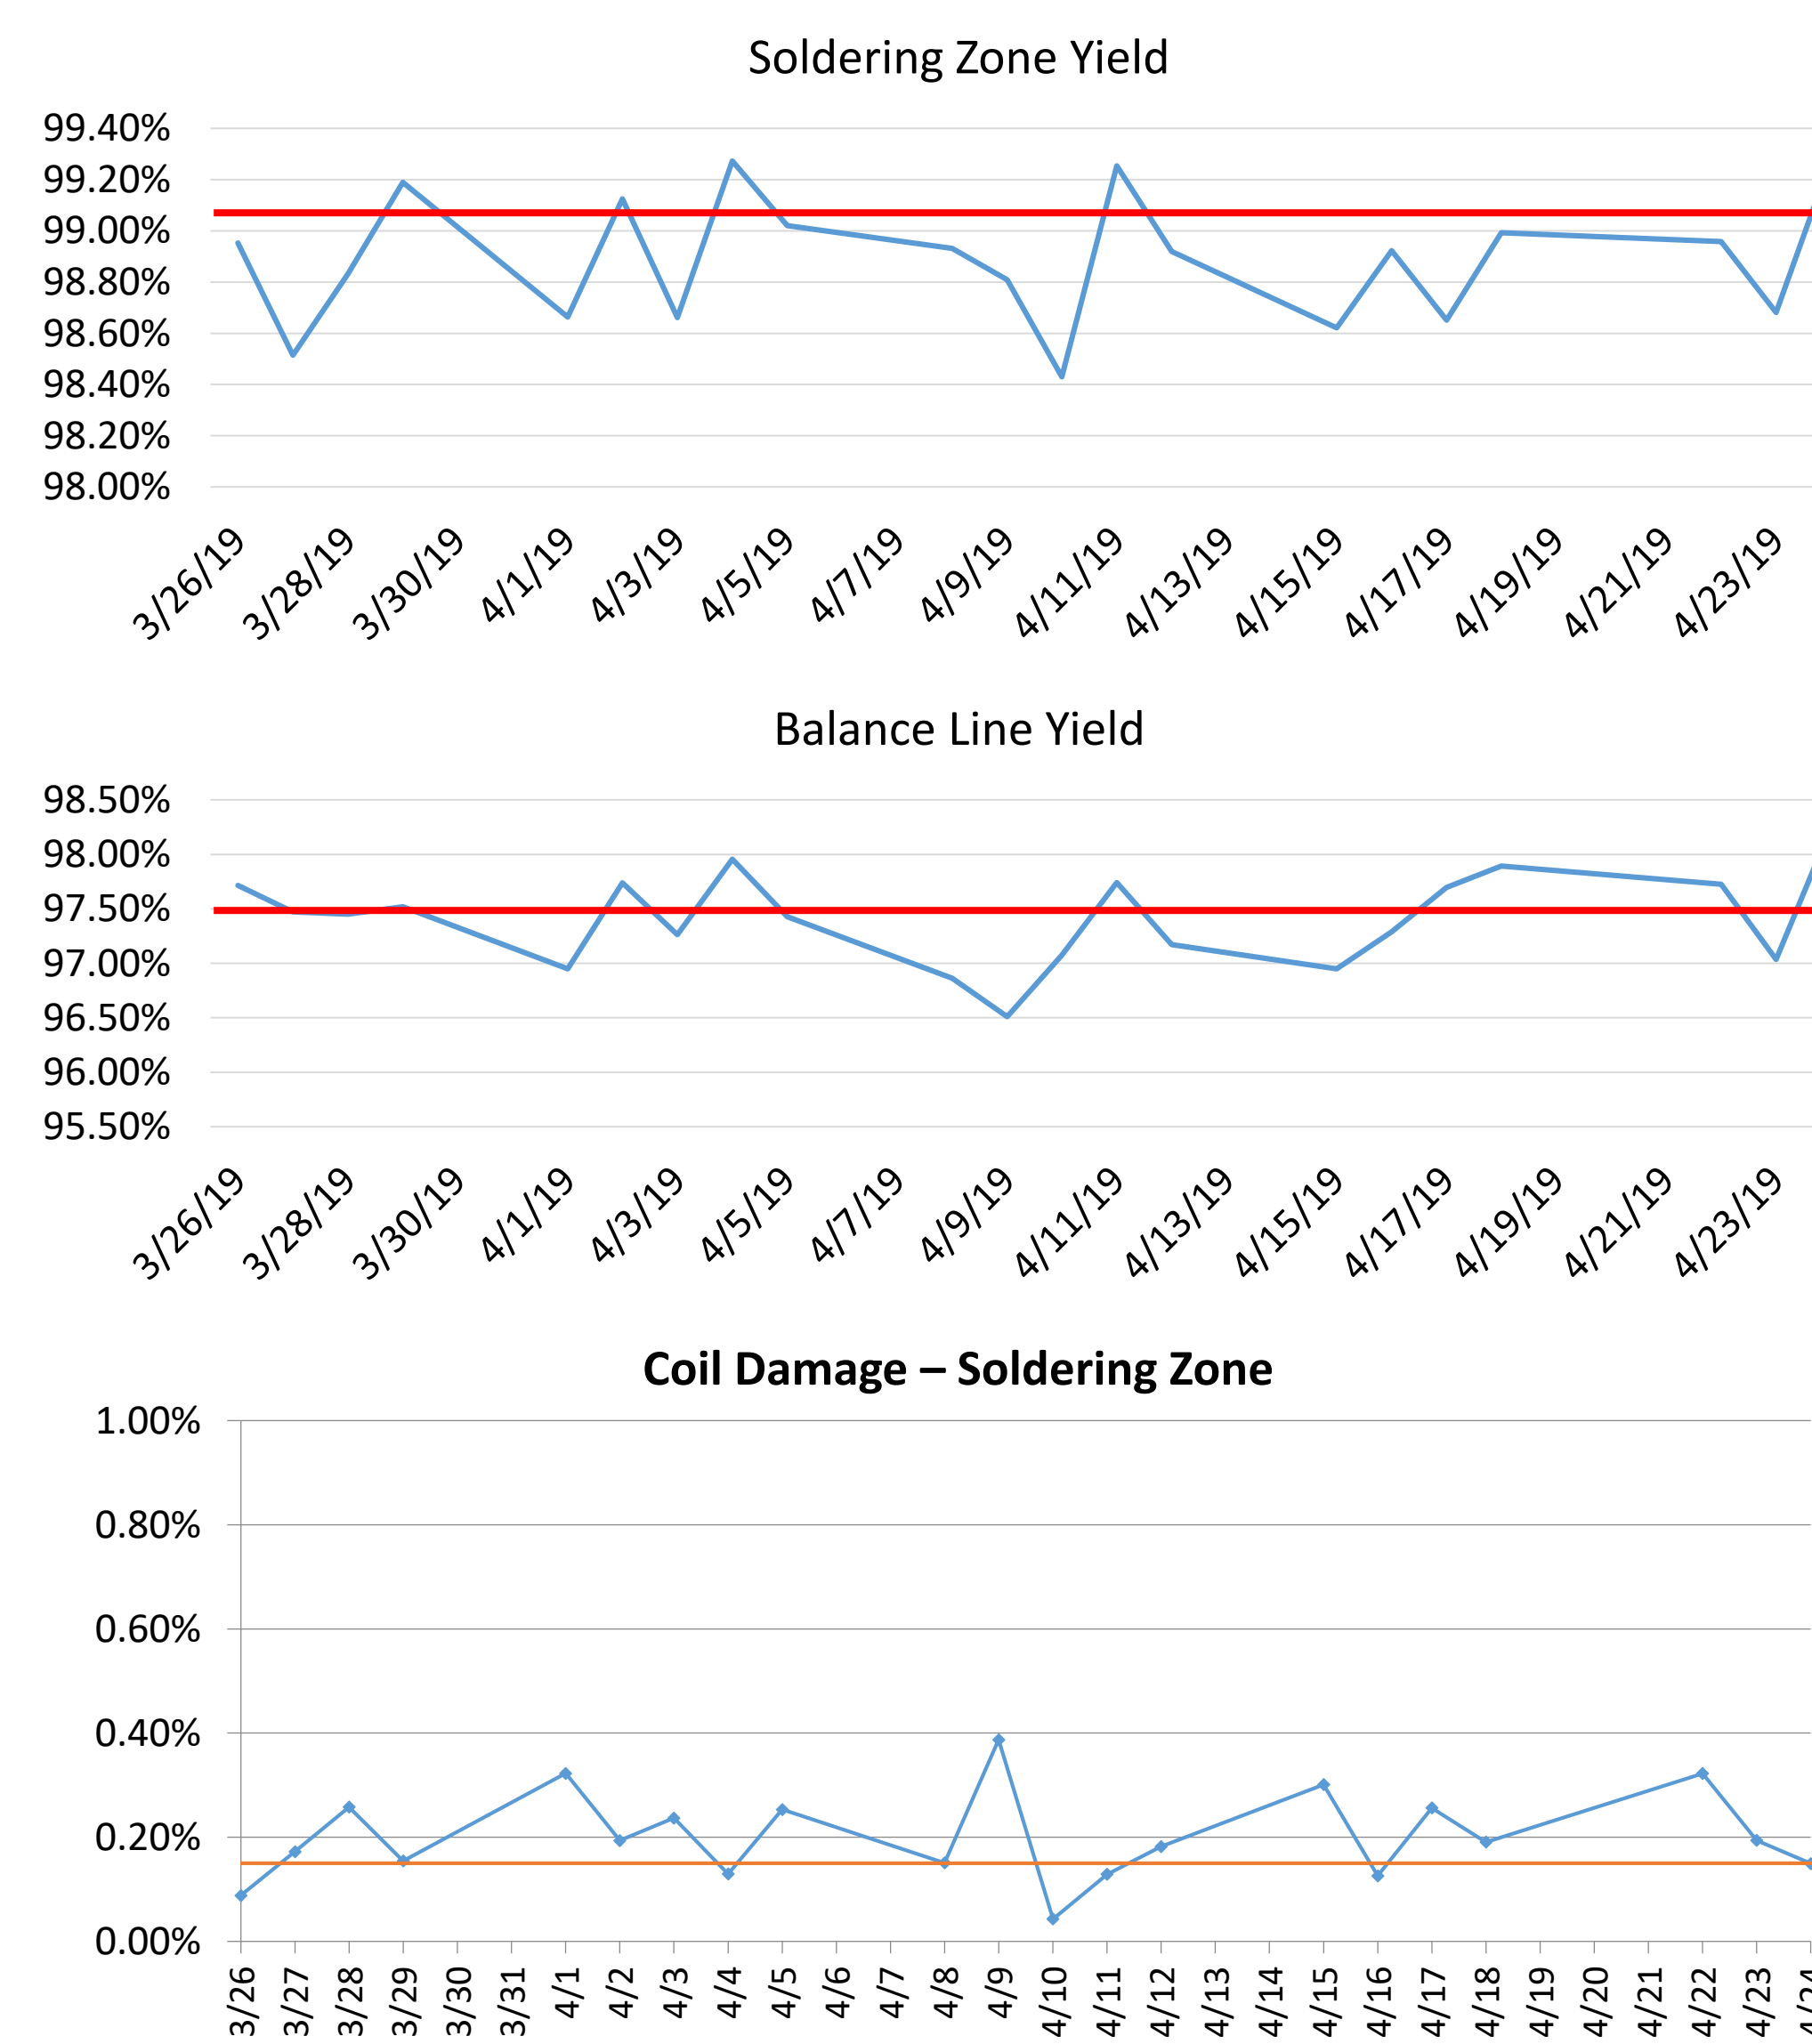
In order to make coil cutting Manufacturing Process Instructions for Balance Manufacturing error-proof, the format was reconfigured, instructions were modified and figures were added to make the instructions more graphic. After implementing all these changes, the approval of the operators was received to make the new Manufacturing Process Instructions an official document.
