# ***Rio Humacao Channelization Viability Study***

*Francisco J. Marrero Guinot  
Master of Engineering in Civil Engineering  
Auristela Mueses Pérez, Ph.D.  
Civil and Environmental Engineering and Land Surveying Department  
Polytechnic University of Puerto Rico*

**Abstract** — *Río Humacao is located in the southeast coast of Puerto Rico and it flows generally northeastward and then southeastward and enters the alluvial floodplain at the town of Humacao, 6 kilometers upstream from its mouth. Major tributaries are Quebrada Mabu, and Quebrada Mariana. Quebrada Mabu, flows southward and Quebrada Mariana flows eastward. Both tributaries cross through the town of Humacao. A great portion of the town lies on the Special Flood Hazard Areas as designated by the Federal Emergency Management Agency (FEMA) on its Flood Insurance Rate Map (FIRM). This happens because mostly of the town of Humacao was developed around the river in their floodplain before the FEMA FIRM's were adopted by the PR Planning Board on 1984. The main objective of this project is to determine the preliminary extent of the channelization of the Río Humacao and its tributaries to remove out the portion of the town fro

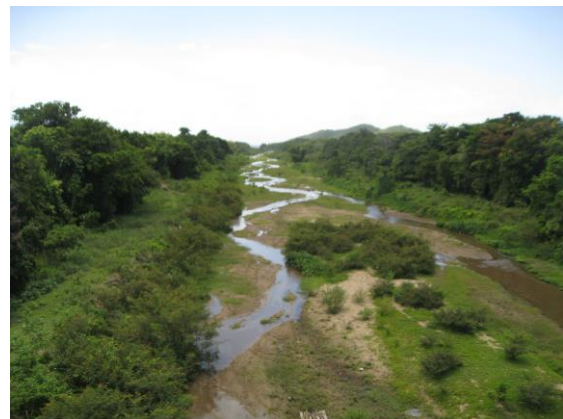
**Figure 3**  
Downstream view of Rio Humacao from State Road PR-923

- The three streams are heavy vegetated and site is heavy vegetated with grass and brush.
- Rio Humacao downstream of crossing with bridge from State Road PR-53 is heavy vegetated on both sides and sediment deposits, mostly sand, on the bottom of the stream channel as seen on Figure 3.

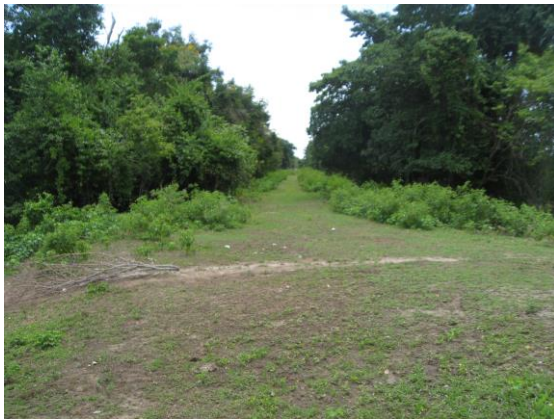
**Figure 4**  
Downstream view of Right Side Levee of Rio Humacao from Bridge on State Road PR-53

- The levee along Rio Humacao channel is covered with brush and grass as observed in Figure 4. This levee extends from State Road PR-3 to the river mouth. This channelization also included the downstream reaches of Quebrada Catano and Quebrada Mabu from its mouth to downstream of PR Highway 3. According to the FIS, this channel was designed in 1975 by the Puerto Rico Department of Transportation and Public Works to provide protection against a flood with a recurrence interval of approximately 100 years. However, silting (as observed) has reduced the flood-carrying capacity of the channel. The levees on each side of the channel can be overtopped or are lacking adequate freeboard to protect against the 1-percent annual chance flood [5].

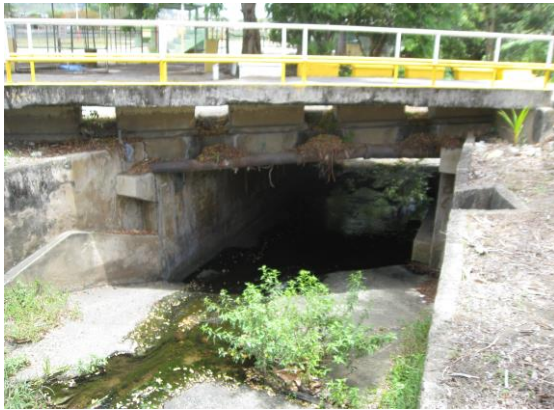
**Figure 5**  
**Bridge that has to be replaced on Quebrada Mabu**

On Quebrada Mabu, one (1) culvert was eliminated at cross section 1550, seven (7) of the eight (8) bridges were replaced, and four (4) of the five (5) culverts were replaced with bridges. Figure 5 shows one of the bridges that had to be replaced.

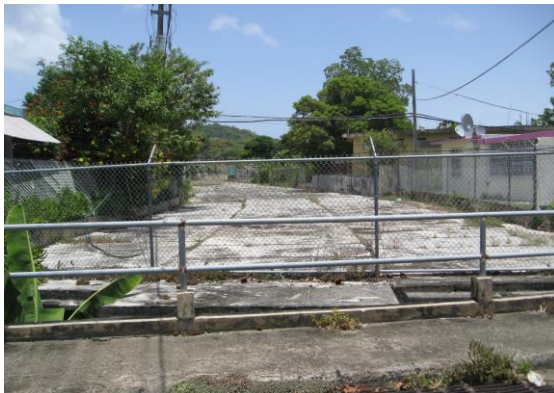
**Figure 6**  
**Box Culvert at Quebrada Mabu that has to be eliminated**

The culvert on Quebrada Mabu was eliminated because it had no infrastructural use as road or pedestrian sidewalk or anything else, Figure 6 and Figure 7 shows the box culvert that had to be eliminated.

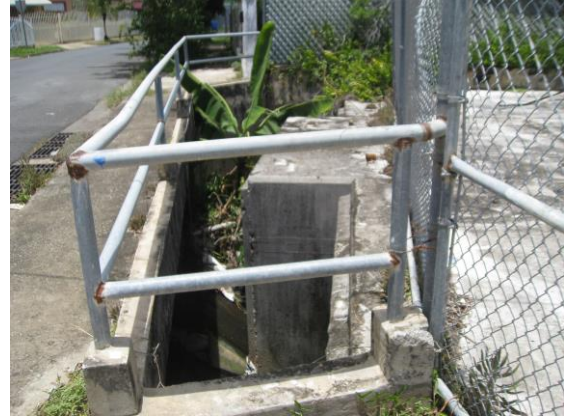
**Figure 7**  
**Box Culvert at Quebrada Mabu that has to be eliminated**
