# ***Damaged Magnet Wire Solution for Boeing 787-10 Electric Motor Pump***

*Frank R. Montes Diaz  
Master in Engineering Management  
Dr. Hector J. Cruzado  
Graduate School  
Polytechnic University of Puerto Rico*

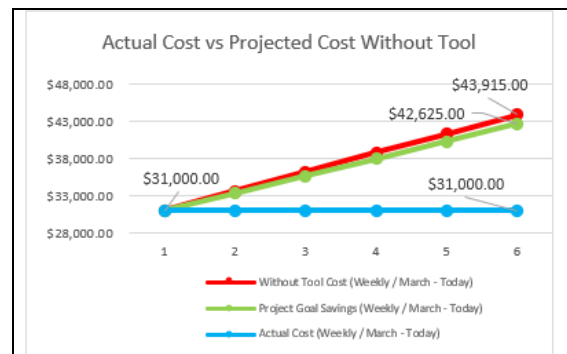
**Figure 2**  
Actual Cost vs Projected Cost

Financial progress is greater than the projected 52,700\$ by the end of May. Figure 2 demonstrates the actual financial progress vs the projected progress of the project. Initially, the project scope was to reduce 30% the overall recurrence of the incidence, but after implementation of the tool proposed, no incidence was currently recorded resulting in a 100% reduction after implementation. The differential between the without tool trendline and the actual cost trendline, by the end of April is \$12,915.00 or the actual savings of the project. The project initially calculated a rework cost of 70% or \$9,045 by the day of this report, but project results are a 100% reduction in defect and a \$12,915 in overall cost avoidance.

In addition to the PPM improvement, the project set a secondary objective of reducing the overall rework cost by 30% in the upcoming months. The target was set at \$52,700 by May 2023, with the current rework cost estimated at \$62,000 if the solution was not implemented. By implementing the plastic shim, substantial cost savings were expected to be achieved, contributing to improved financial performance. The successful implementation of the plastic shim occurred on April 3, 2023, following a meticulous evaluation process that determined the optimal dimensional thickness of 0.015". This thickness was selected based on considerations of the slot walls' thickness in the stator space, ensuring effective protection for the magnet wires during the removal process.
