# ***Wind Blade Composite Design, Manufacturing and Experimental Testing***

*Miguel J. Hernandez Gelpi  
Mechanical Engineering  
Julio Noriega, Ph.D.  
Mechanical Engineering Department  
Polytechnic University of Puerto Rico*

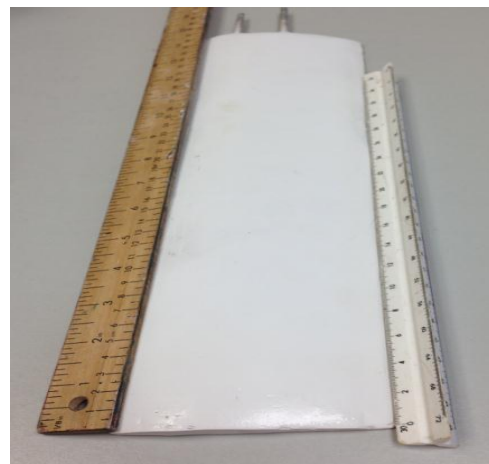
Blade surface is sanded due to only one surface is smooth. Next apply a damp cloth to remove debris, and applied a coat of paint Figure 7.

**Figure 7**  
Finishing Blade

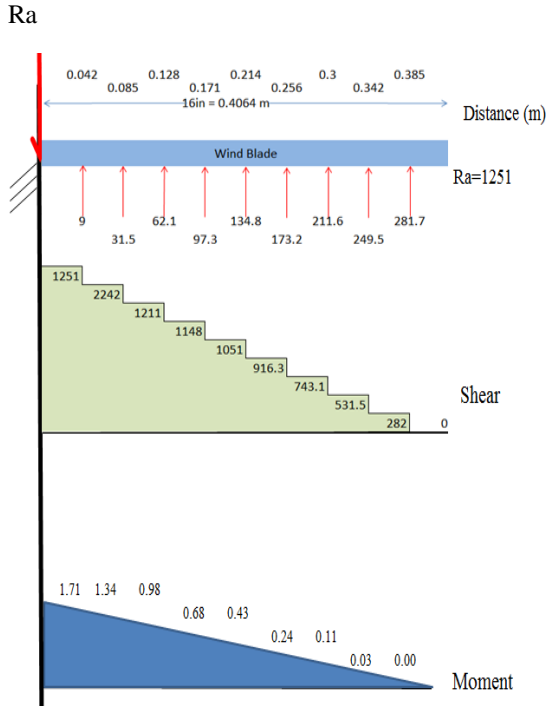
Cantilever Beam Method is used to approximate forces in each blade. The shear and momentum diagrams (Figure 8) [6] calculated is as follow:

Figure 8  
Conditional Blade Shear and Momentum

Using the total moment is 6N-m see Figure 8,  $I = 2.52e^{-11} \text{ m}^4$  moment of inertia acting in the rods.

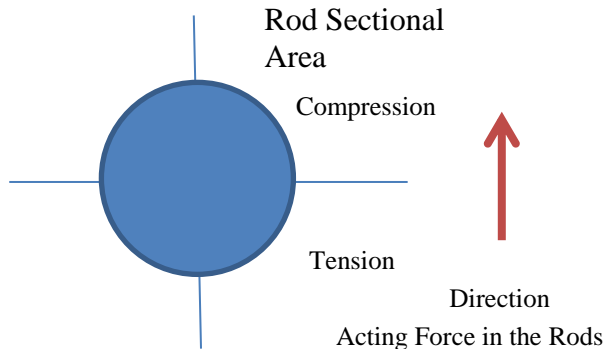
Using the maximum shear and moment values from the previous diagrams for Figure 9.

Figure 9  
Blade Shear and Momentum

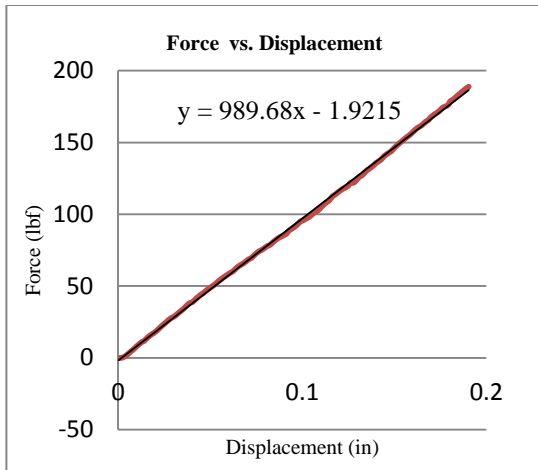
**Figure 15**

**Force vs. Displacement Bending Test 2 (Linearity)**

Elastic stress linearity at second bending stress is 191 lb. at 0.18in, low in comparison to bending test 1 of 250lb at 0.26 in.

First test indicates linearity at maximum of 233 lb.; Figure 13 and 15 show a similitude in the elastic range.

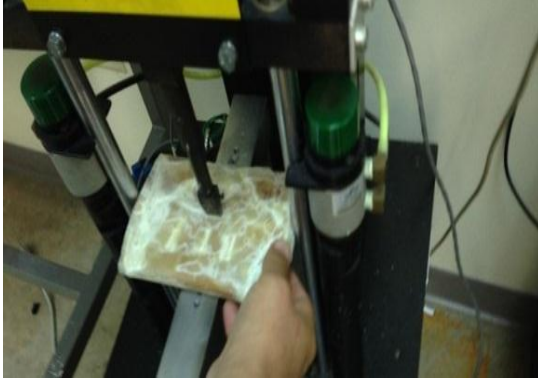
- Initially the impact test was measured close to leading edge.
- Test 1 not completely holed the blades but debonding it, result in internal crack.
- Test 3 the energy in this point crush the matrix blade, not holed all layer in the blade surface.
- Test 2 and 3 penetrated the layers (holed the blade, Figure 17), the impact energy is presented in Table 3.
- Evaluating Test 4 and 5, near the trailing edge, delamination results complete separation of the laminae. Three layer could take off with the hand, the other internal three layers reminded intact.

**Figure 17**  
**Impact Test # 4**

Test	Weight (kg)	Height (cm)	Velocity (m/s)	Energy (J)	Impact Side
1	13.02	45	2.97	57.42	Surface Front
2	13.02	40	2.80	51.04	Surface Middle
3	13.02	35	2.62	44.69	Surface Middle
4	13.02	26.5	2.28	33.84	Side Border back
5	13.02	40	2.80	51.04	Side Border back

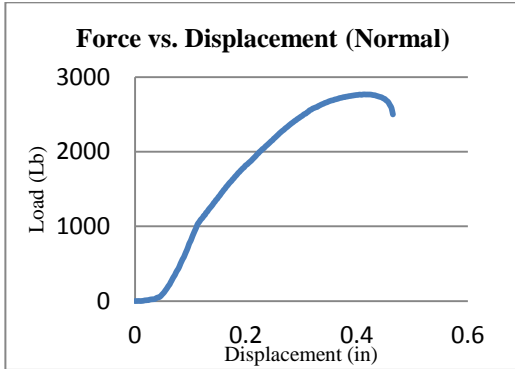
Figure 22

Force vs. Displacement Threaded Test

To obtain preload force the threaded graphical linear test was selected see Figure 22. Approximately 1000 lb. = 4448.22 N of force there in the elastically limit (3). Using from Reference [10], obtain the Diameters and areas of coarse-pitch and fine pitch metric thread. Nominal Major Diameter  $d = 5\text{mm}$  and Pitch = 0.8 and Tensile Stress Area =  $14.2 \text{ mm}^2$  [10].
