Carnauba Dispenser to Improve Coated Tablets Elegance

Author: Mara L. Negron Romero Advisor: Dr. José A. Morales Morales Industrial and Systems Engineering Department

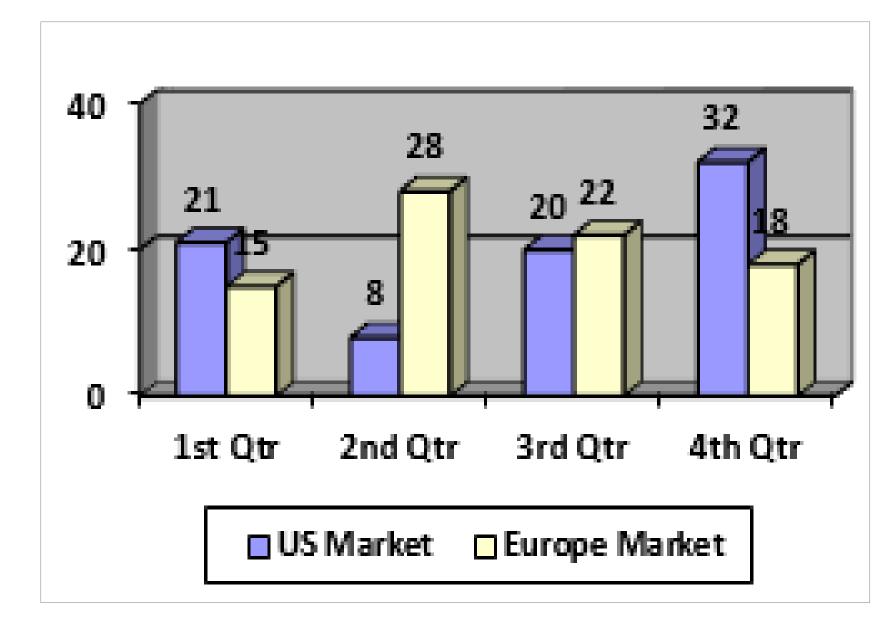
Figure 1: Customer Complaints (2019)

DEFINE: The problem faced by the organization was that the operational method of adding carnauba wax was covering tablets engraving (see Figure 1). This was resulting in reportable defects and extra efforts for support and resolution of customer complaints.

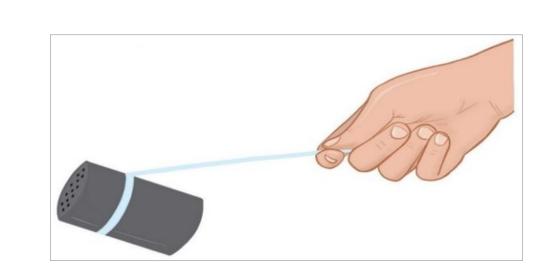
Figure 4: Carnauba Dispenser Prototype

The new tool consists of a stainless steel container with small holes that is manipulated by holding the Teflon handle. The required amount of carnauba will be transferred to the carnauba dispenser by the operator. Then, performing multiple agitations, the carnauba will be randomly distributed.

IMPROVE AND CONTROL: The tool was added to SOPs for coating process. Also, process guides were discussed in the production area to emphasize its importance in order to mitigate human error due to lack of information on the manufacturing process. Company emphasized the responsibility at every level to identify problems and suggest ideas, creating positive attitudes towards the improvement process.

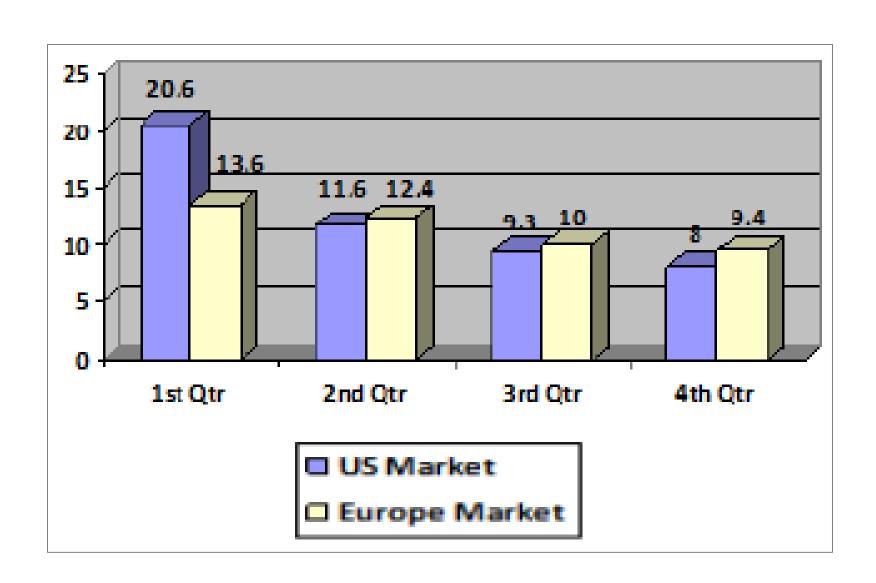
Figure 5: Customer Complaints (2020)

The implemented tool helped towards overall method improvement for taking action for the particular complaint significantly reducing more than 20% customer complaints for the specific coated tablet defect.
